**Experimental Evaluation of Axial, Shear, and Moment Forces of
Double Angle Connections when Subjected to Unanticipated Loading**

A Report Submitted to the Faculty of the
Milwaukee School of Engineering
in Partial Fulfillment of the
Requirements for the Degree of
Master of Science in Architectural Engineering

May 2019

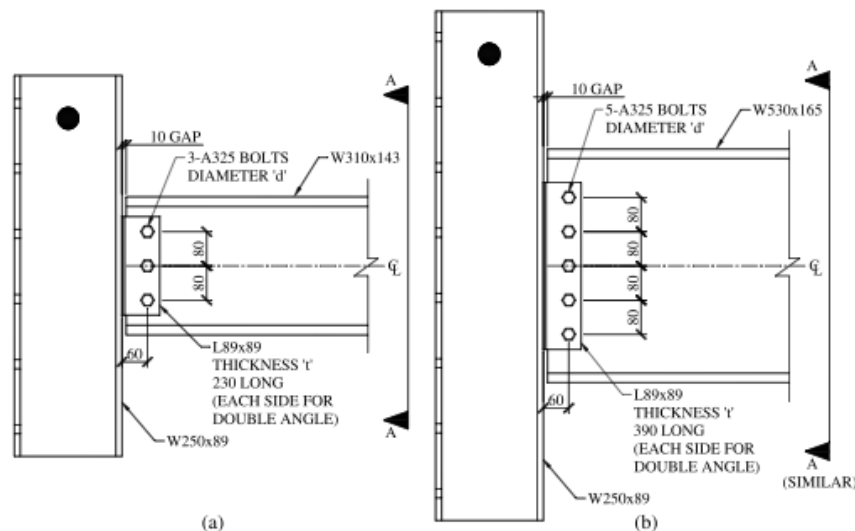
Figure 2.2-2: Testing configuration for double angle specimens (Oosterhof & Driver, 2015).

The double-angle specimens were $2L3\frac{1}{2} \times 3\frac{1}{2} \times \frac{1}{4}$ with a yield strength of 50 ksi, with either three or five bolt holes spaced at 3.15 inches. Testing bolts were $\frac{3}{4}$ -in. A325 bolts, mounted in all standard holes, fastened to a snug tight condition. Connection geometry is shown in Figure 2.2-2.

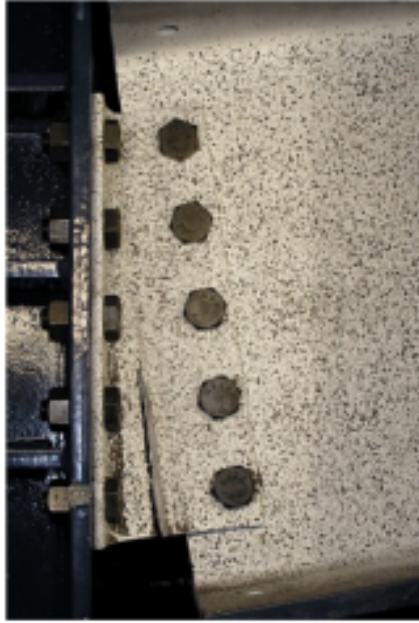
Figure 2.2-4: Tear propagation near the heel (Oosterhof & Driver, 2015).

All angle connections failed by the propagation of a tear initiating from either the bottom heel of the angle, as shown in Figure 2.2-4, or along the length of the column-side connection bolts nearest to the beam web as shown in Figure 2.2-5. Tearing of the gross section near the angle heel, while not commonly observed, was found to be unstable; any increase in rotation caused the tear to continue along the length of the angle with an accompanied decrease in load. This failure mode at times occurred suddenly, with immediate formation of tears across the entire depth of the angle. This type of failure, because it resulted in complete connection failure, may be considered brittle failure mode most akin to tensile rupture. This failure mode typically occurred at the beam side of the angle heel.

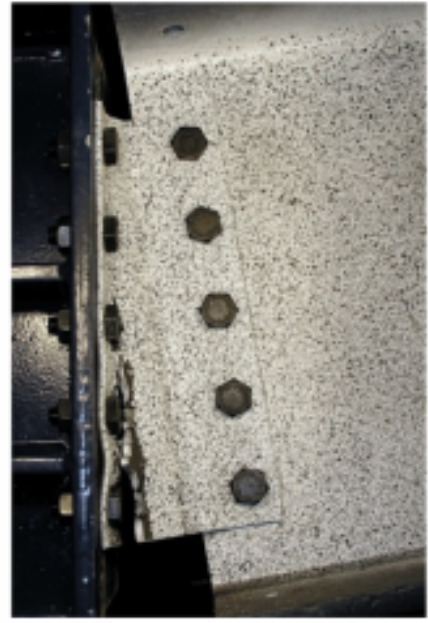
Figure 2.2-5: Tear propagation near column bolts (Oosterhof & Driver, 2015).

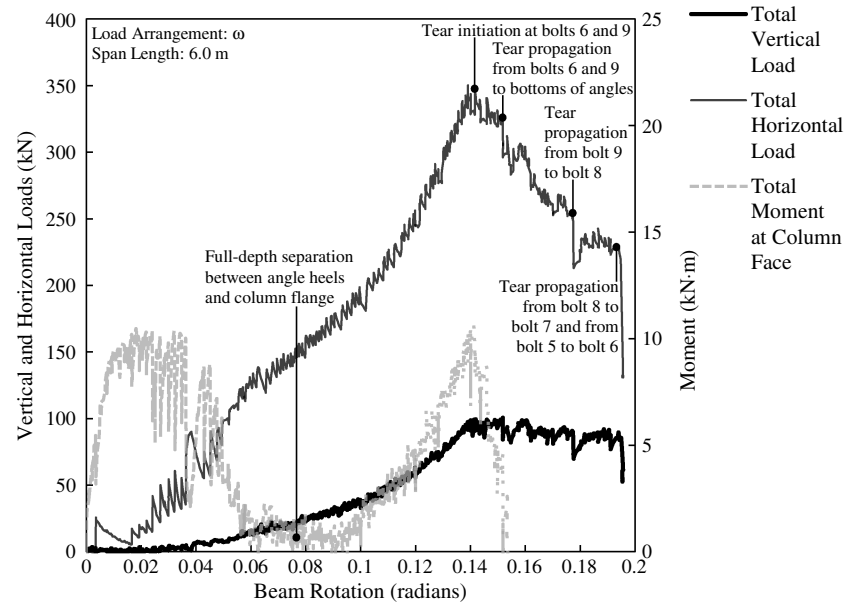
Figure 2.2-6: Load development plot of a double angle test (Oosterhof & Driver, 2015).

Tears forming at the column bolt line was the most common type of failure. These tears would follow a jagged path from bolt to bolt but would be arrested before reaching a subsequent bolt hole. This arrest allowed the connection to find new load paths. Upon examination of connection bolts used in one of these types of failures it was found that no shear deformation had occurred and bolt bearing deformation at the beam-side connection of the angle was limited to less than 1 mm. Figure 2.2-6 shows a load development plot typical of a double angle test failing along a plastic hinge which developed at the column bolt line.

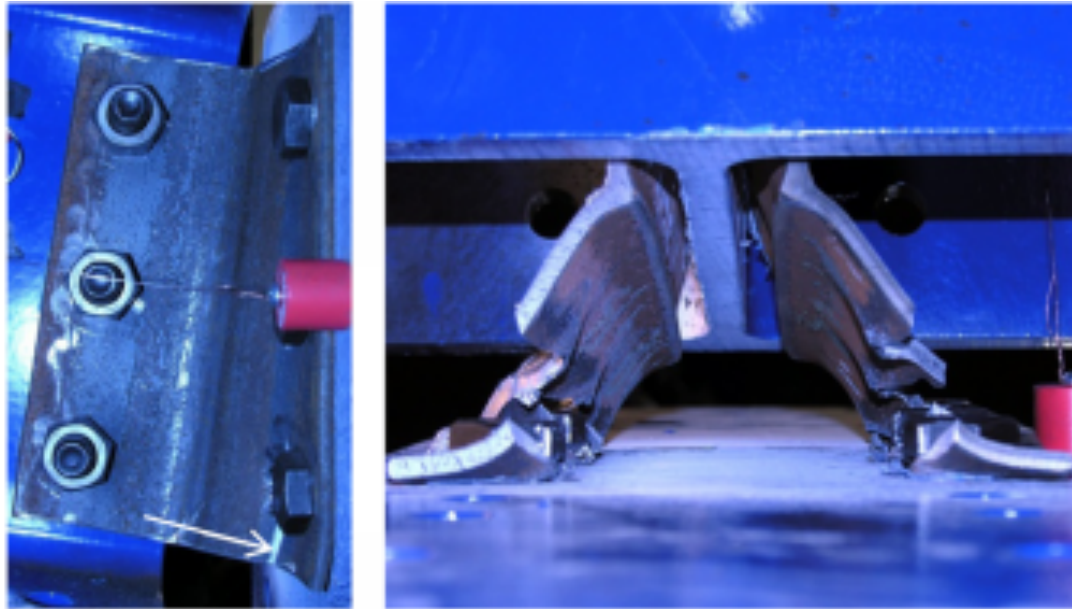
Figure 2.2-7: Propagation of tears along the column bolt line (Oosterhof & Driver, 2015).

Photographs of the angles during this test are shown in Figure 2.2-7. In the test shown, a tear is propagating along the heel of the angle, following a jagged path from bolt hole to bolt hole. The maximum horizontal load was recorded immediately prior to tear initiation at the bottom column bolt hole. A stepwise decrease in load capacity is observed, and results from the initiation and progression of tears along the depth of the angle leg along the column flange. The plateau in the total vertical loading data indicates

a significant presence of residual capacity in the connection despite the progression of these tears along the depth of the angle.

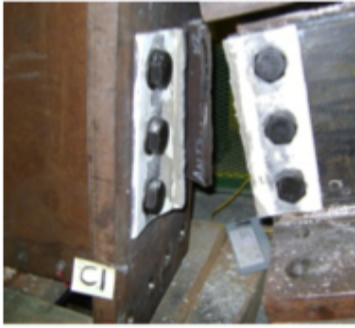
Figure 2.3-4:
Specimen C1
failure (Gong,
2017).

For test C1, the first angle rupture occurred on the left-side beam of the assembly on one angle only. Loading continued until the other angle on the same beam ruptured. These ruptures occurred at the gross section of the angle as shown in Figure 2.3-4. Specimen C2 failed by one of the right-side angles. Because of this failure, the central column tilted dramatically and therefore the testing was terminated immediately. The failure also occurred at the gross section of the angle, along the yield line near the heel of the angle. This location of failure agrees with the plastic hinge locations proposed by Oosterhof and Driver (2015). For C3, the first failure was a partial tear located along the bolt line of the column-side leg of the angle, which was followed by a complete tear along an identical bolt line on the other angle as shown in Figure 2.3-5. The partial tear of the other angle during the C3 test is shown in Figure 2.3-6.

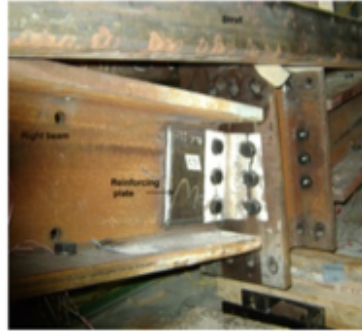
Figure 2.3-5:
Specimen C2
failure (Gong,
2017).

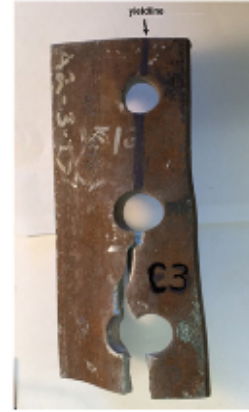
Figure 2.3-6: Tear
along C3 specimen
(Gong, 2017).

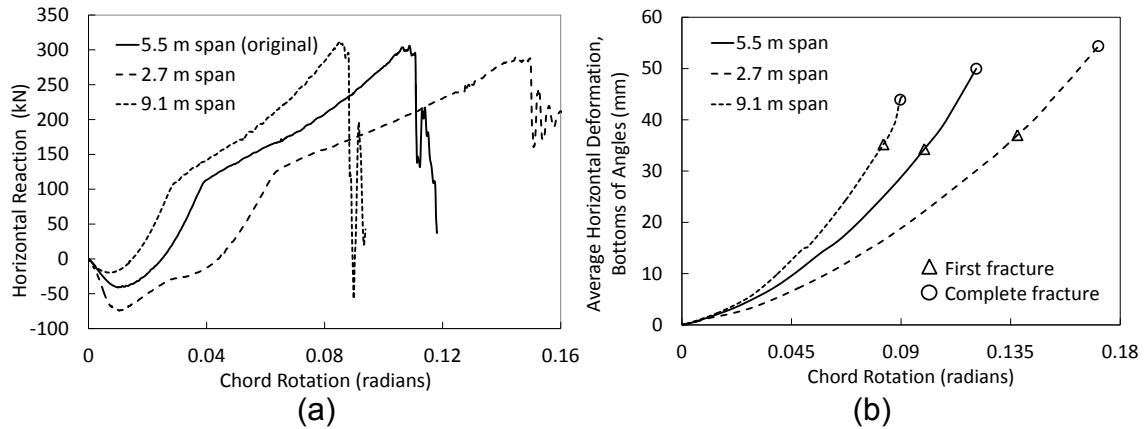
Figure 2.4-2: (a) Horizontal reaction versus chord rotation for varying beam spans, and (b) average horizontal deformation of angle versus chord rotation (Weigand, Liu, & Main, 2017).

Results from model analysis indicated that the length of beam span played a role in the robustness of the connection, with fracture occurring at a lower rotation when a longer beam was used. It is mentioned that a longer beam span results with a greater elongation at the connection for identical beam chord rotations when compared to shorter beams. It was found, however, that horizontal deformation at failure was only slightly affected by the beam span length. The first fracture at the connection occurred at the bottom of the angle near the k-area of the column leg of the angle and then propagated upward through the angle as loading continued. This is consistent with other research (Gong, 2017; Oosterhof & Driver, 2015; Weigand & Berman, 2016). Horizontal deformation of the angle increased with varying magnitude in relation to a decrease in span length, but the angle deformation at first fracture was nearly constant across tests. The relationship of chord rotations to the horizontal reaction at the connection and the deformation of the angle is shown in Figure 2.4-2(a) and Figure 2.4-2(b).

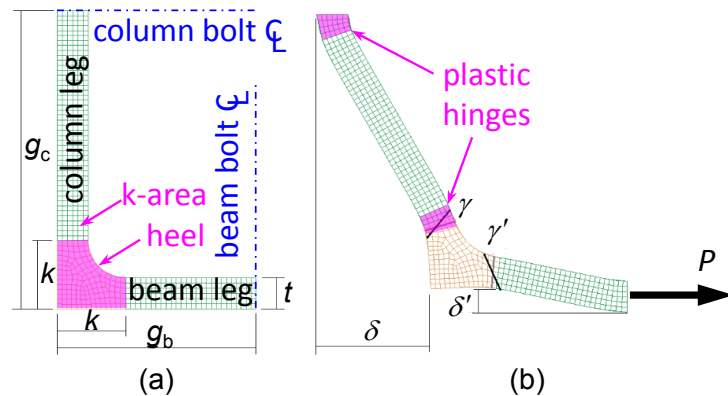
Figure 2.4-3: (a) Initial angle geometry, and (b) deformed angle geometry (Weigand, Liu, & Main, 2017).

Results from testing and the use of a high-fidelity finite-element model under specific loading and restraint conditions is shown in Figure 2.4-3. Note that the angle legs were truncated at the bolt locations and the angles were modeled as fully fixed at these locations.

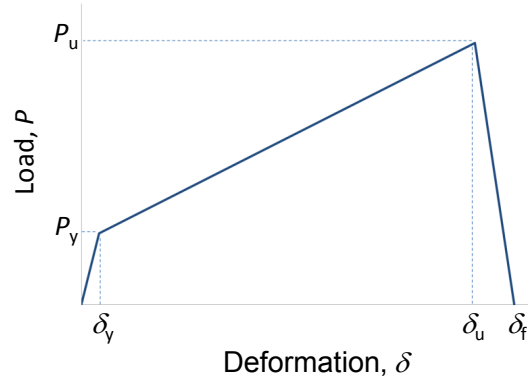
Figure 2.4-4: Load-deformation relationship for angle (Liu, Main, & Sadek, 2016).

A piecewise-linear relationship was established to represent the behavior of the angle while undergoing various levels of loading. This relationship is based on the axial load P and the angle deformation δ . A single angle was considered with a component width of b which was found by dividing the total angle depth by the number of bolts. The load corresponding to one bolt row of the double angle connection was found by simply doubling the load P . The yield capacity P_y corresponds with the development of plastic hinges at the column leg of the angle, and the ultimate capacity P_u is associated with fracture of the angle near the k-area. The load deformation relationship is shown in Figure 2.4-4.

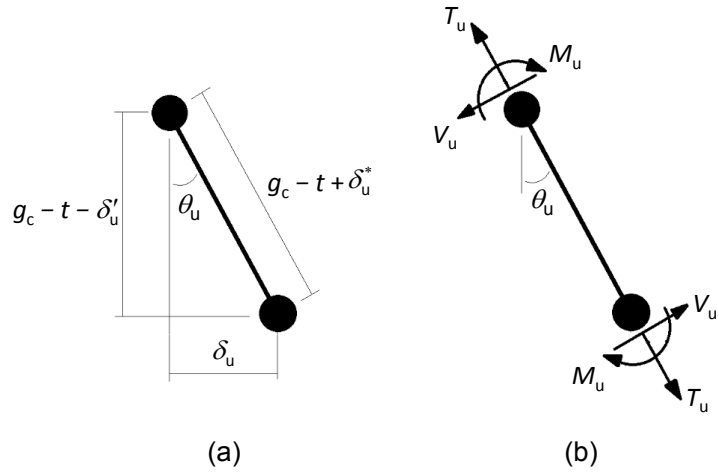
Figure 2.4-5: Two-hinge idealization of angle's column leg at ultimate load: (a) geometry and (b) free-body diagram (Weigand, Liu, & Main, 2017).

The geometry of a deformed angle was simplified and used to develop expressions for the ultimate load P_u and the corresponding angle deformation δ_u . This simplified geometry is shown in Figure 2.4-5. The angle's column leg was modeled as a straight-line segment with plastic hinges at its ends and was subjected to axial tension T_u , shear force V_u , and bending moment M_u . The lengths of the plastic hinges were assumed equal to the thickness of the angle, t .

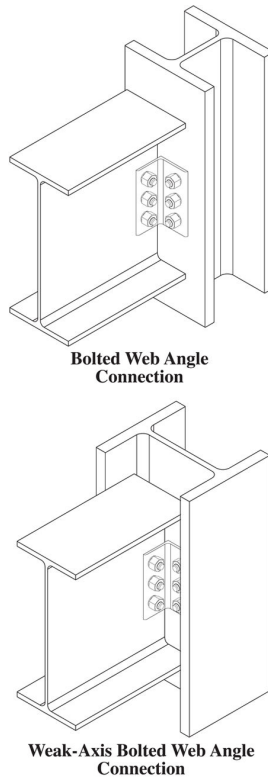
Figure 2.5-1: Typical bolted-bolted configuration (Weigand & Berman, 2016).

Most connection assemblages were bolted-bolted configurations with 3/4-in. bolts and either 1/4-in. or 1/2-in. thick angle legs; these configurations are shown in Figure 2.5-1. These two angle thicknesses were chosen to investigate the differences in connection performance with respect to the limit states of angle leg rupture and bolt prying rupture when the angle is subjected to a tensile catenary force. The thinner angle specimens were also chosen to isolate damage to the angles rather than the supported beams, ensuring that they could be re-used without significant damage or introduction of imperfection.

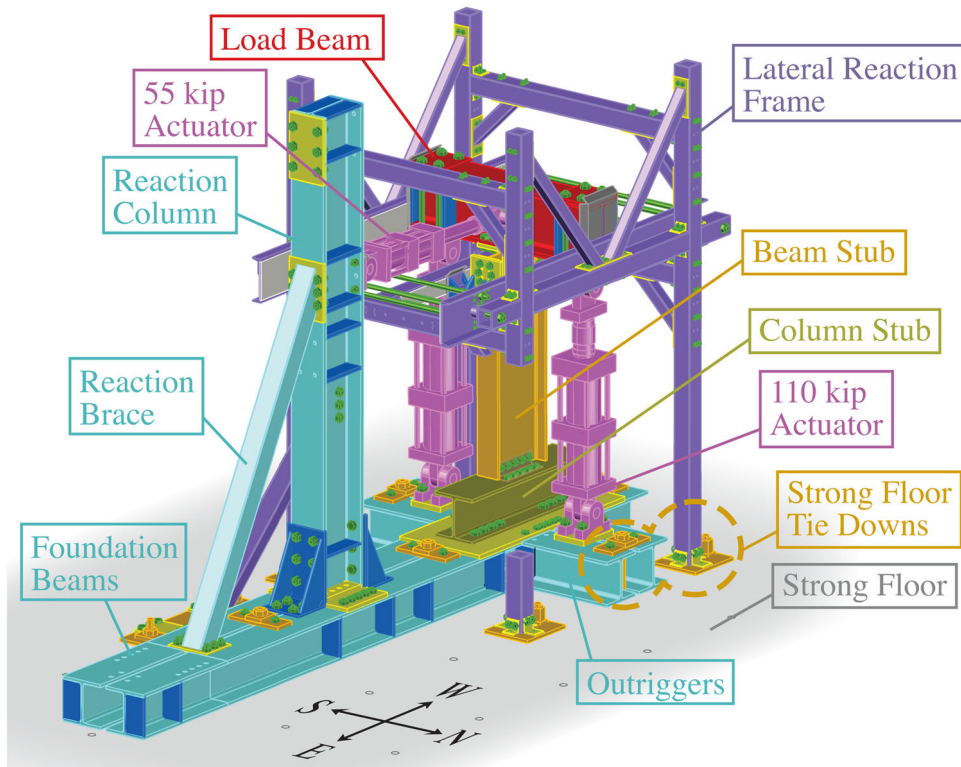
Figure 2.5-2: Load frame assembly (Weigand & Berman, 2016).

The sub-assemblages were tested using a self-reacting frame at the University of Washington Structural Research Laboratory. This frame is shown in Figure 2.5-2.

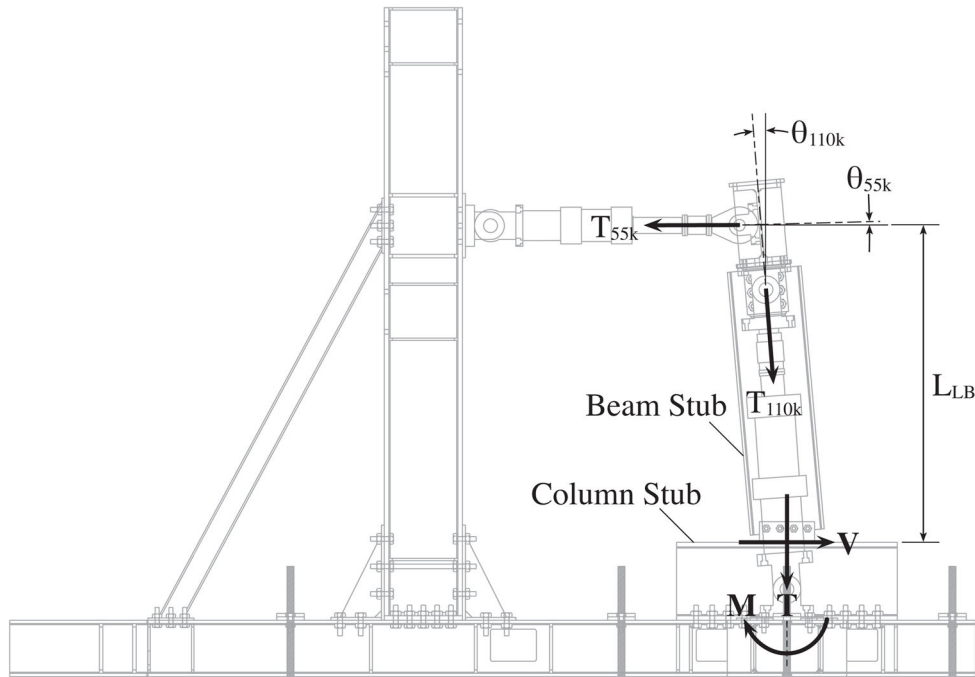
Figure 2.5-3: Free body diagram of testing frame (Weigand & Berman, 2016).

undergone a column-removal scenario in a double span condition. The loading was applied quasi-statically over a time span of approximately 60 minutes. A free body diagram of the testing frame, test beam and actuators are shown in Figure 2.5-3.

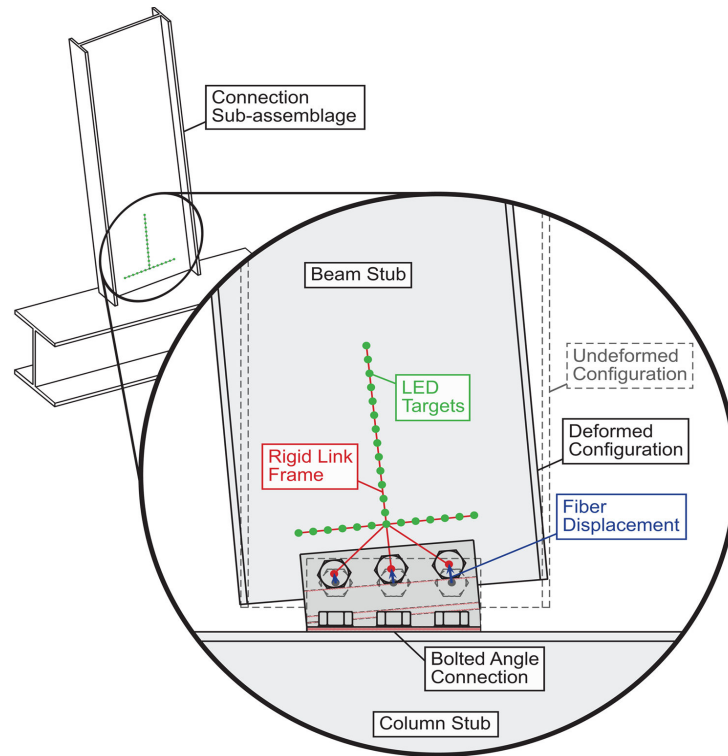
Figure 2.5-4: Method for computing fiber displacements (Weigand & Berman, 2016).

exactly coincide and the length of each of the two fibers is zero. After load application and consequent deformations, the fiber displacements were computed as the distance between the undeformed and the deformed locations of the fiber nodes and were then decomposed into axial and shear components.

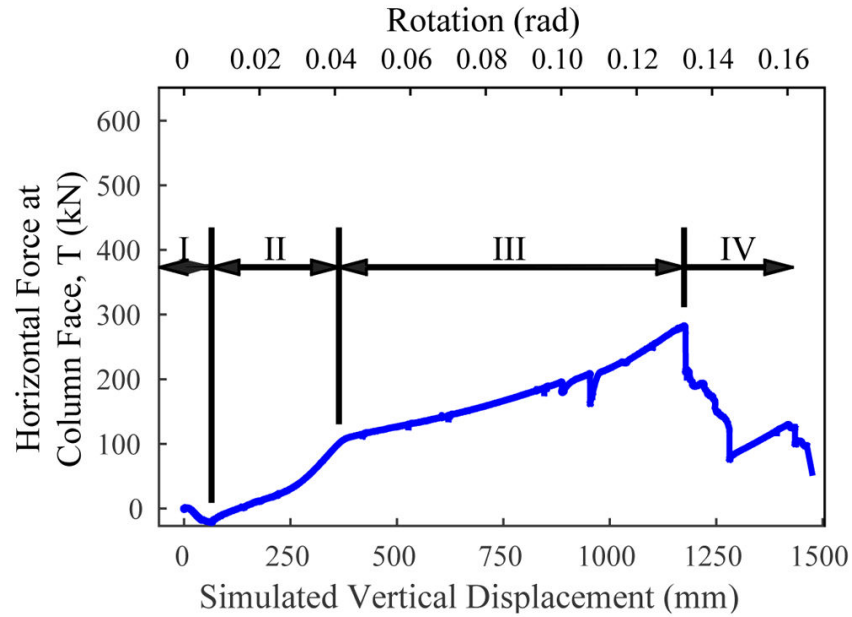
Figure 2.5-5: Phases of vertical and horizontal force-displacement behavior for ba3b|34|14| (Weigand & Berman, 2016).

The behavior of the bolted connection sub-assemblages varied with the angle thickness, with the 1/4-in. specimens deforming with little to no prying action in the column leg bolts. With 1/2-in. angles, however, the increased angle strength was sufficient to induce prying into the bolts at the column leg of the angle as the primary mechanism of deformation and ultimate failure.

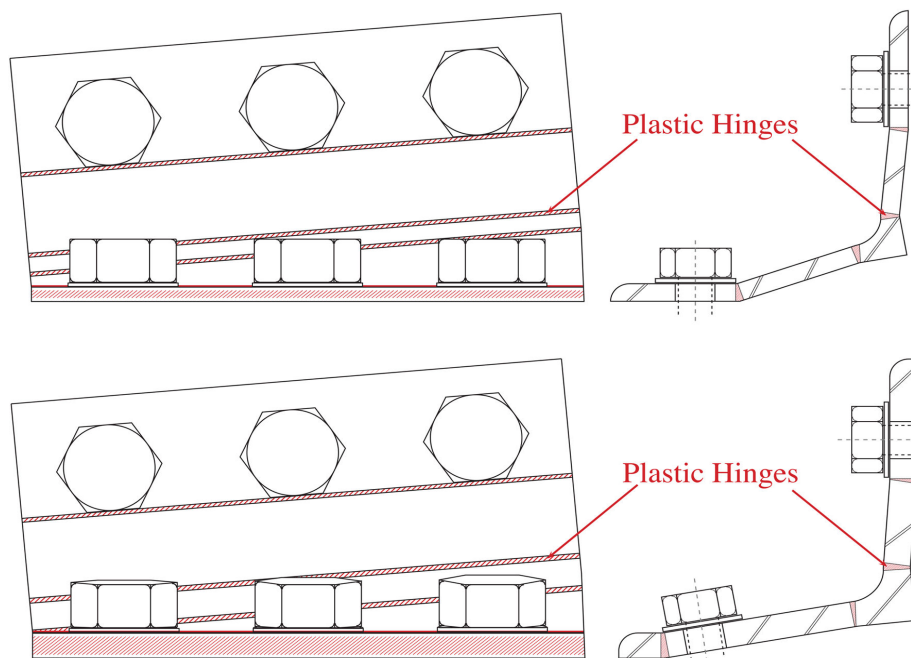
Figure 2.5-9: Plastic hinge formation in 1/4-in. angles (top) and 1/2-in. angles (bottom) (Weigand & Berman, 2016). Column face is along the horizontal. Plastic hinges indicated by hatched regions.

large concentrations of rotations that were visible on the deformed angle cross-sections. The locations of these plastic hinges varied with the thickness of the angle legs relative to the strengths of the column-leg bolts. The 1/4-in. thick angles developed plastic hinges along the inside edge of the column leg bolts at the toe of the angle leg radius and along the inside edge of the beam leg bolts. One half-inch thick angles, similar to 1/4-in. thick angles, formed plastic hinges at the toes of the angle radius and inside of the beam leg bolts. A difference, however, in the plastic hinge formation is found at the toe of the column bolts, where a hinge formed on the far side of the angle leg relative to the radius. This location of plastic hinge formation and consequent deformation is significant as it introduces a prying action on the column leg bolts. Figure 2.5-9 shows the location of plastic hinges in both 1/4-in. and 1/2-in. specimen.

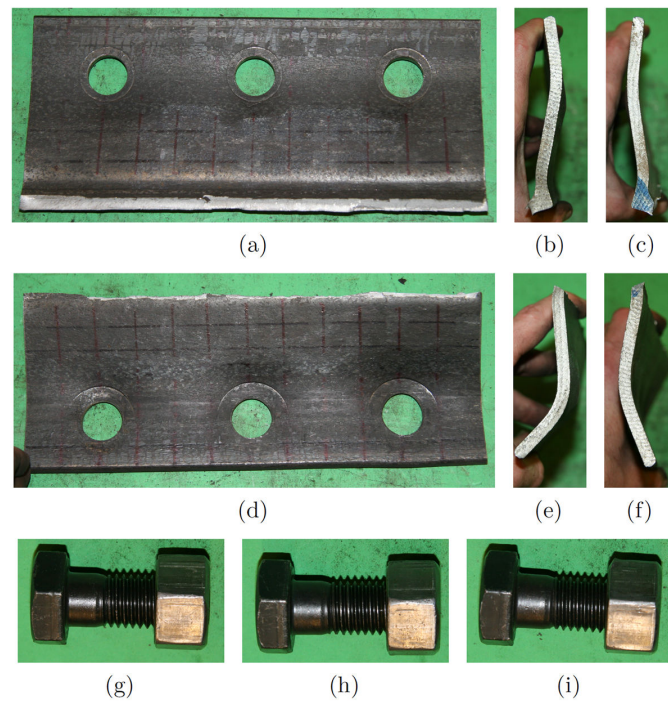
Figure 2.5-10: Specimen ba3b|34|14| post-test (Weigand & Berman, 2016). Representative of 1/4-in. angle behavior.

Deformations in the angles increased until failure, at which point the connection moved into Phase IV degradation behavior. In 1/4-in. thick angles, a common failure mechanism was the formation of a crack at one of the plastic hinges in the angle cross section near the angle radius which subsequently tore a length of 30-50% of the total angle depth. This initial tear, with continued loading, would propagate and extend the entire depth of the angle, leading to complete connection failure. Figure 2.5-10 shows damage to the north web angle and column bolts of specimen ba3b|34|14| following test completion. Damage was isolated to the angles instead of the connection bolts, which is typical for the 1/4-in. thick angles. Views (a, b, c) show front and section views of ruptured north web angle beam leg, (d, e, f) show front and section views of ruptured north web and angle column leg, and (g, h, i) show damage to the north web angle column bolts.

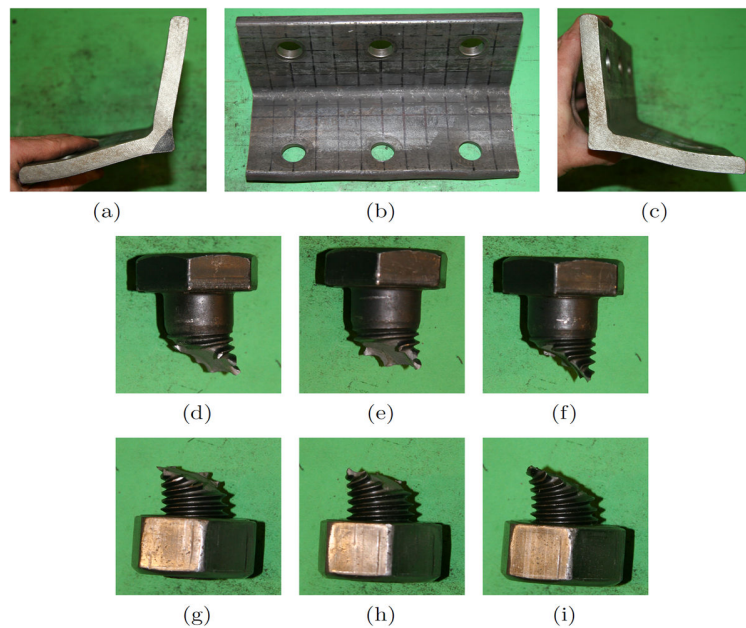
Figure 2.5-11: Specimen ba3b|34|12| post-test (Weigand & Berman, 2016). Representative of 1/2-in. thick angle behavior.

In connections with 1/2-in. thick angles, bolt rupture at column leg bolts due to prying action was the primary failure mechanism. Bolt ruptures always proceeded sequentially from the tension side of the connection toward the compression side, though ruptures were not always evenly distributed between the web angles. Figure 2.5-11 shows specimen ba3b|34|12| following testing; these results are representative of angles with 1/2-in. thick legs. Views (a, b, c) show front and section views of damage to the north web angle, (d, e, f) show ruptured north web angle column leg bolt heads, and (g, h, i) show ruptured north web angle column leg bolts with the nuts attached.

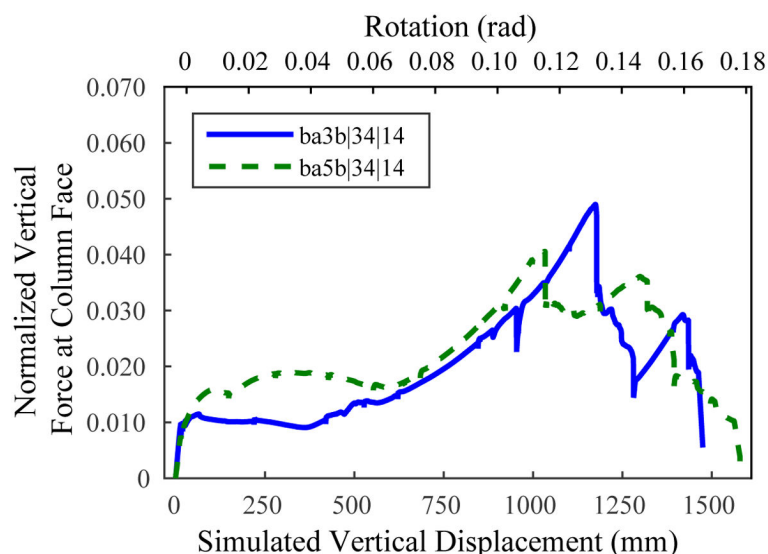
Figure 2.5-12: Normalized vertical responses of 1/4-in. 3- and 5-bolt specimens (Weigand & Berman, 2016).

Figure 2.5-12 plots the normalized vertical responses of Specimens ba3b|34|14| and ba5b|34|14| which differed only by the number of bolts in the connection. These results, along with those listed in Table 2.5-2, demonstrate that while the measured deformation capacities of the angle fibers were slightly higher in the 5-bolt angles in comparison to 3-bolt angles, their simulated vertical displacement at failure and corresponding normalized vertical and horizontal resistances decreased.

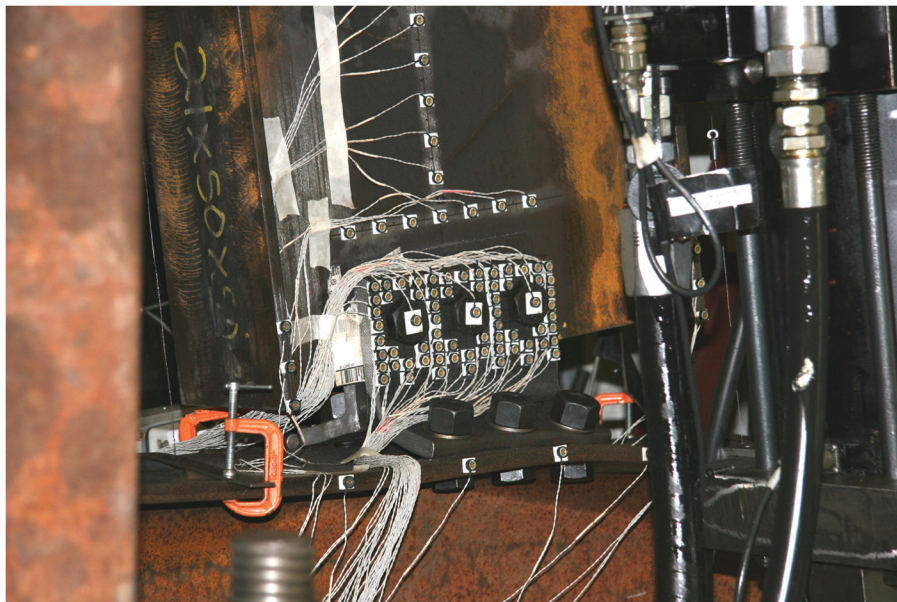
Figure 2.5-13: Extreme column warping of specimen ba3b|1|34| (Weigand & Berman, 2016).

Weigand and Berman found that the connection with the highest overall strength was ba3b|1|34| which used 1-in. diameter bolts with a 3/4-in. thick angle. This connection was so strong that it locally deformed the column web and the beam flange, ultimately failing by a brittle mechanism of block shear rupture at the beam web. In addition, the column leg bolts sustained large prying deformations due to angle uplift. This connection was believed to be, of all connections tested, the connection with the most deformation capacity and normalized vertical resistance. Figure 2.5-13 shows the extreme warping of the column flange during the testing.

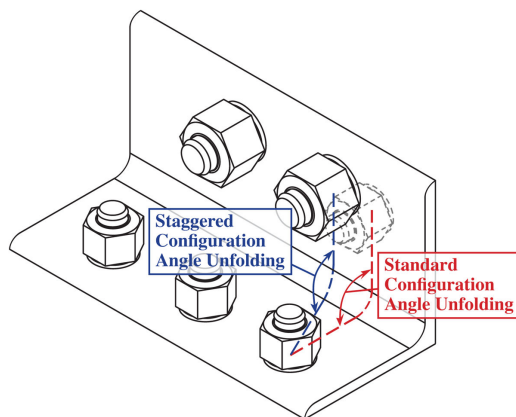
Figure 2.5-14: Staggered angle configuration (Weigand & Berman, 2016).

Specimens with staggered bolt holes were tested to establish whether offsetting bolt holes from one another would eliminate localized plastic strains observed while testing standard configuration bolted angle connections. A specimen designated as ba3b|34|14|HConfig was tested to establish a connection response which was compared to the response of ba3b|34|14|, a standard configuration. Figure 2.5-14 shows a staggered angle configuration.

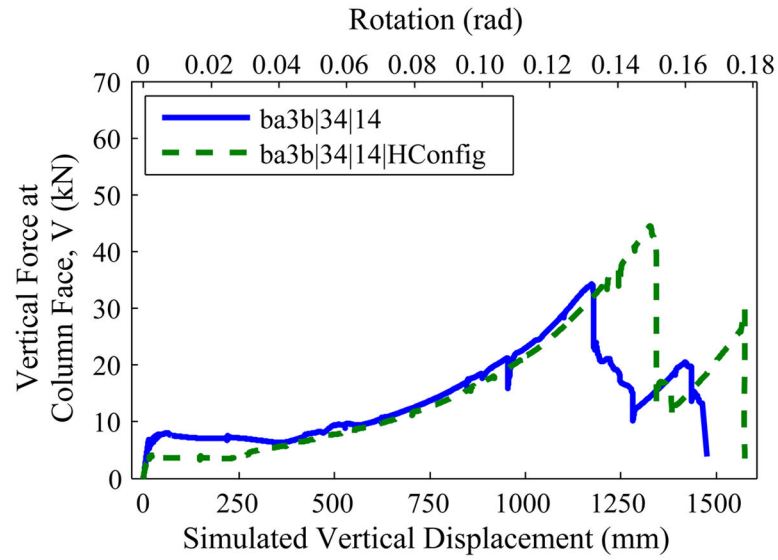
Figure 2.5-15: Specimen ba3b|34|14|HConfig compared to ba3b|34|14| (Weigand & Berman, 2016).

From testing, it was found that the staggered angle configuration of ba3b|34|14|HConfig had a 30% improvement in strength and 13% improvement in deformation capacity in comparison to its conventionally detailed counterpart. Similarly, a test was run with 1/2-in. thick angles with staggered bolt holes as well, designated as ba3b|34|12|HConfig. However, the test in which these specimens were used failed prematurely during testing due to beam web tear-out, so the extent to which the staggering of bolt holes might improve connection performance with relation to angle prying performance is unclear. However, from the 1/4-in. thick angle tests and the data collected from the 1/2-in. thick angle test, the data do collectively support the conclusion that staggering of the bolt holes may reduce concentrations of deformations at the angle plastic hinge lines, consequently improving connection performance under column removal-type scenarios. Results from these tests are shown in Figure 2.5-15 and 2.5-16.

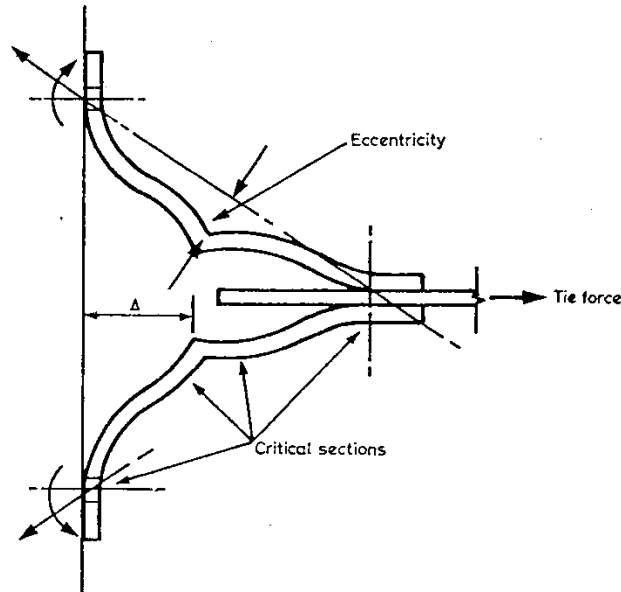
Figure 2.7-1: Critical sections in double-angle connections (Owens & Moore, 2006).

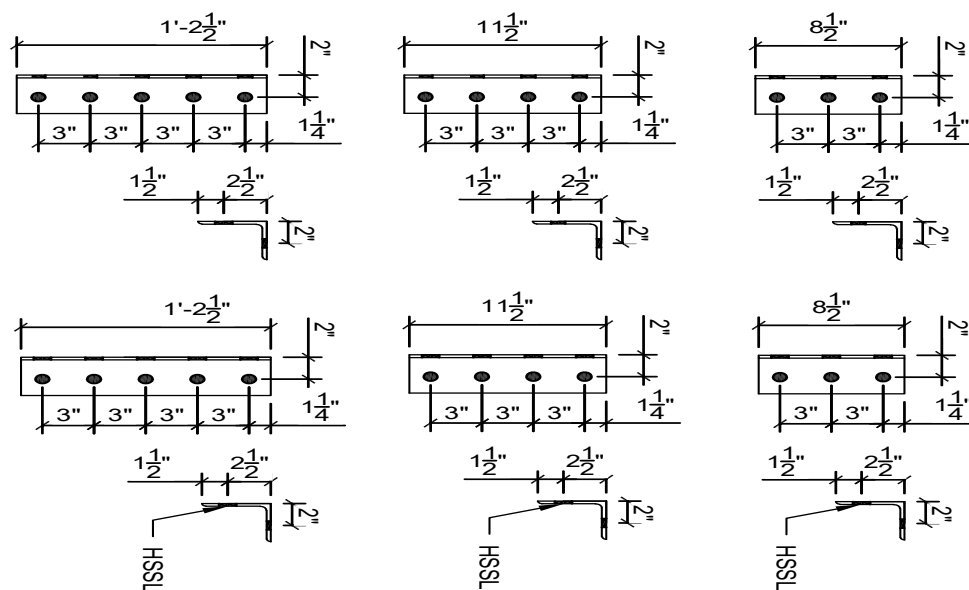
Figure 3.2-2: Angle configurations for testing with (a) 3 bolt lines, (b) 4 bolt lines, and (c) 5 bolt lines.

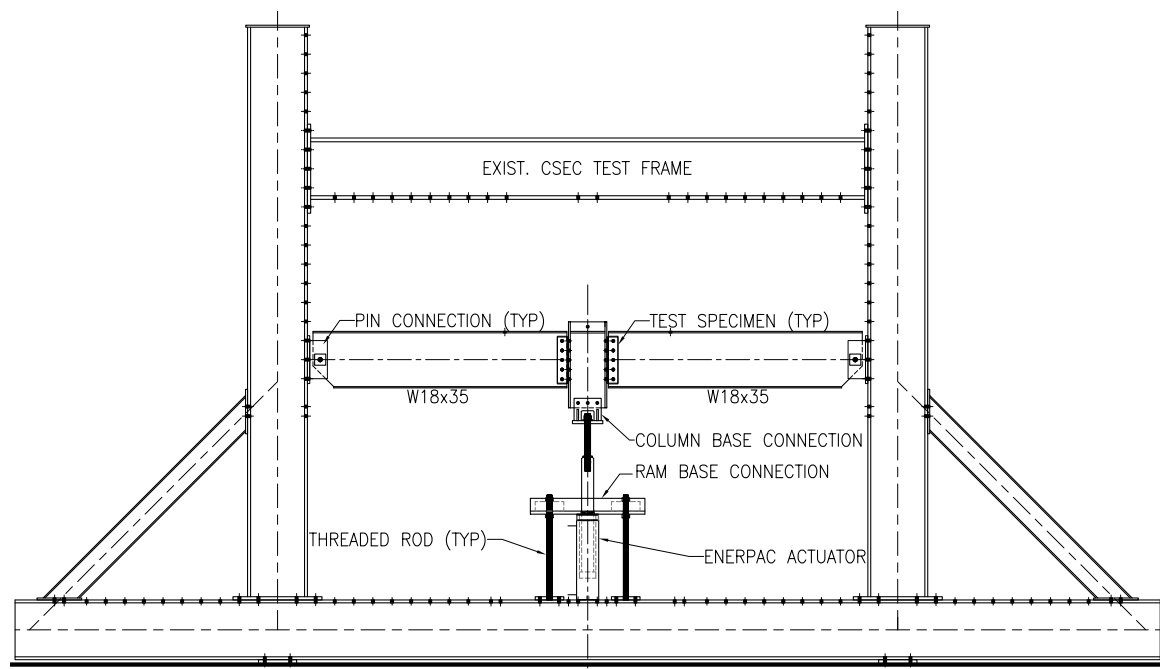
Figure 3.3-1: Test assembly overview.

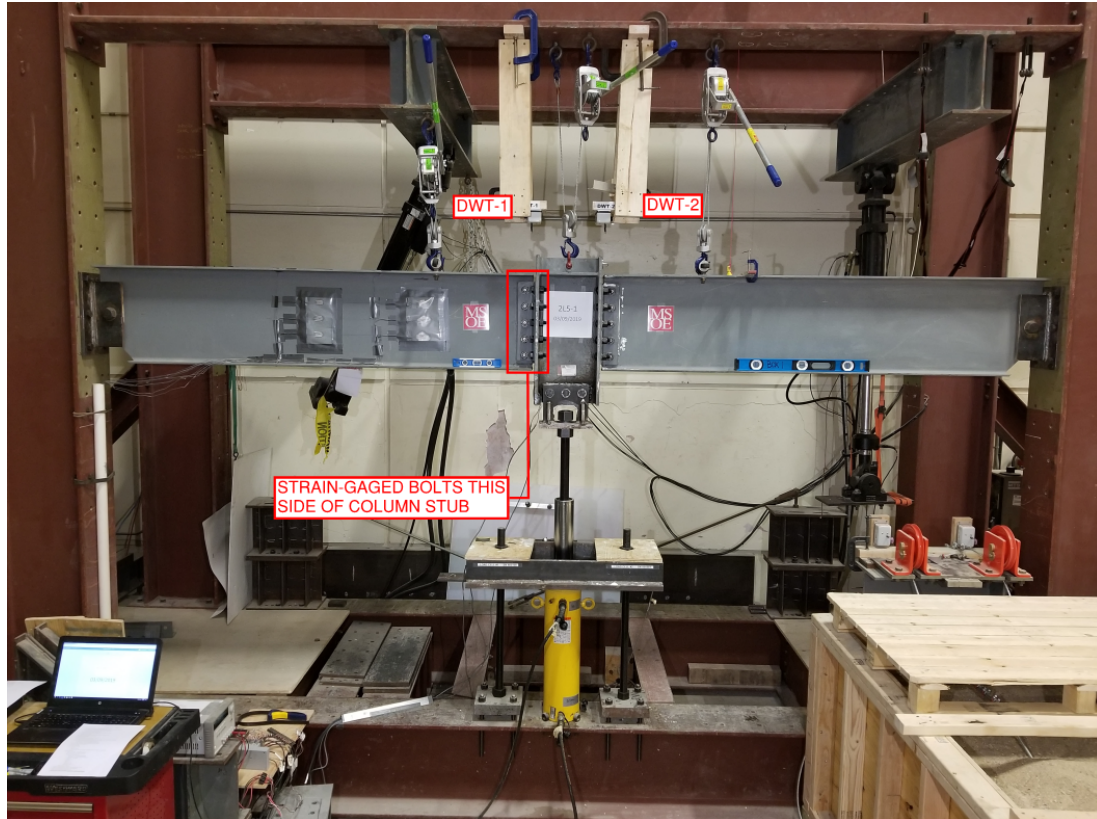
Figure 3.3-2: Test assembly overview.

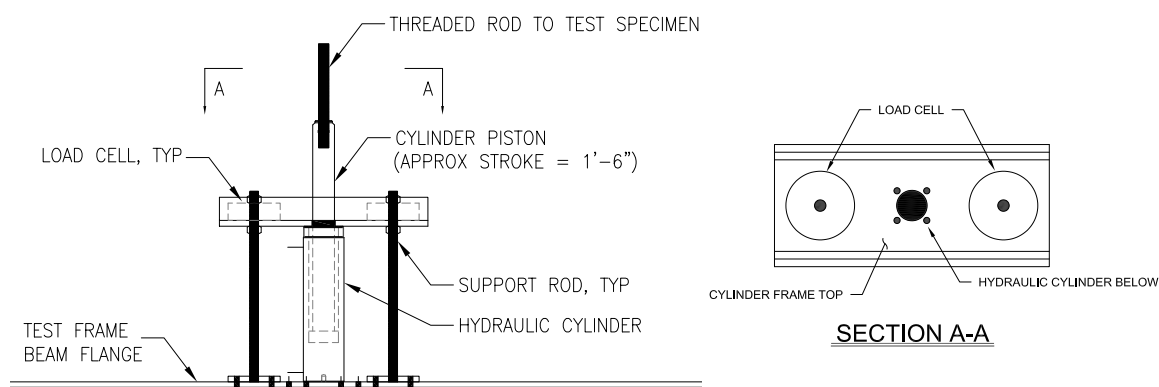
Figure 3.3-4: Hydraulic cylinder assembly.

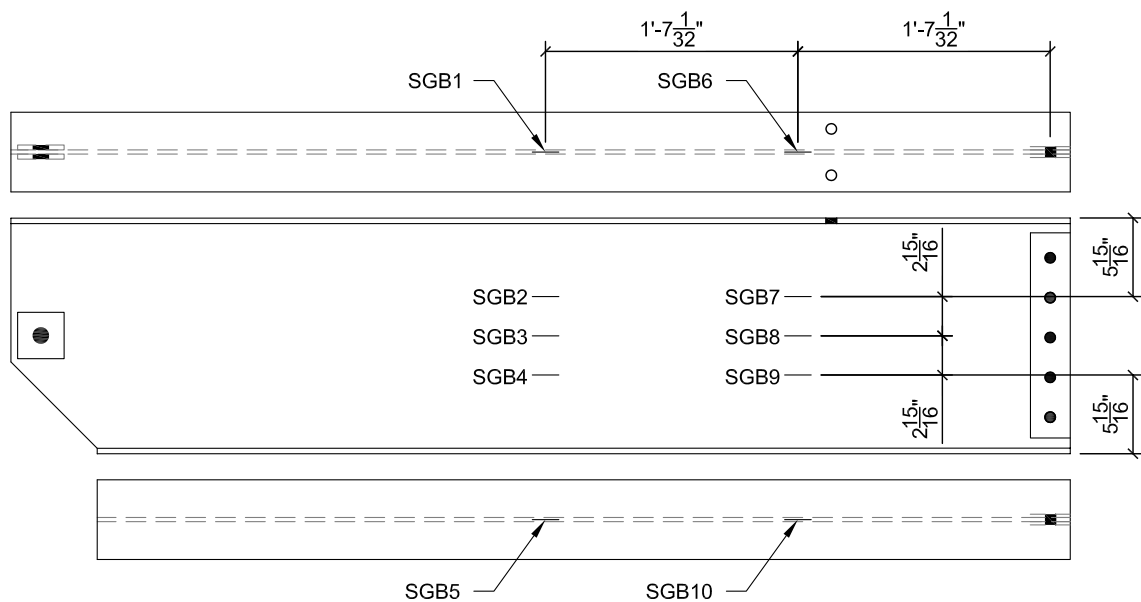
Figure 3.3-5: Strain gage placement on beam.

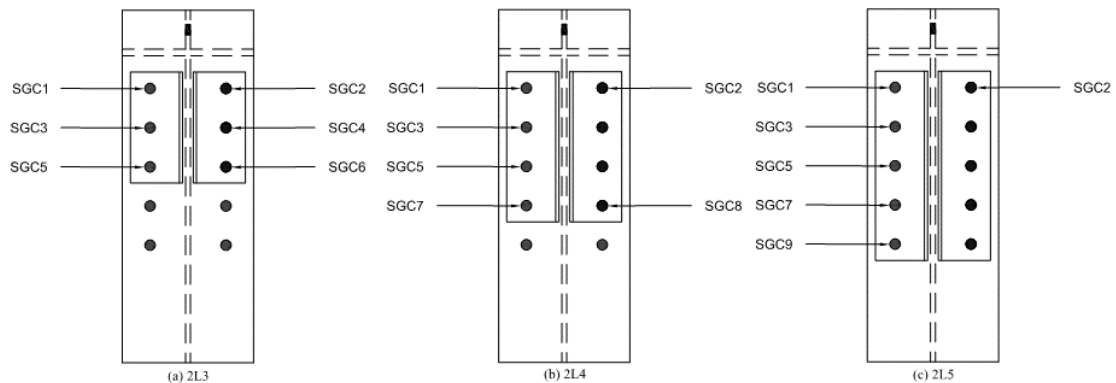
Figure 3.3-6: Strain gage placement for (a) 2L3, (b) 2L4 and (c) 2L5 specimens.

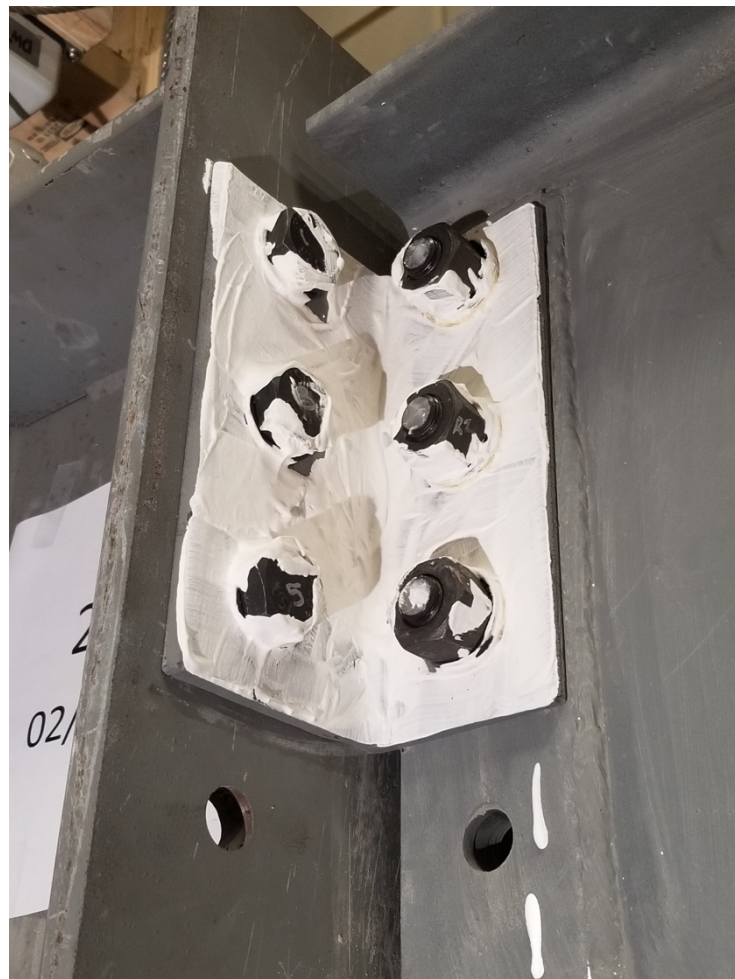
Figure 3.4-1: Plaster application on 2L3 specimen.

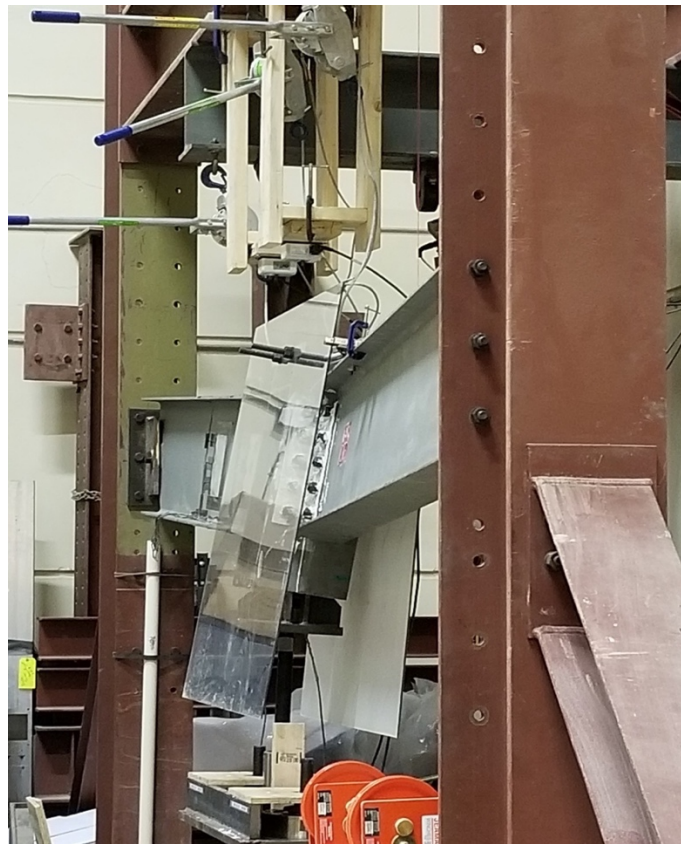
Figure 3.4-2: Lateral torsional buckling of test assembly.

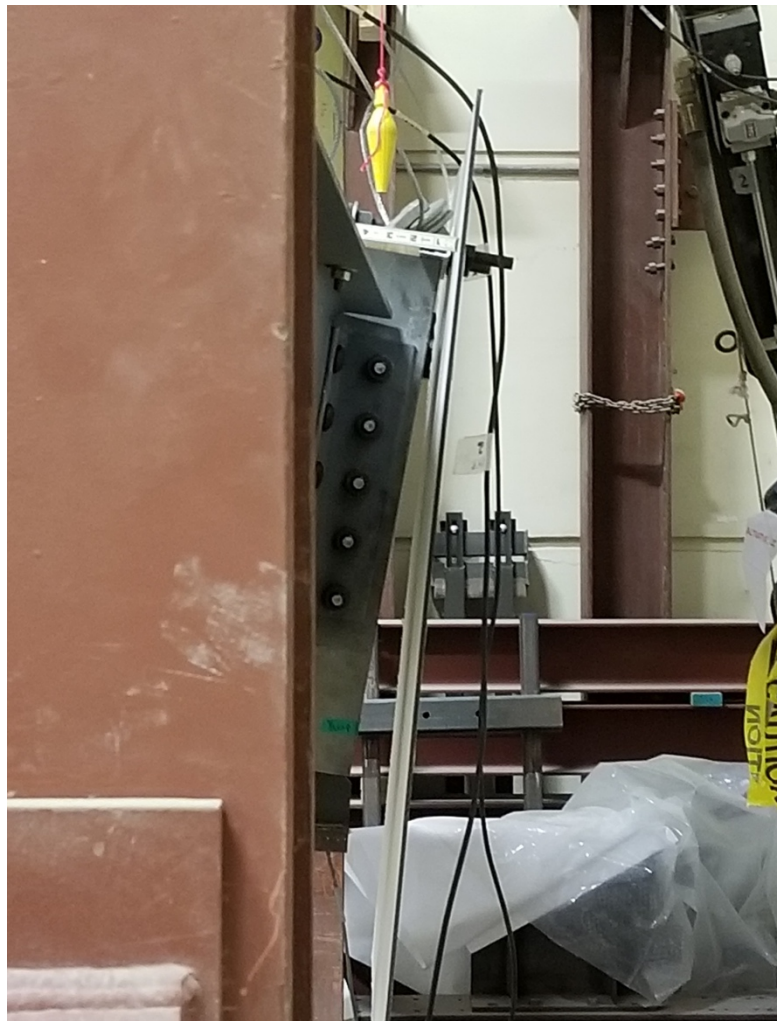
Figure 3.4-3: Measurement of LTB behavior.

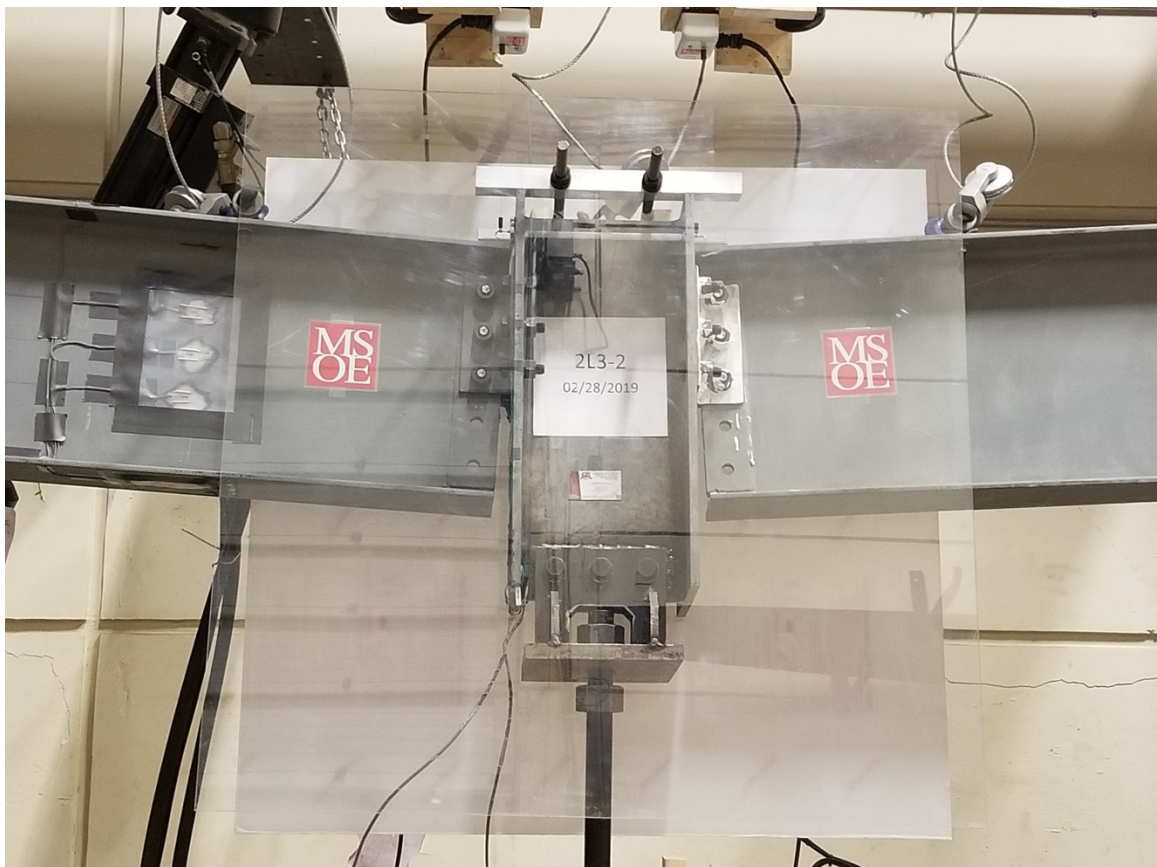
Figure 3.4-4: 2L3-2 test following completion.

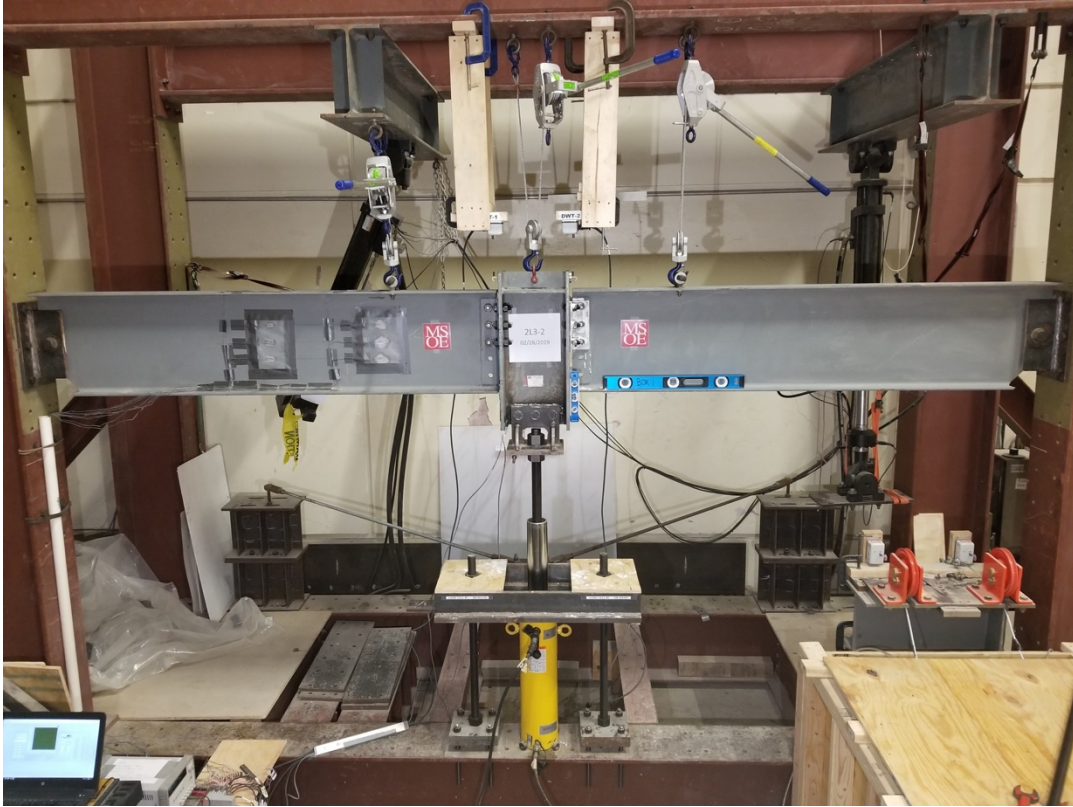
Figure 4.4-1: Typical 2L3 assembly before testing.

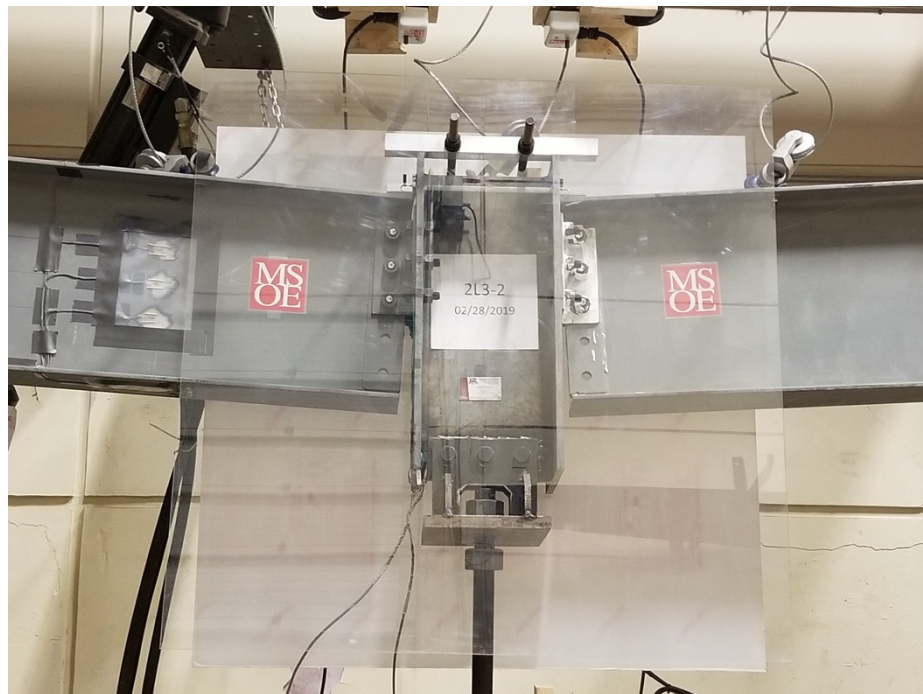
Figure 4.4-3: Typical 2L3 series specimen post-test.
