**Experimental Evaluation of Axial, Shear, and Moment Forces of
Double Angle Connections when Subjected to Unanticipated Loading**

A Report Submitted to the Faculty of the
Milwaukee School of Engineering
in Partial Fulfillment of the
Requirements for the Degree of
Master of Science in Architectural Engineering

May 2019

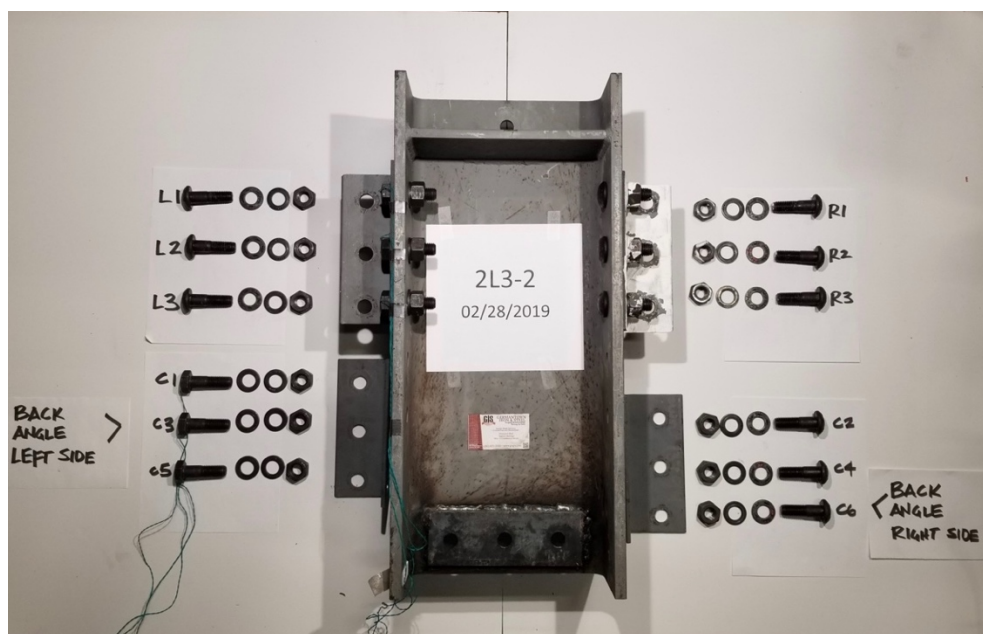
Figure 4.4-4: Typical post-test layout of 2L3 series specimen.

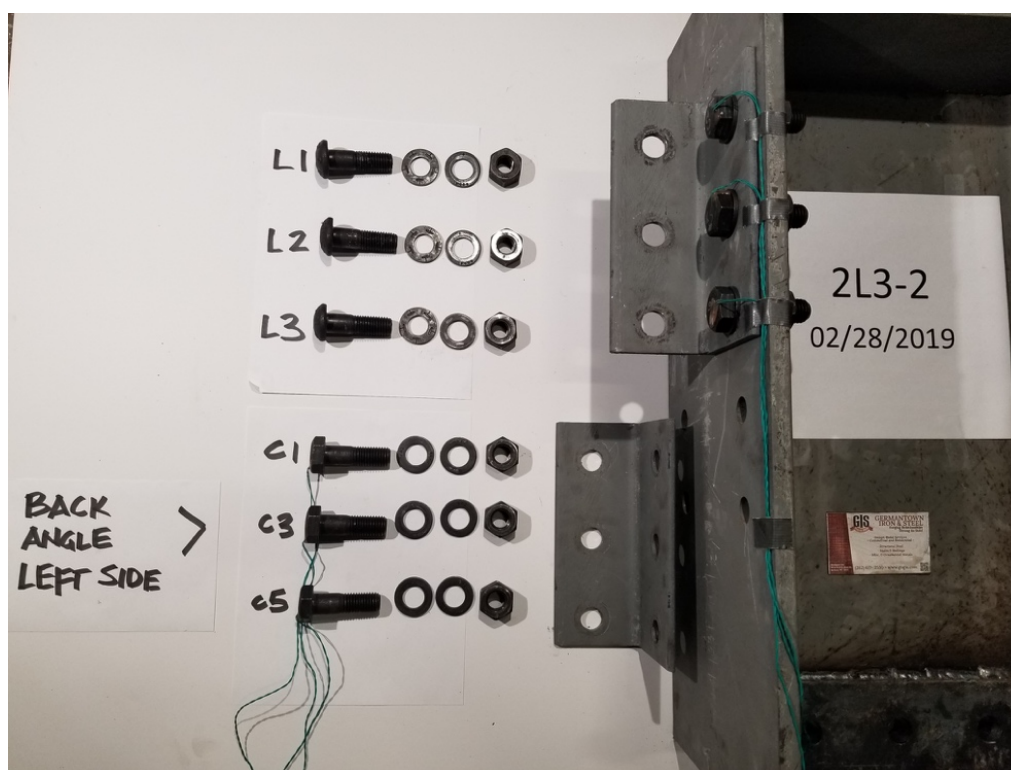
Figure 4.4-5: Typical left-hand side of a 2L3 series specimen following testing.

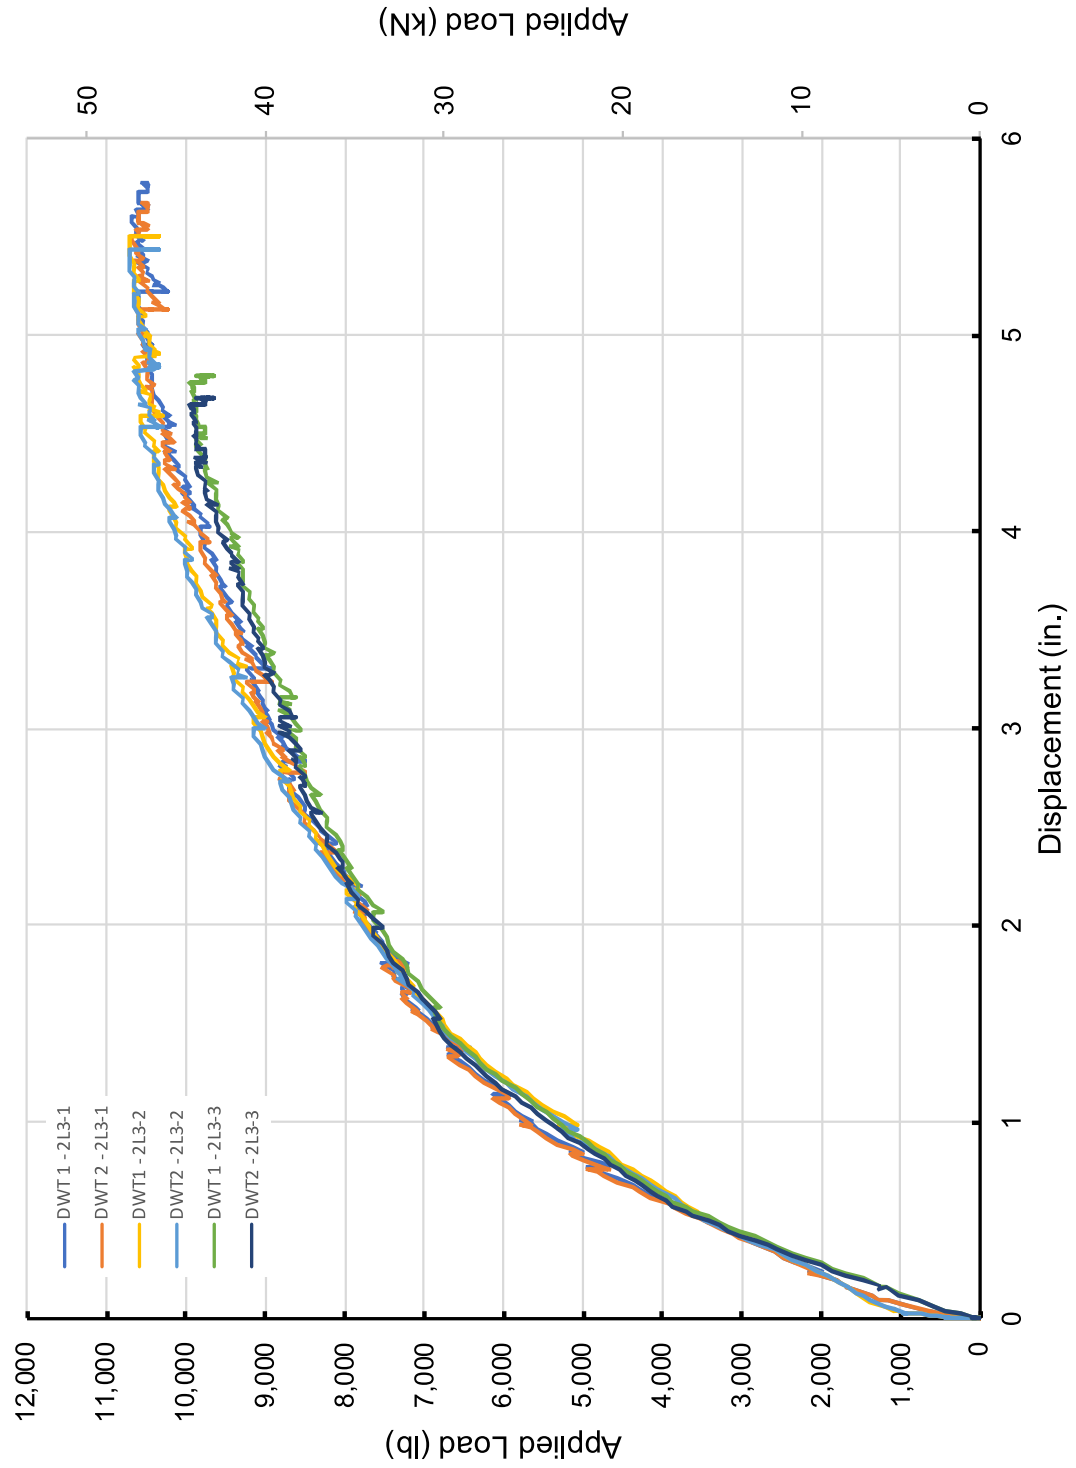
Figure 4.4-8: Load versus displacement for 2L3 series of tests.

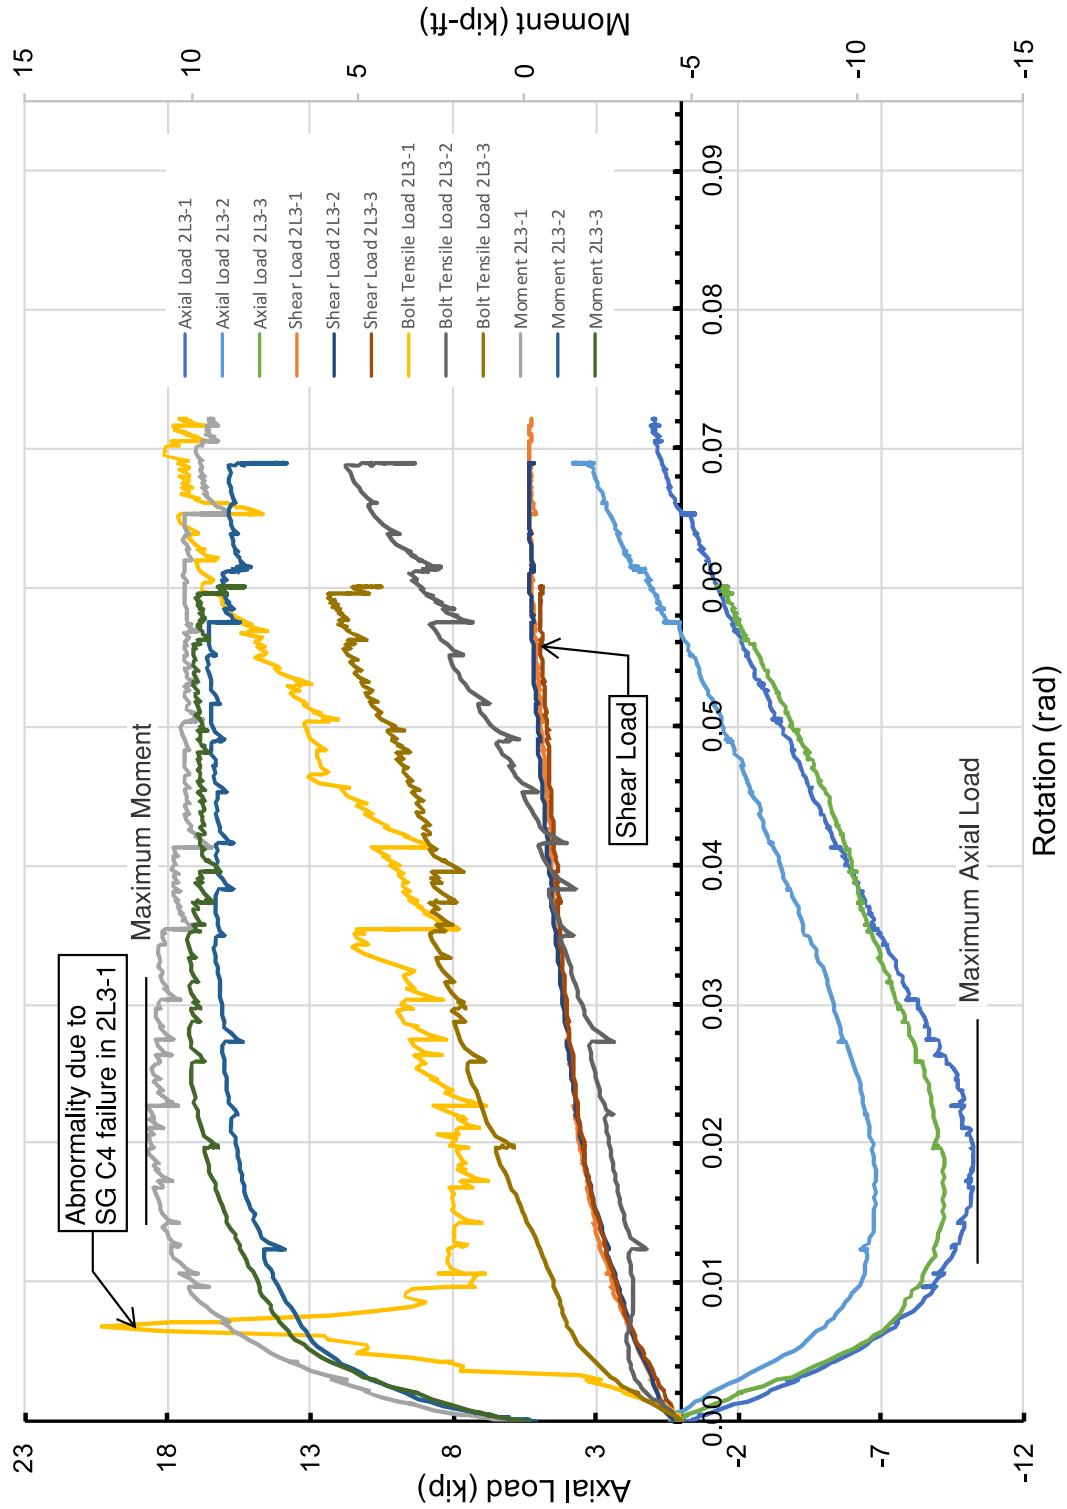
Figure 4.4-9: Load versus rotation for 2L3 series of tests with respect to DWT1 (US units).

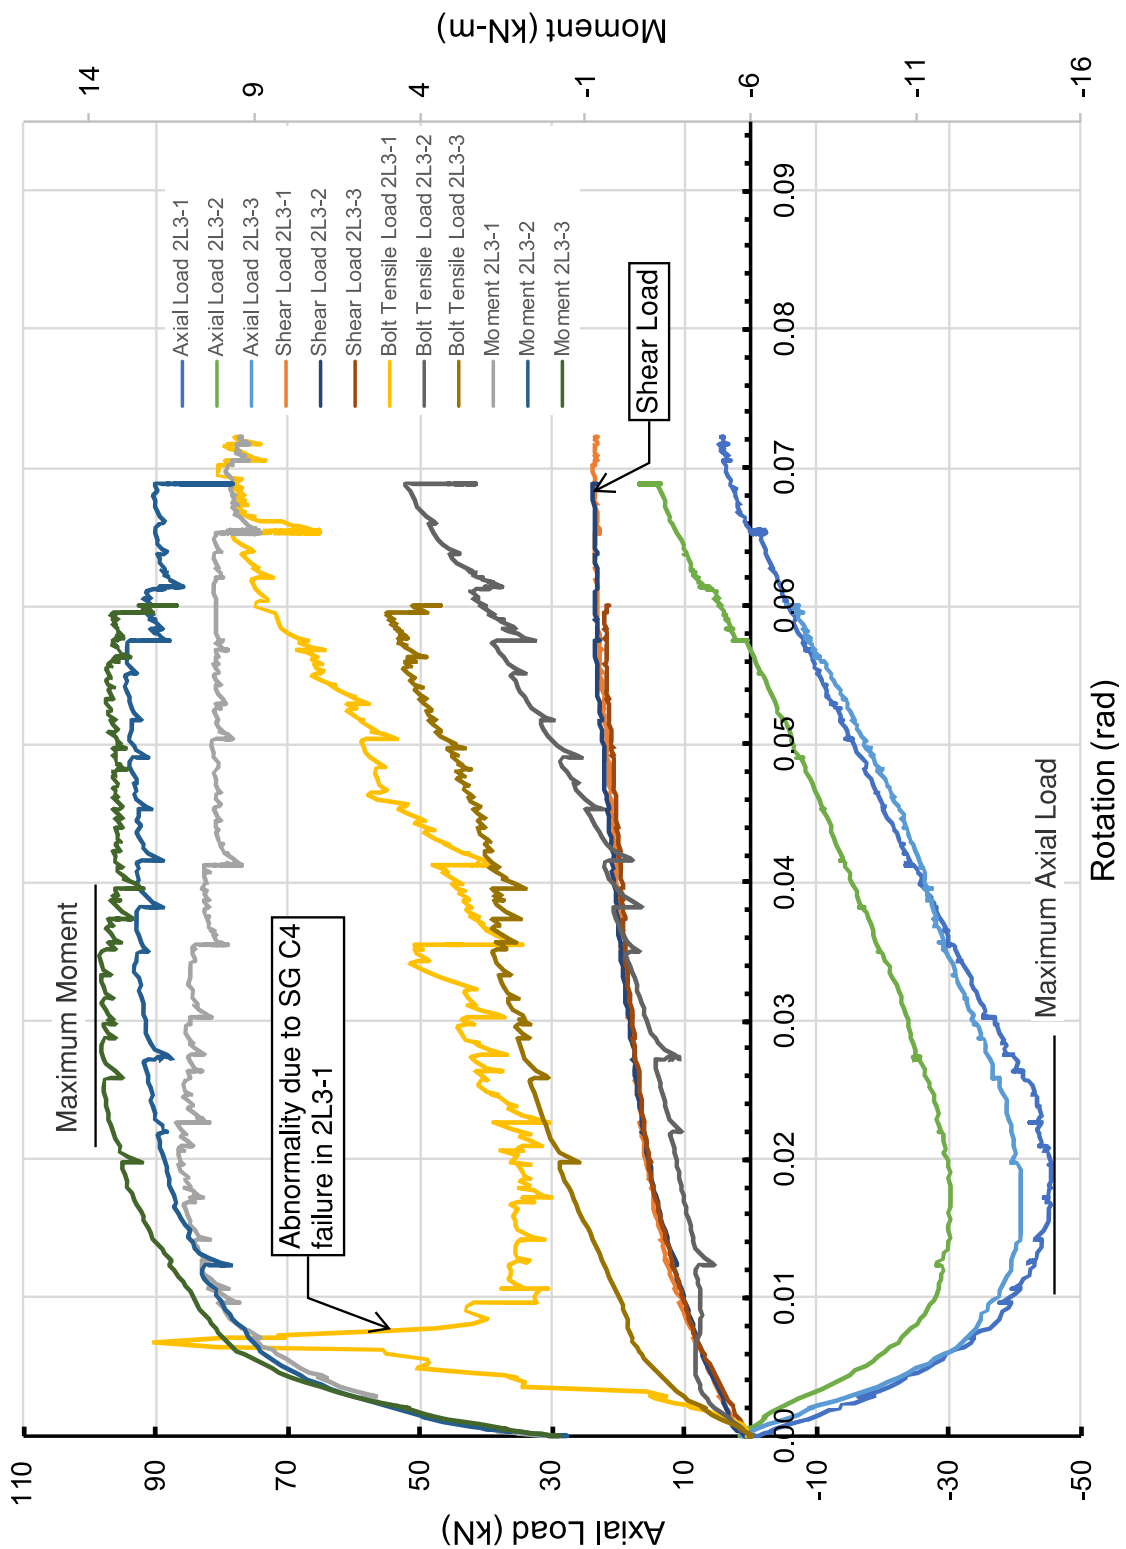
Figure 4.4-10: Load versus rotation for 2L3 series of tests with respect to DWT1 (Metric units).

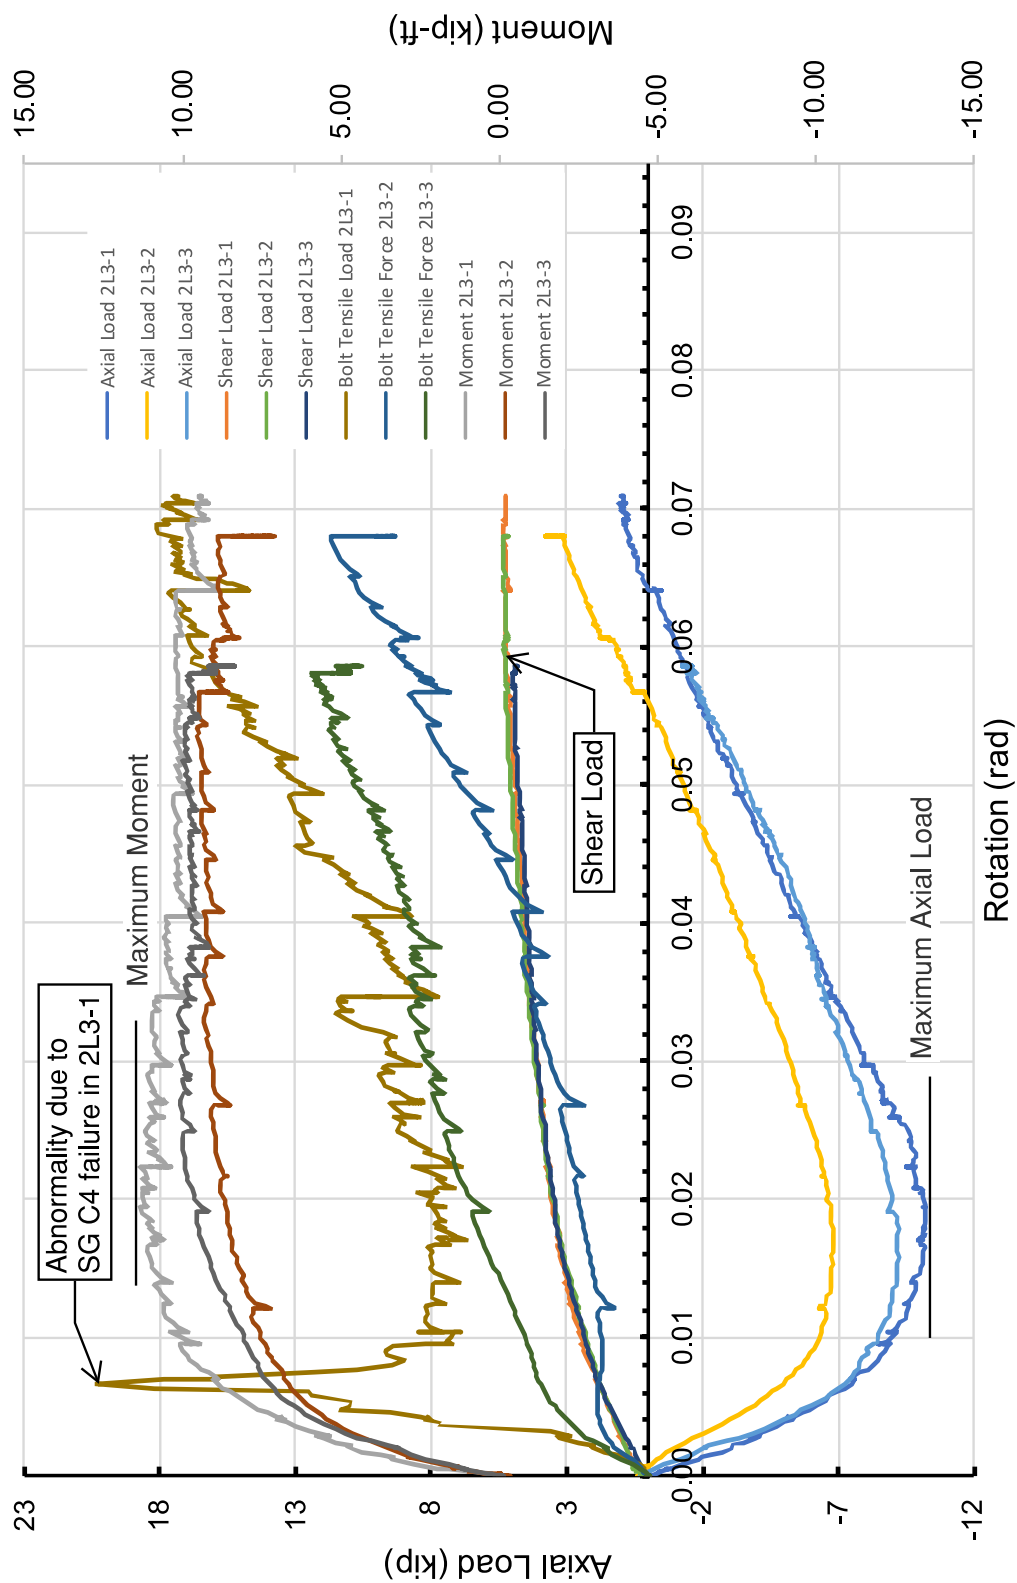
Figure 4.4-11: Load versus rotation for 2L3 series of tests with respect to DWT2 (US units).

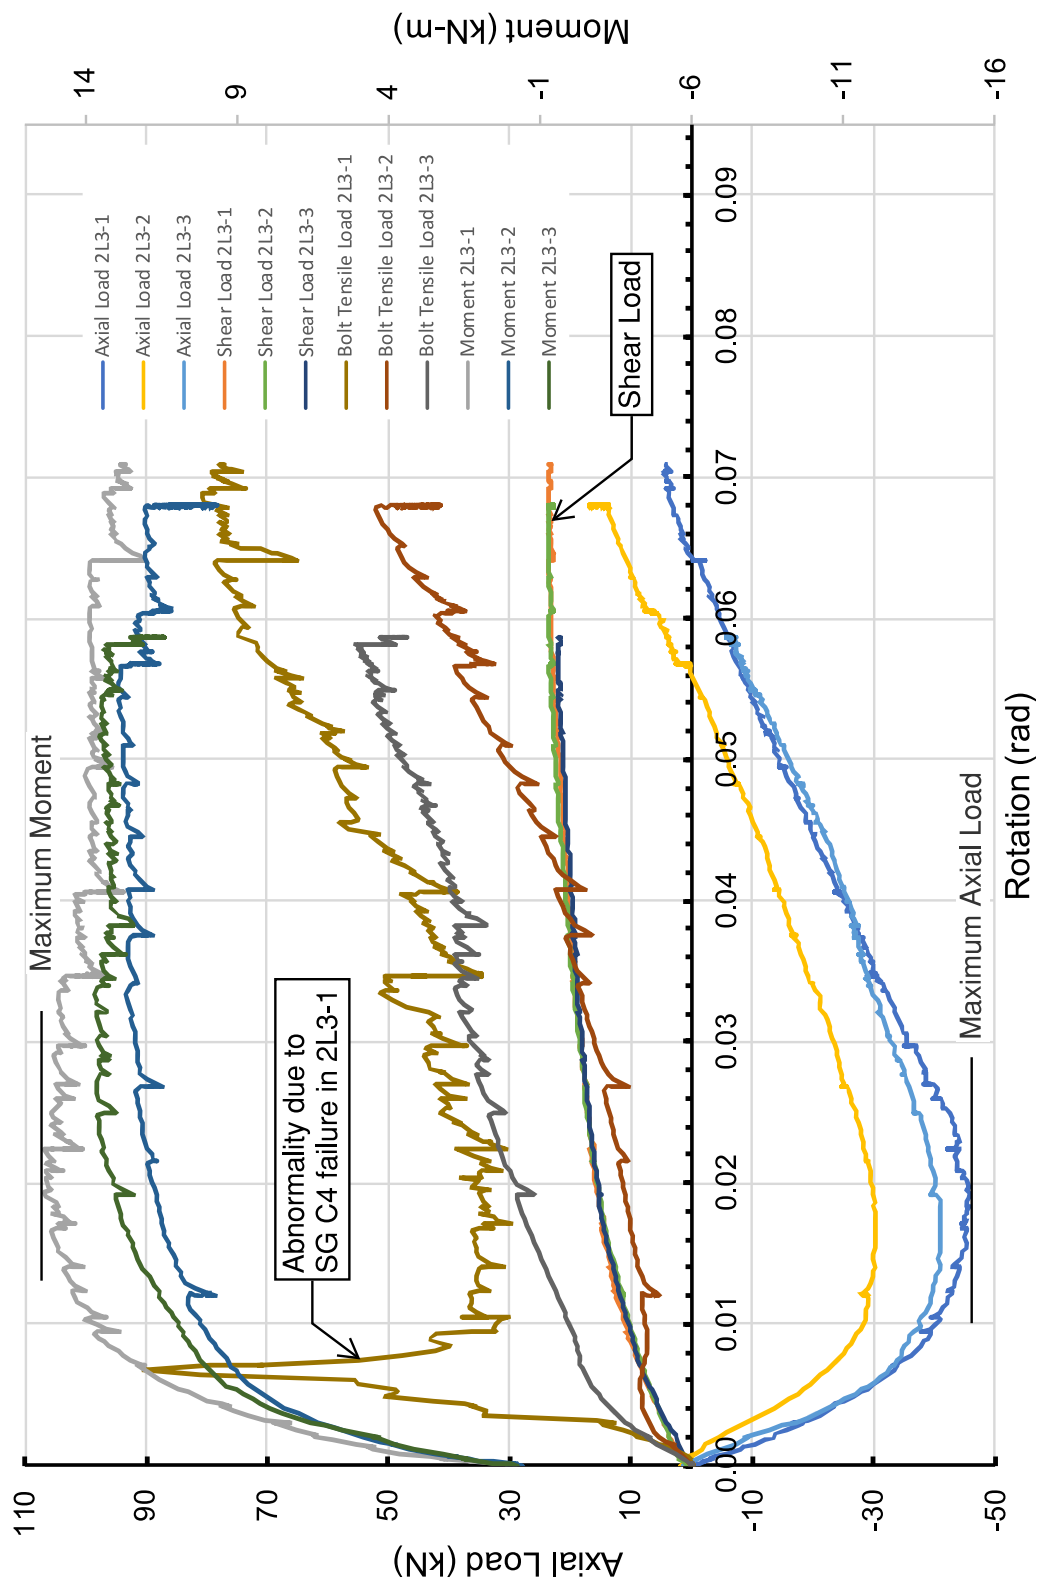
Figure 4.4-12: Load versus rotation for 2L3 series of tests with respect to DWT2 (Metric units).

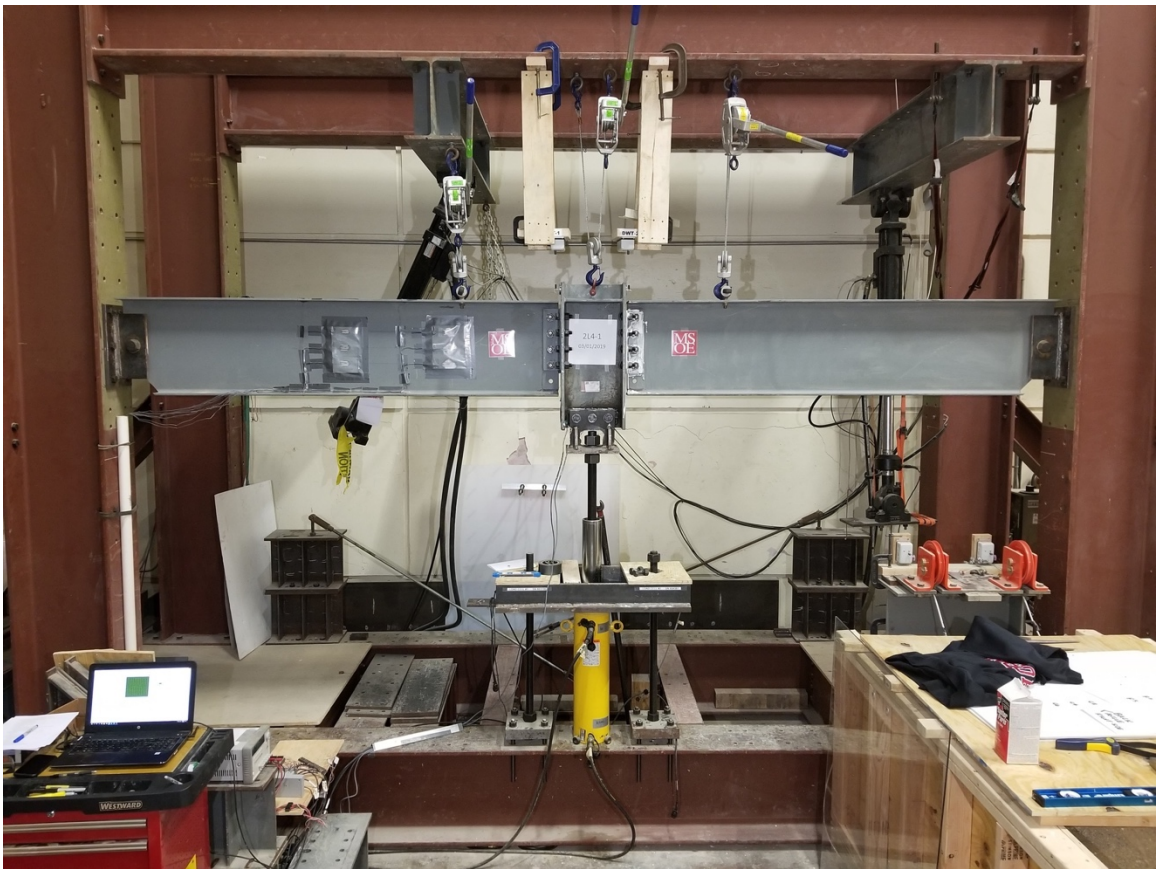
Figure 4.4-13: Typical 2L4 assembly before testing.

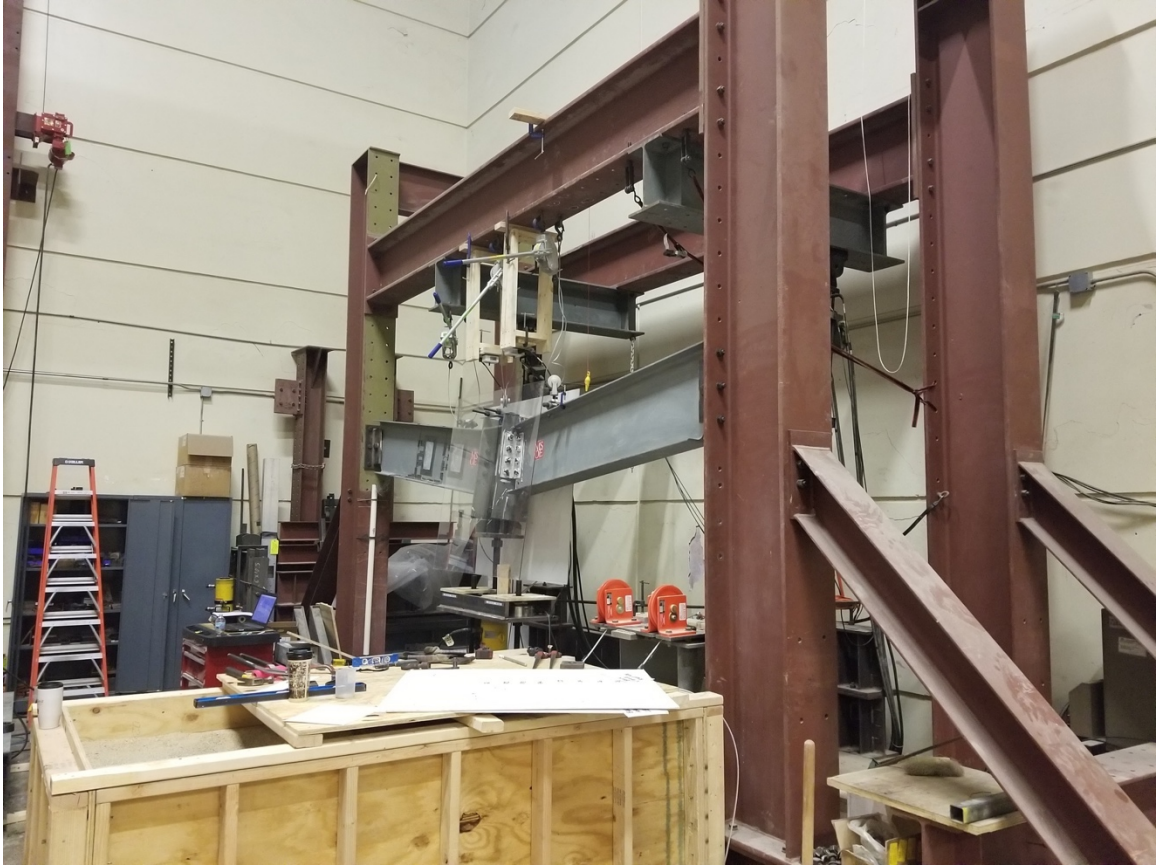
Figure 4.4-14: Typical LTB behavior of 2L4 series specimen during testing.

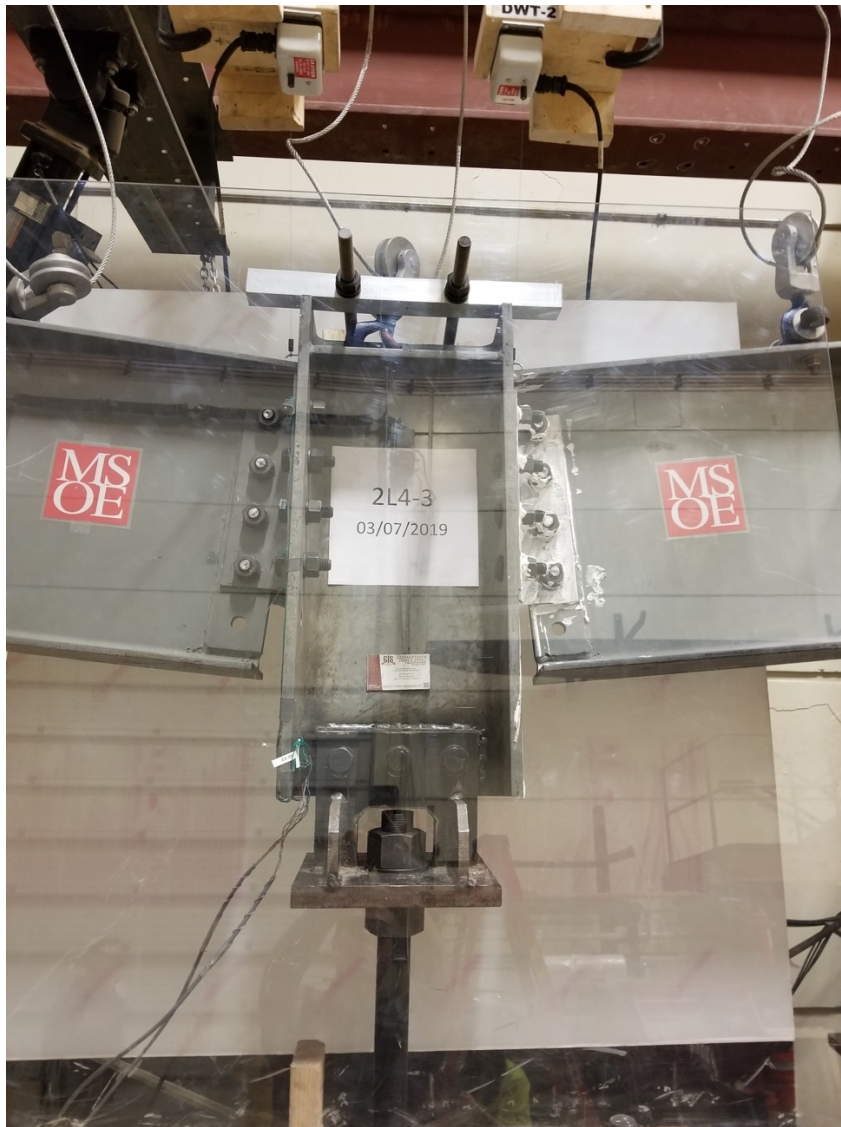
Figure 4.4-15: Typical 2L4 specimen post-test.

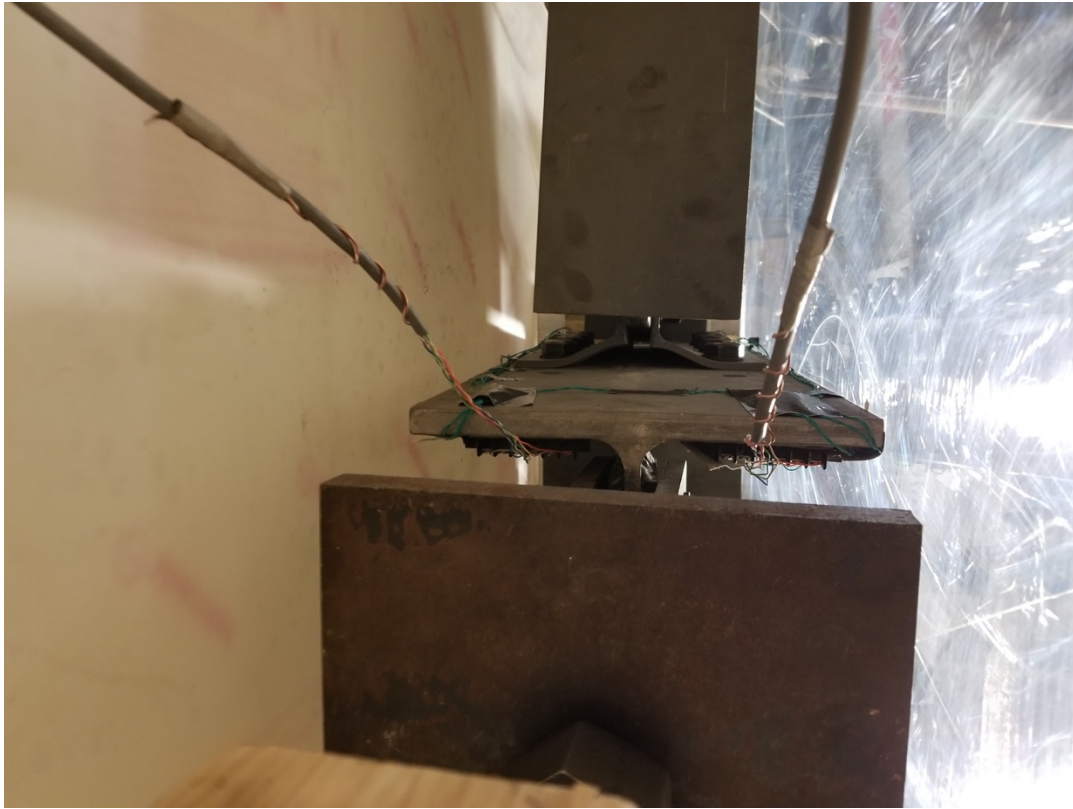
Figure 4.4-16: Typical underside view of specimen post-test showing angle deformation.

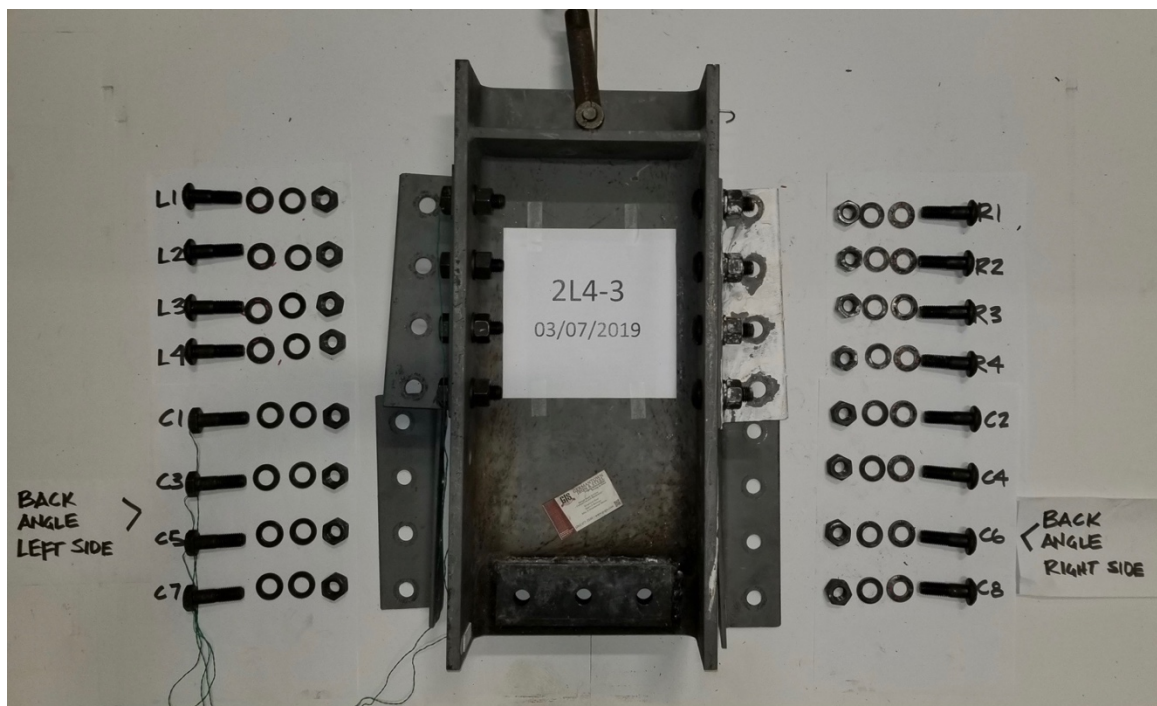
Figure 4.4-17: Typical post-test layout of 2L4 series specimen.

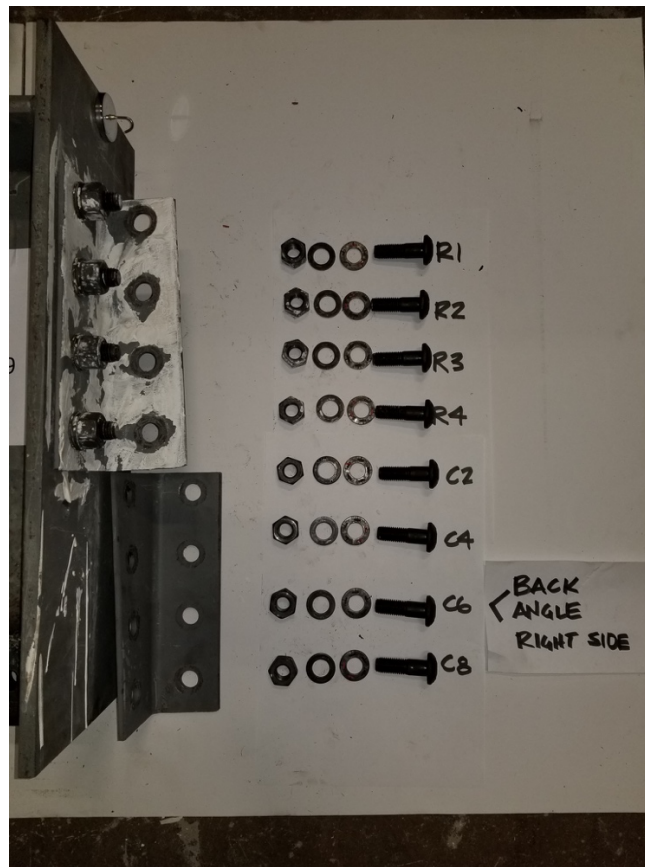
Figure 4.4-19: Typical right hand-side of a 2L4 series specimen following testing.

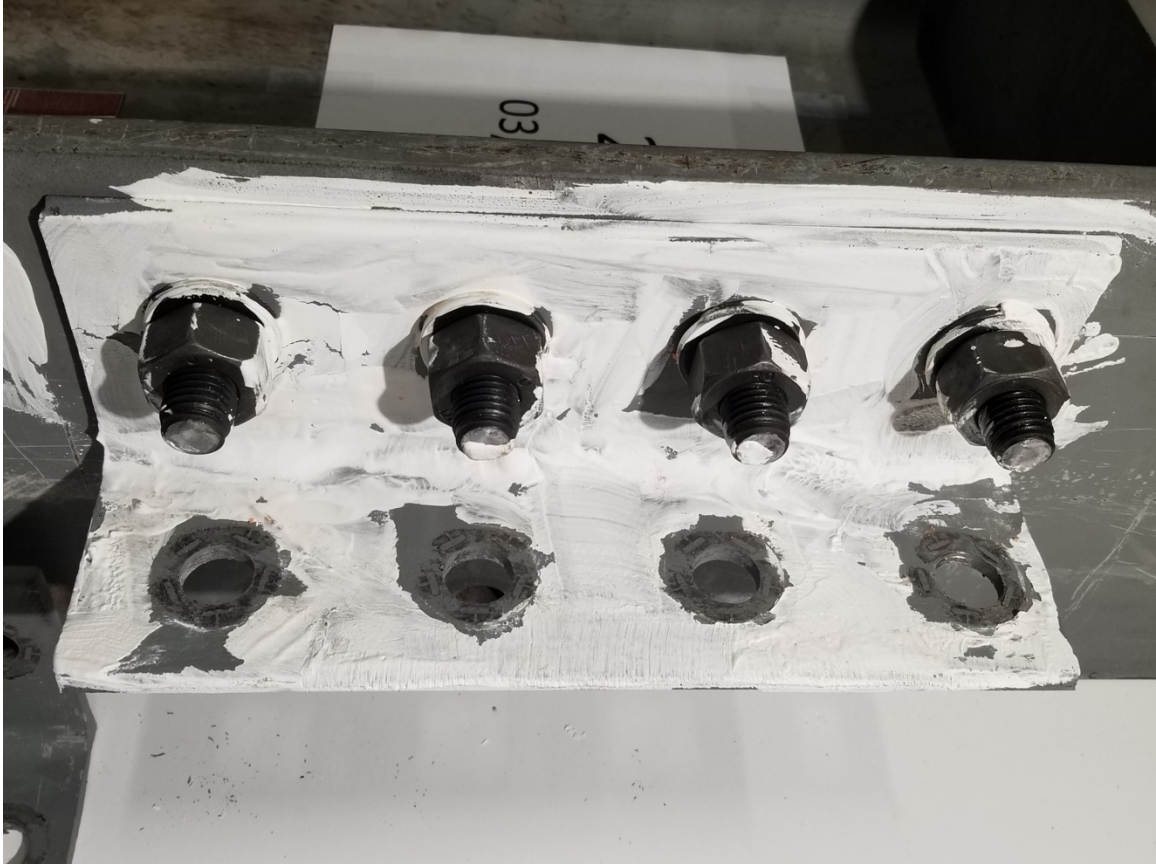
Figure 4.4-20: Plaster flake on specimen 2L4-1.

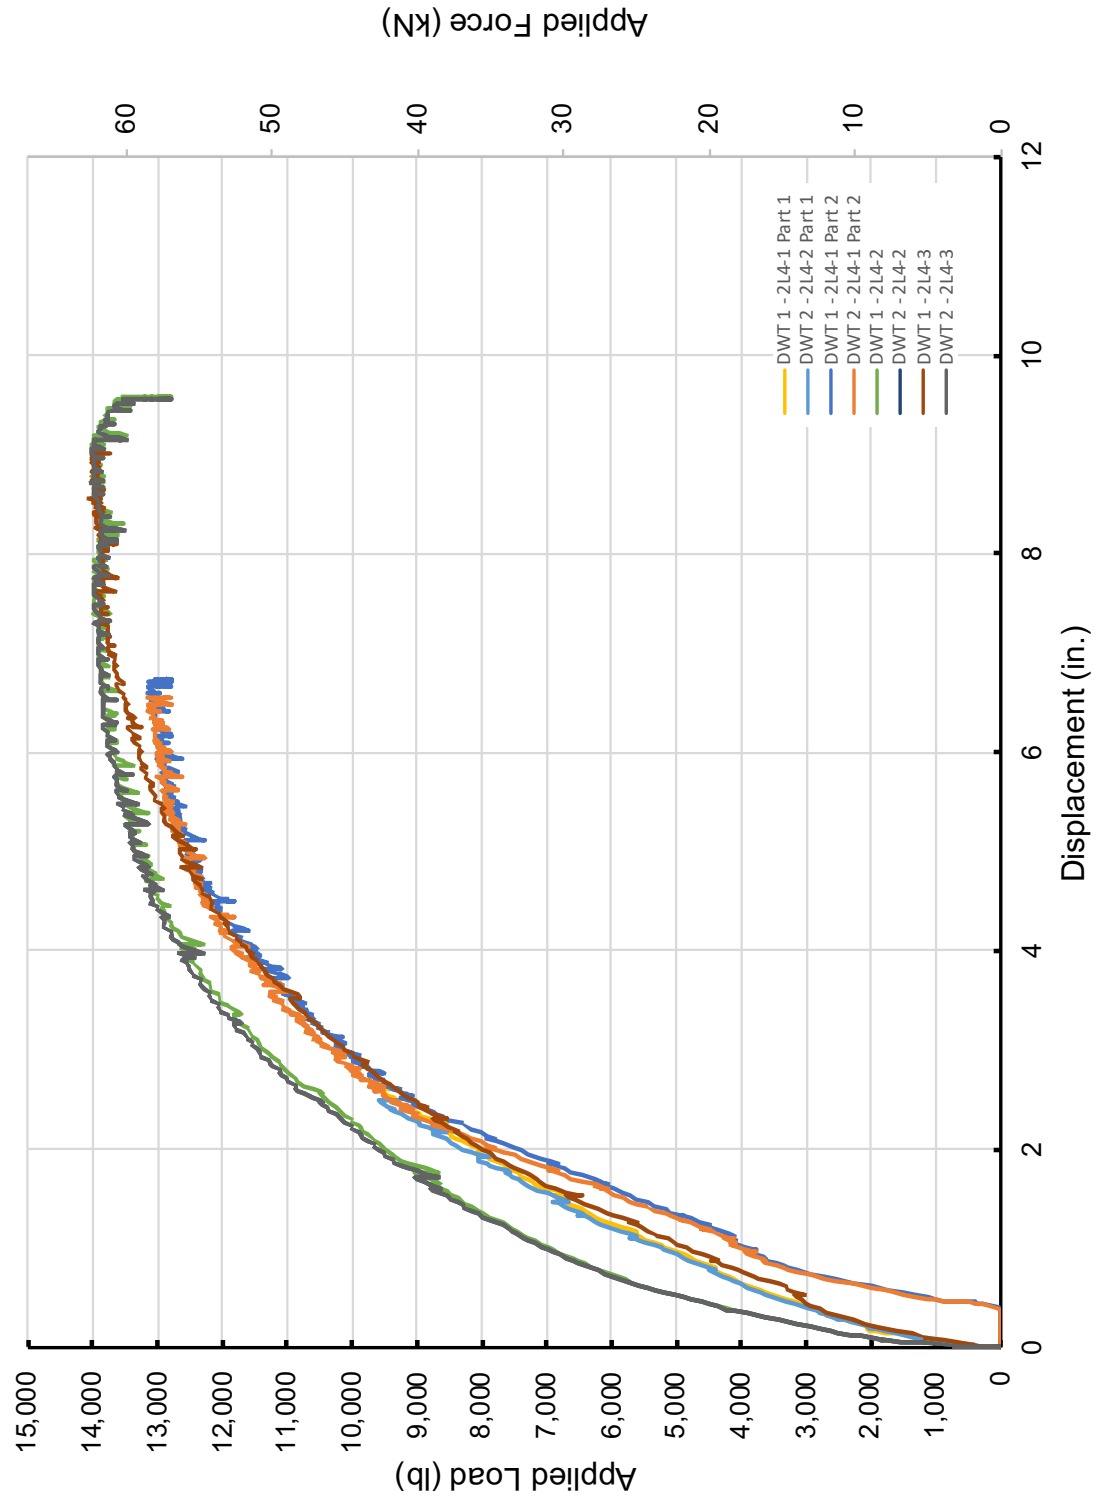
Figure 4.4-21: Force versus displacement for 2L4 series of tests.

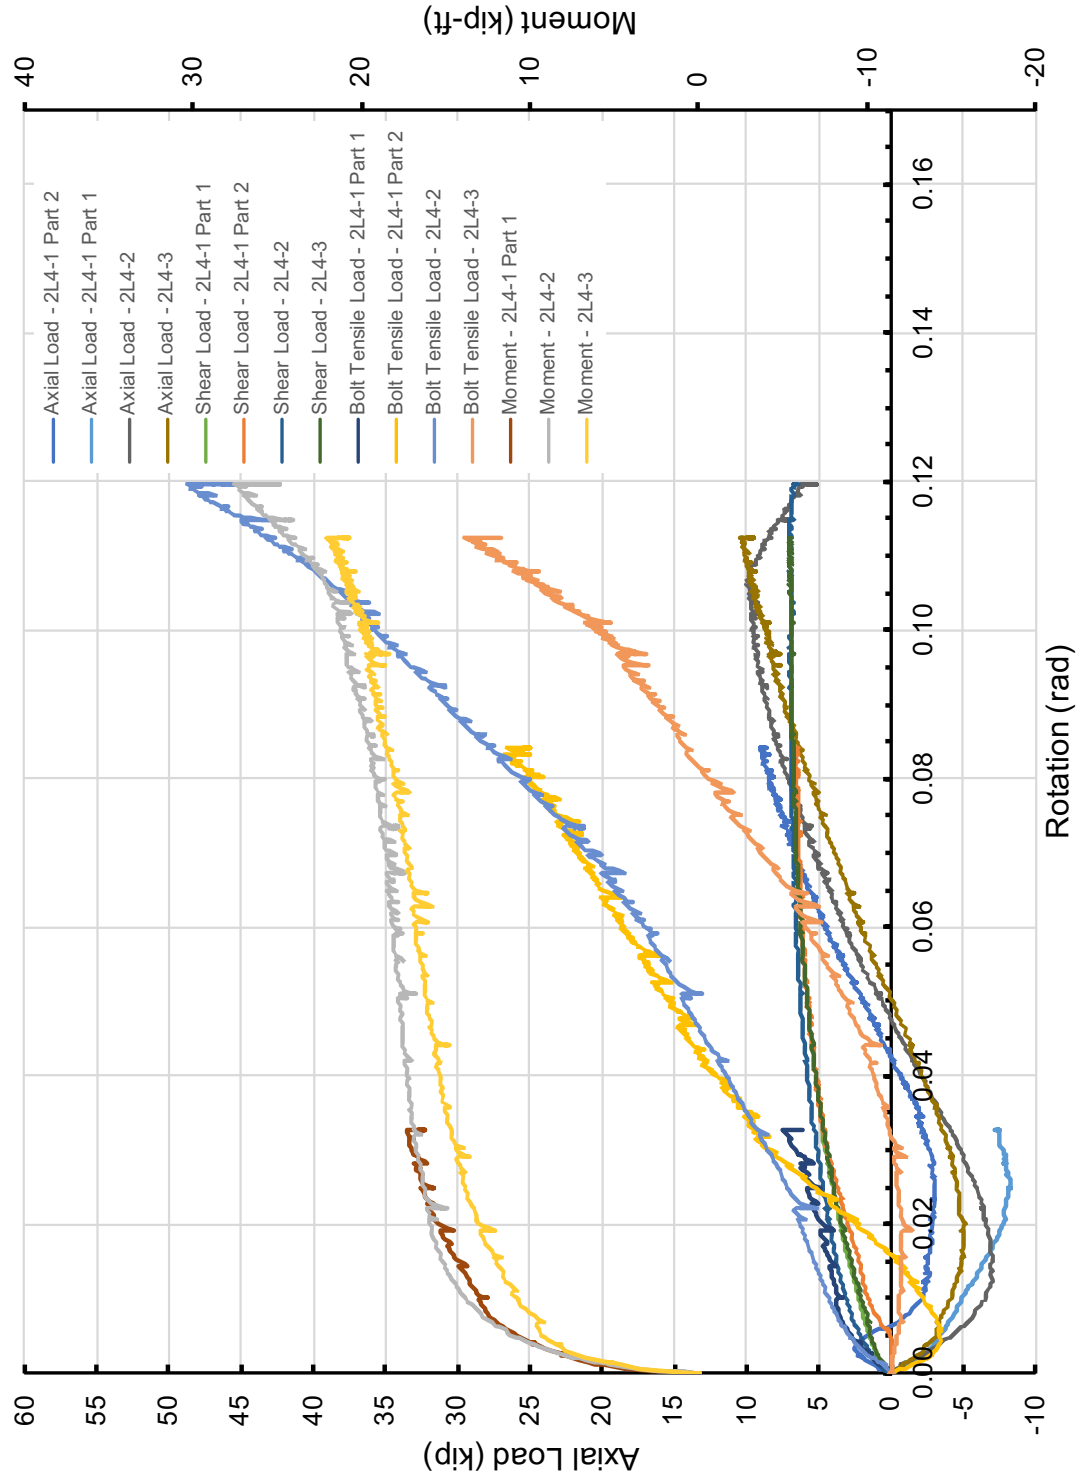
Figure 4.4-22: Load versus rotation for 2L4 series of tests with respect to DWT1 (US units).

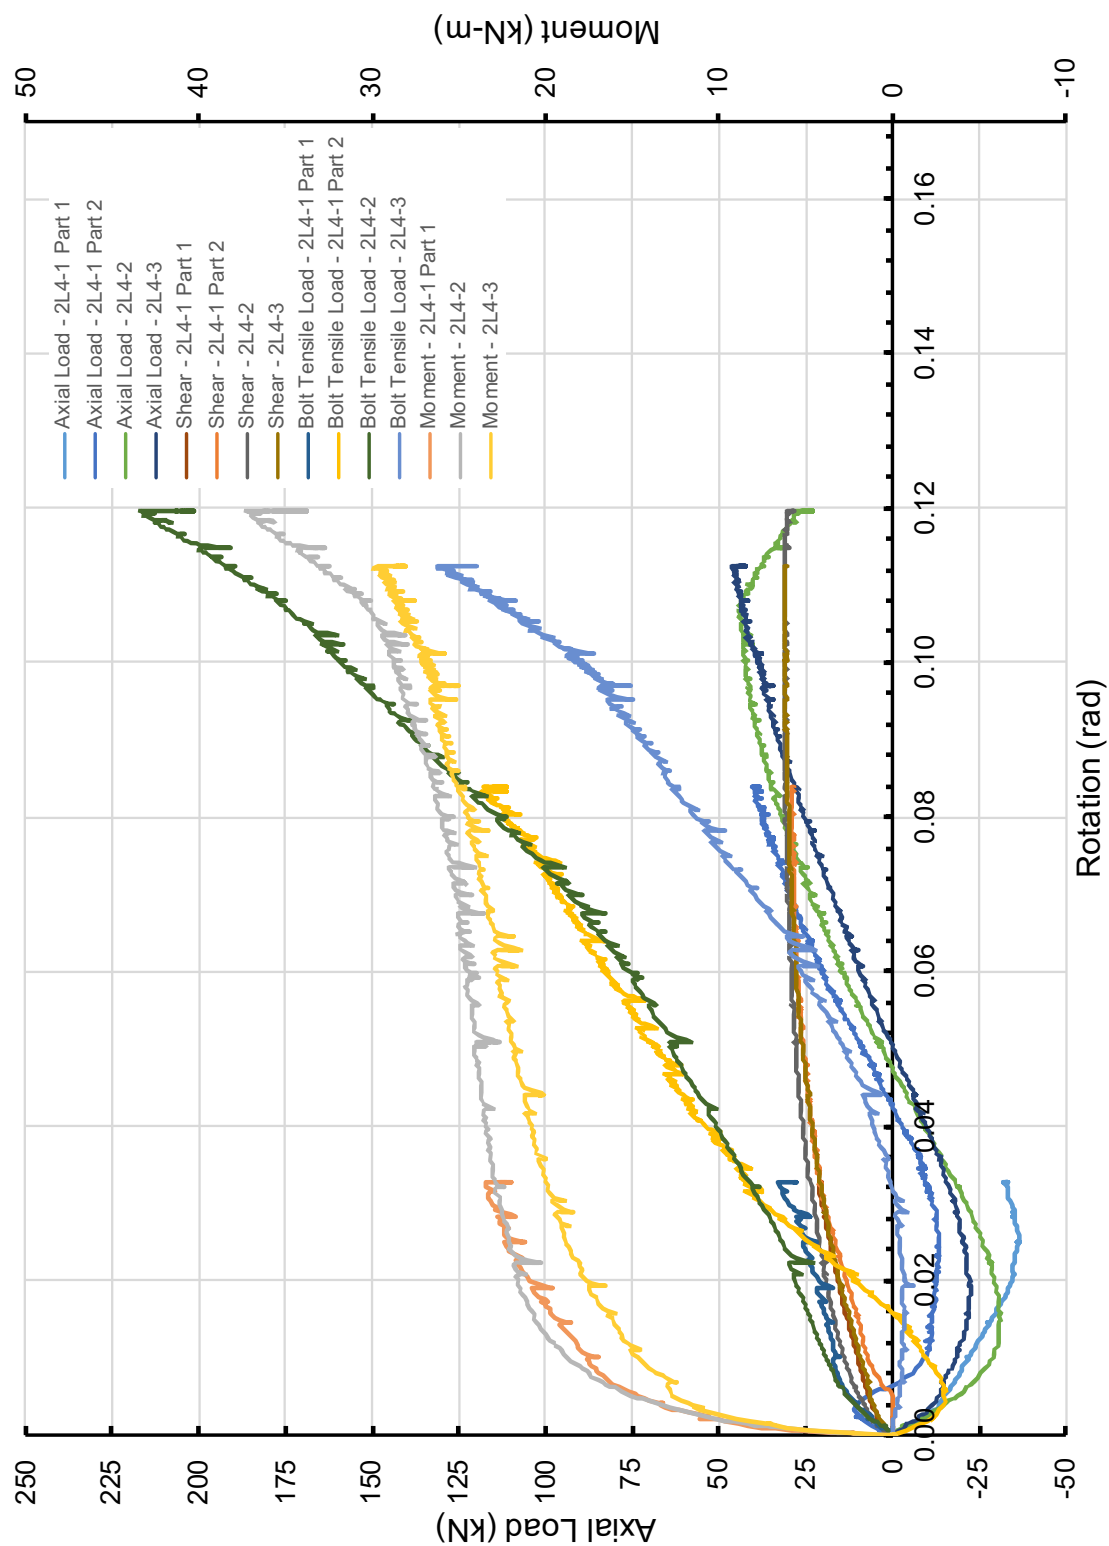
Figure 4.4-23: Load versus rotation for 2L4 series of tests with respect to DWT1 (Metric units).

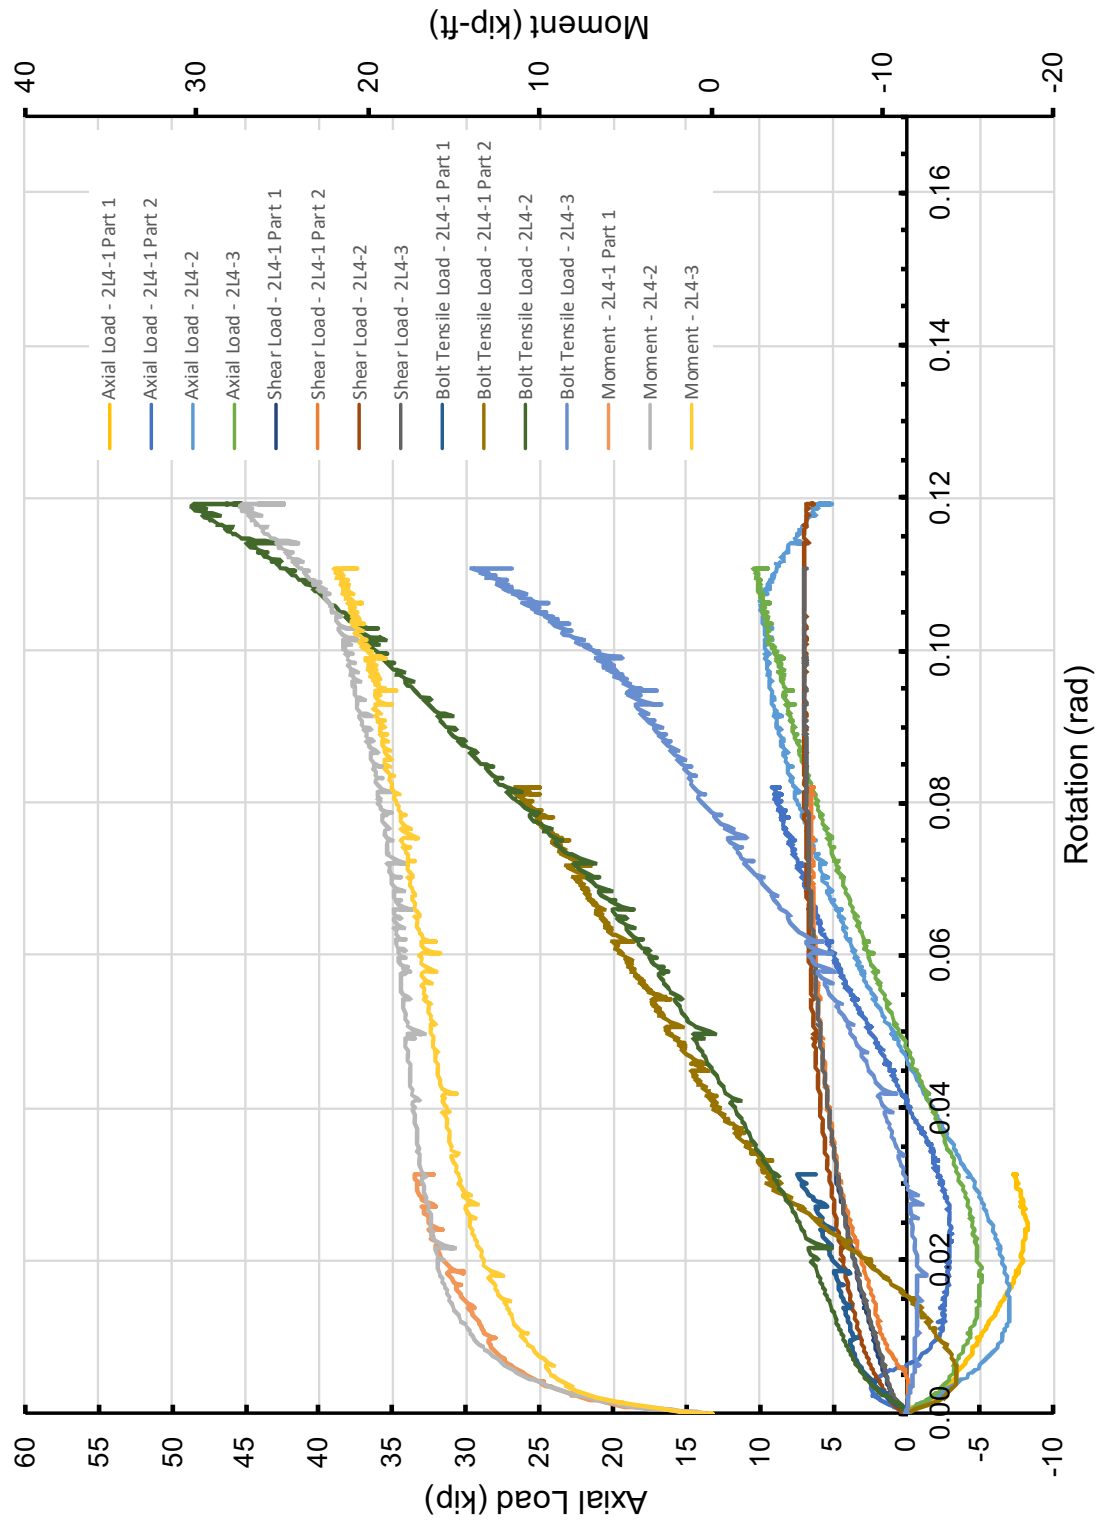
Figure 4.4-24: Load versus rotation for 2L4 series of tests with respect to DWT2 (US units).
