**Experimental Evaluation of Axial, Shear, and Moment Forces of
Double Angle Connections when Subjected to Unanticipated Loading**

A Report Submitted to the Faculty of the
Milwaukee School of Engineering
in Partial Fulfillment of the
Requirements for the Degree of
Master of Science in Architectural Engineering

May 2019

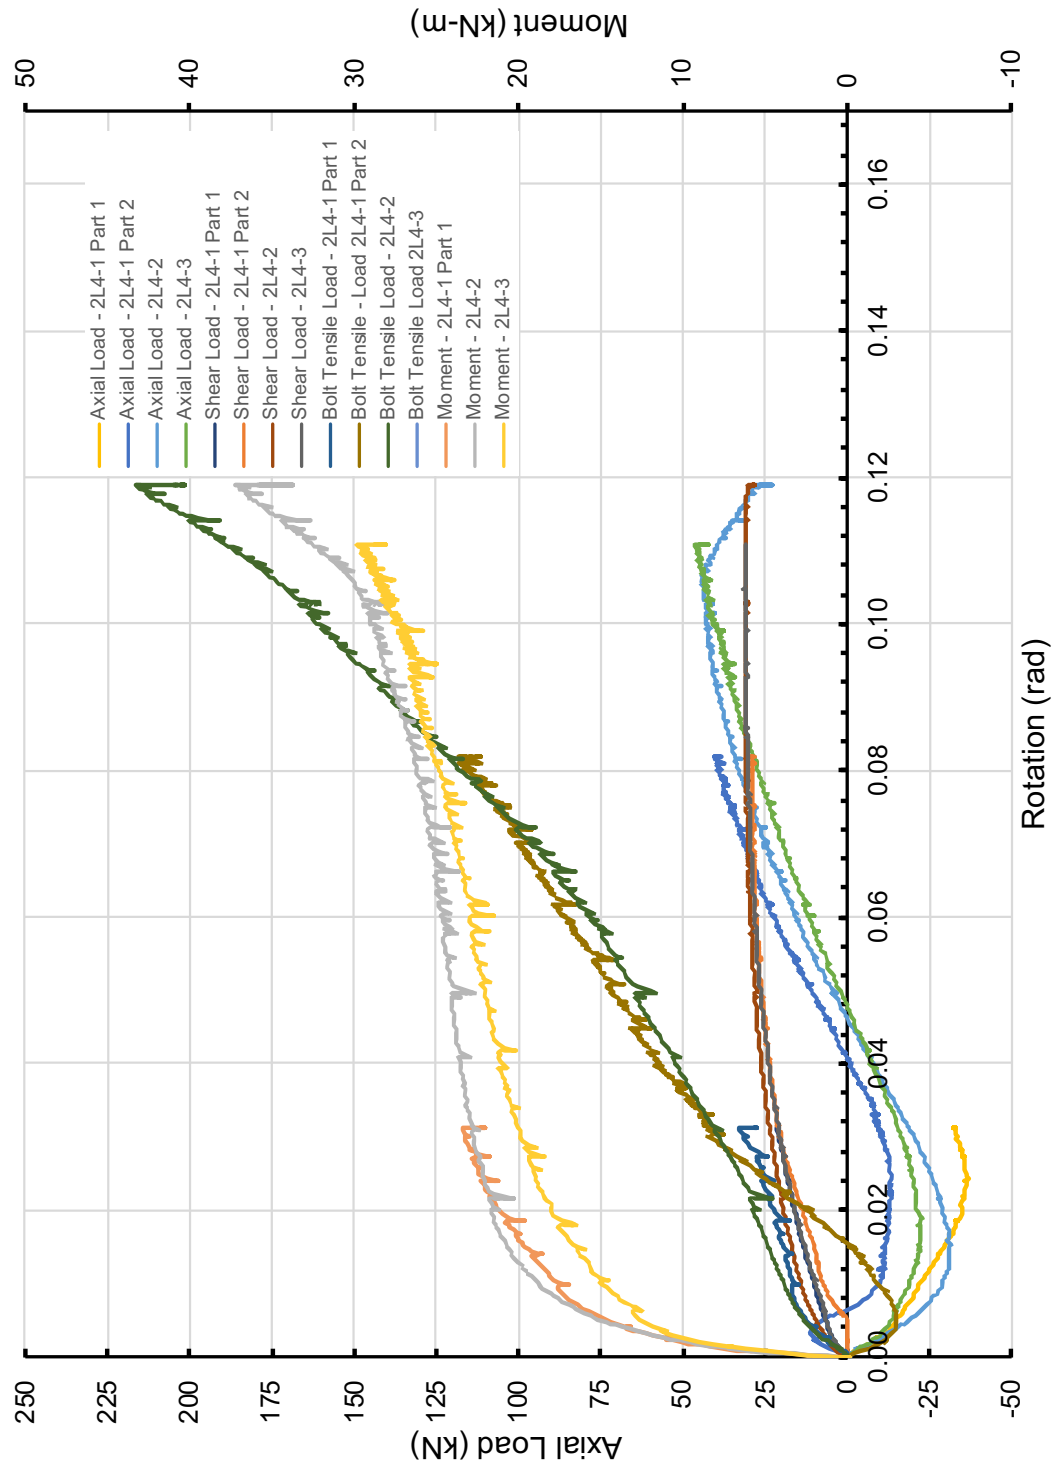
Figure 4.4-25: Load versus rotation for 2L4 series of tests with respect to DWT2 (Metric units).

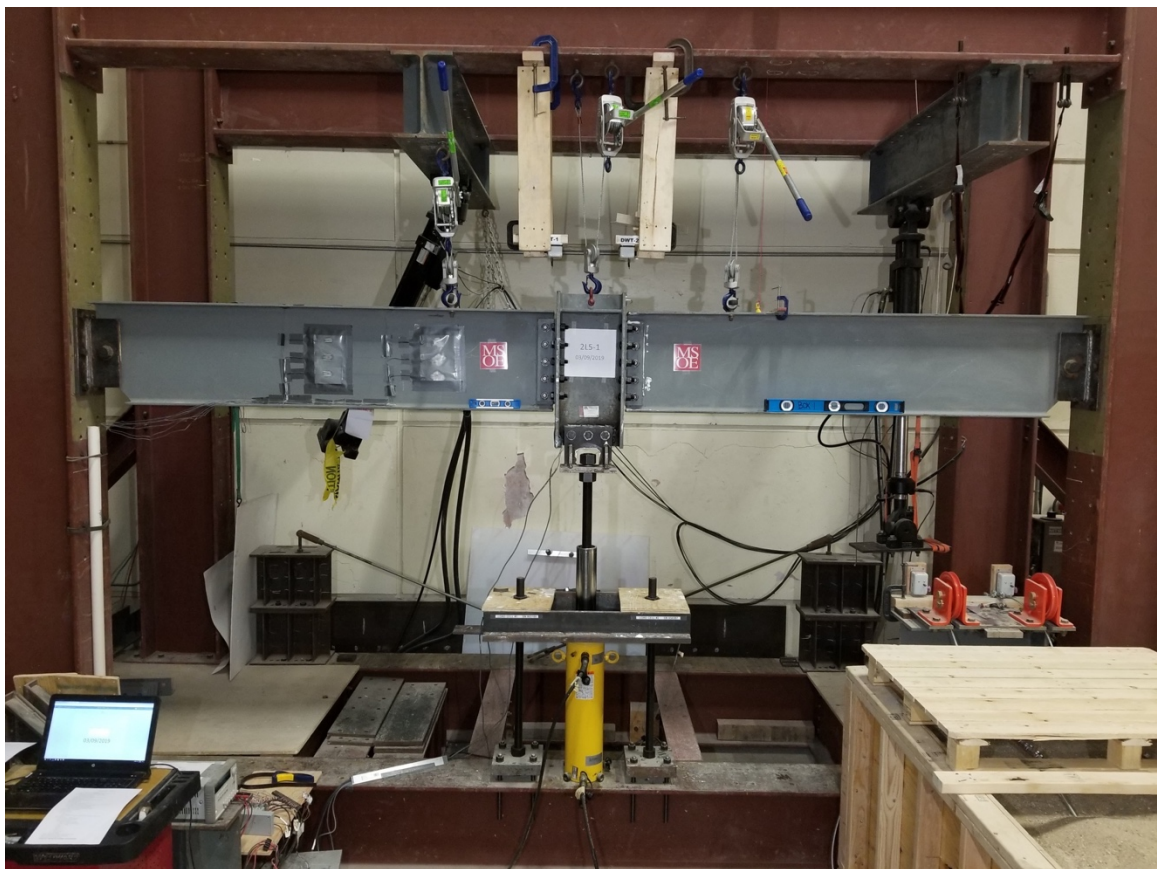
Figure 4.4-26: Typical 2L5 assembly before testing.

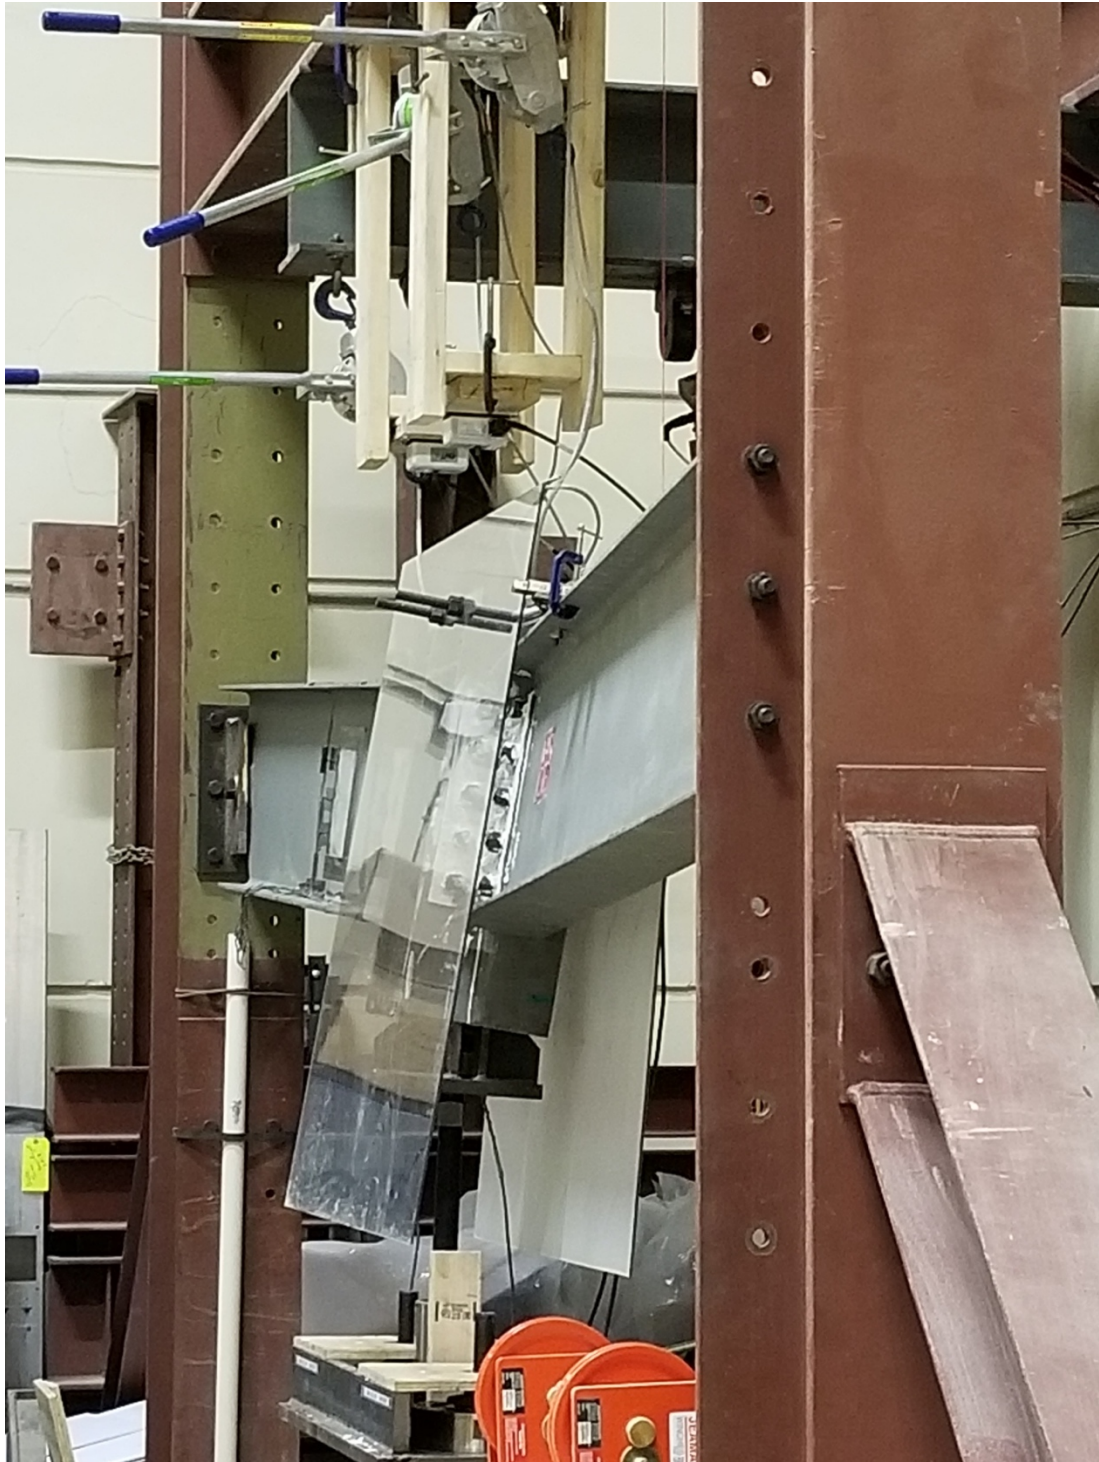
Figure 4.4-27: Typical LTB behavior of 2L5 series specimen during testing.

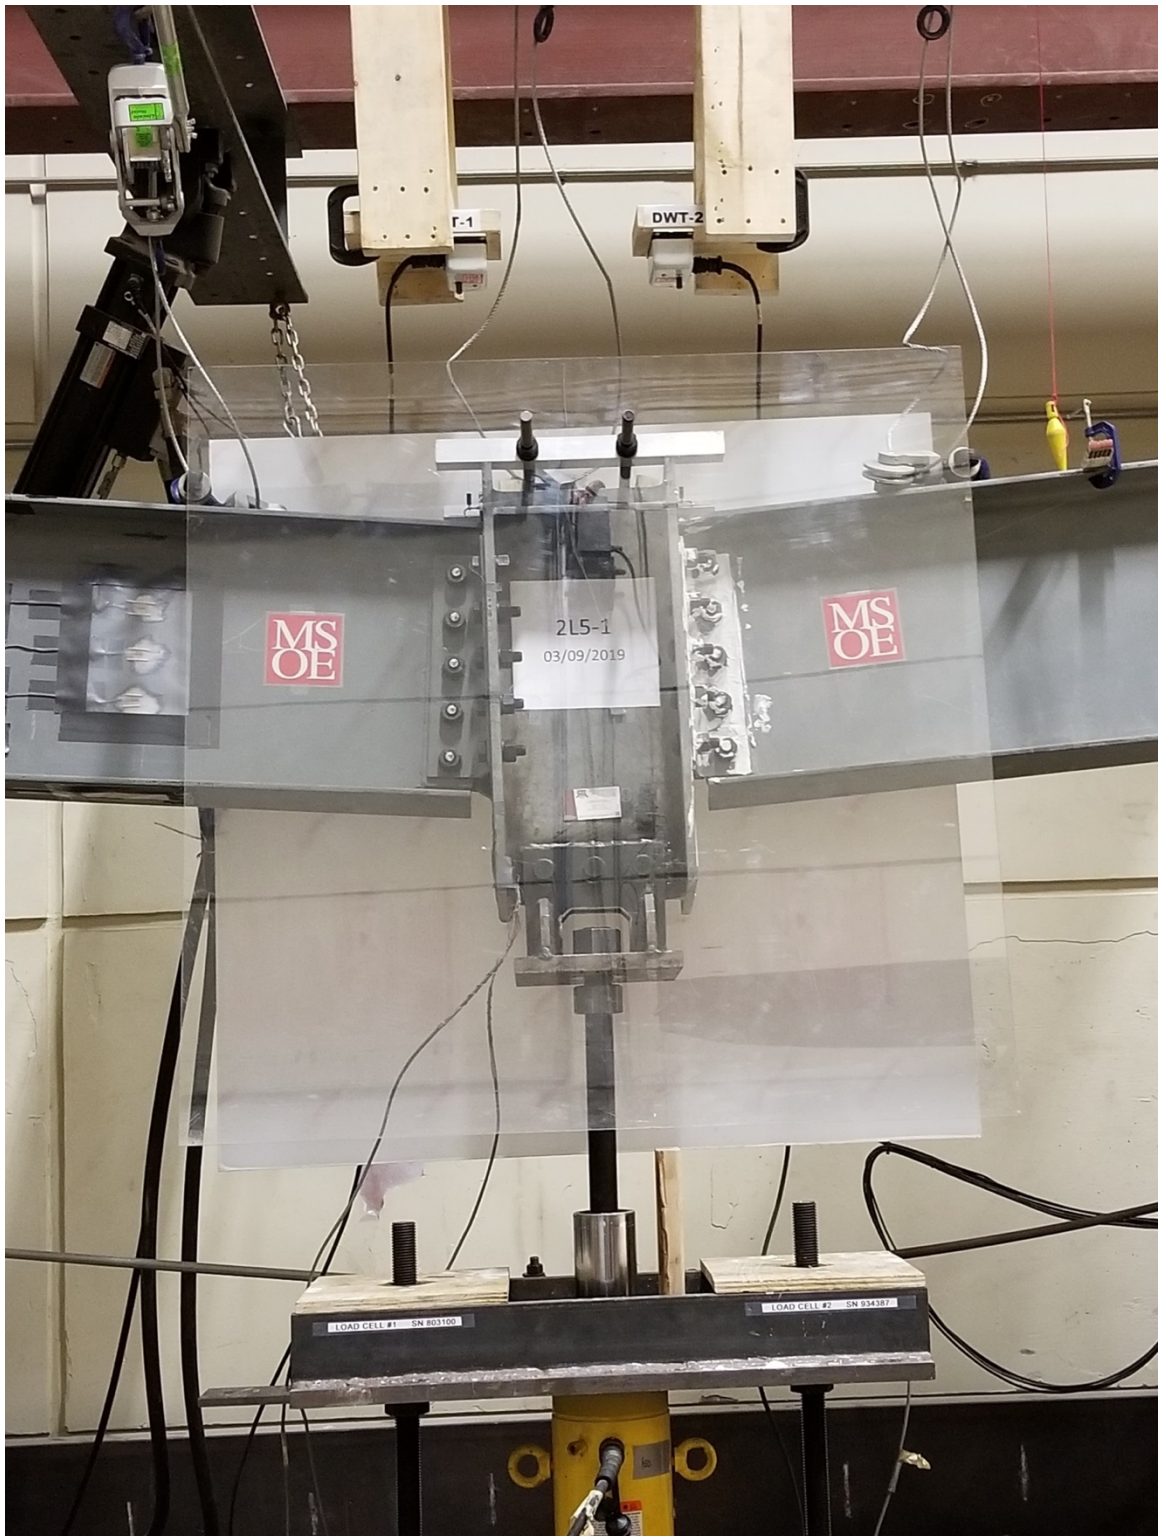
Figure 4.4-28: Typical 2L5 specimen post-test.

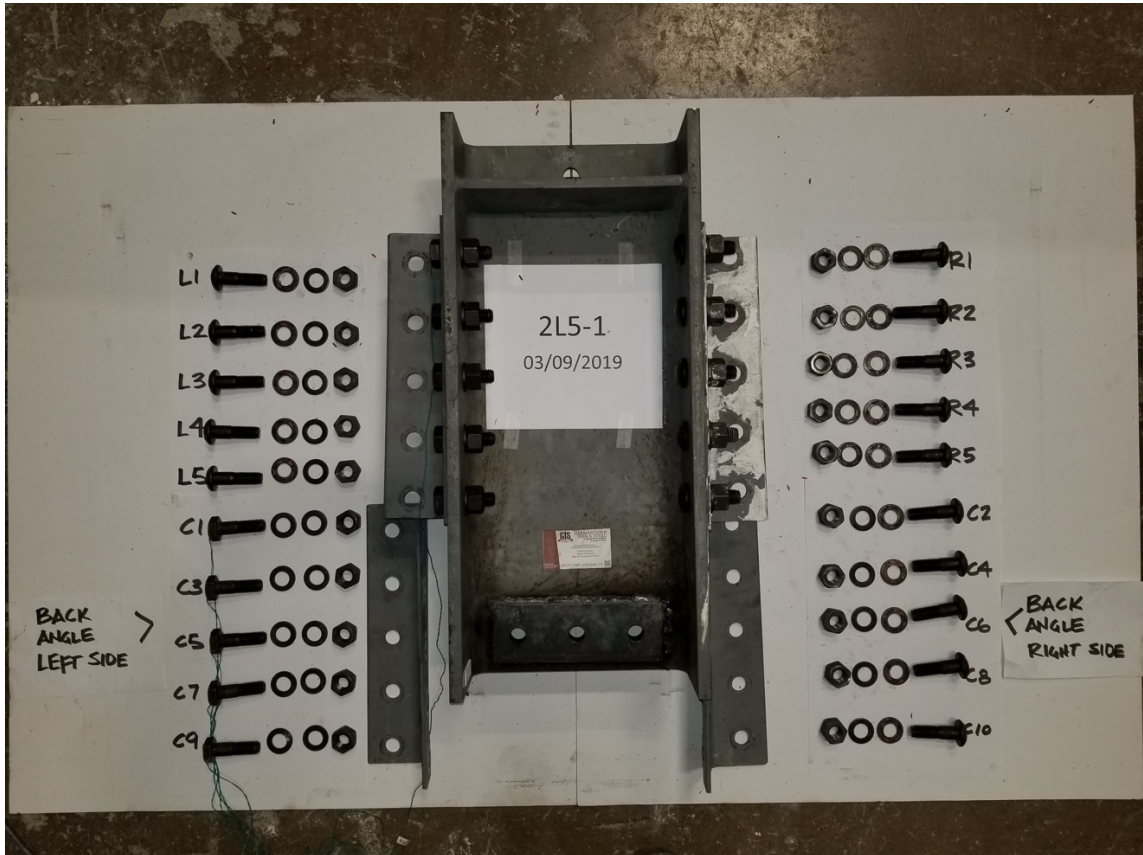
Figure 4.4-29: Typical post-test layout of 2L5 series specimen.

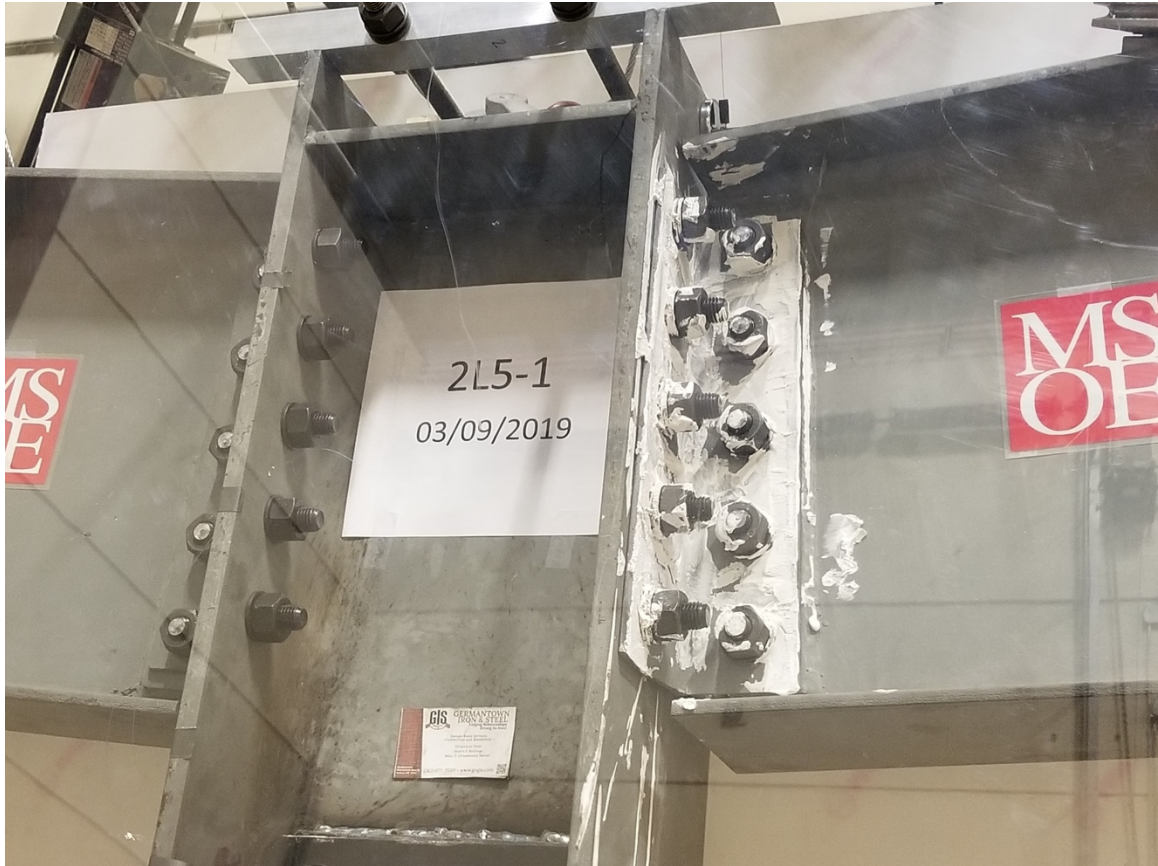
Figure 4.4-32: Plaster flake on specimen 2L5-1. Typical for 2L5 series of tests.

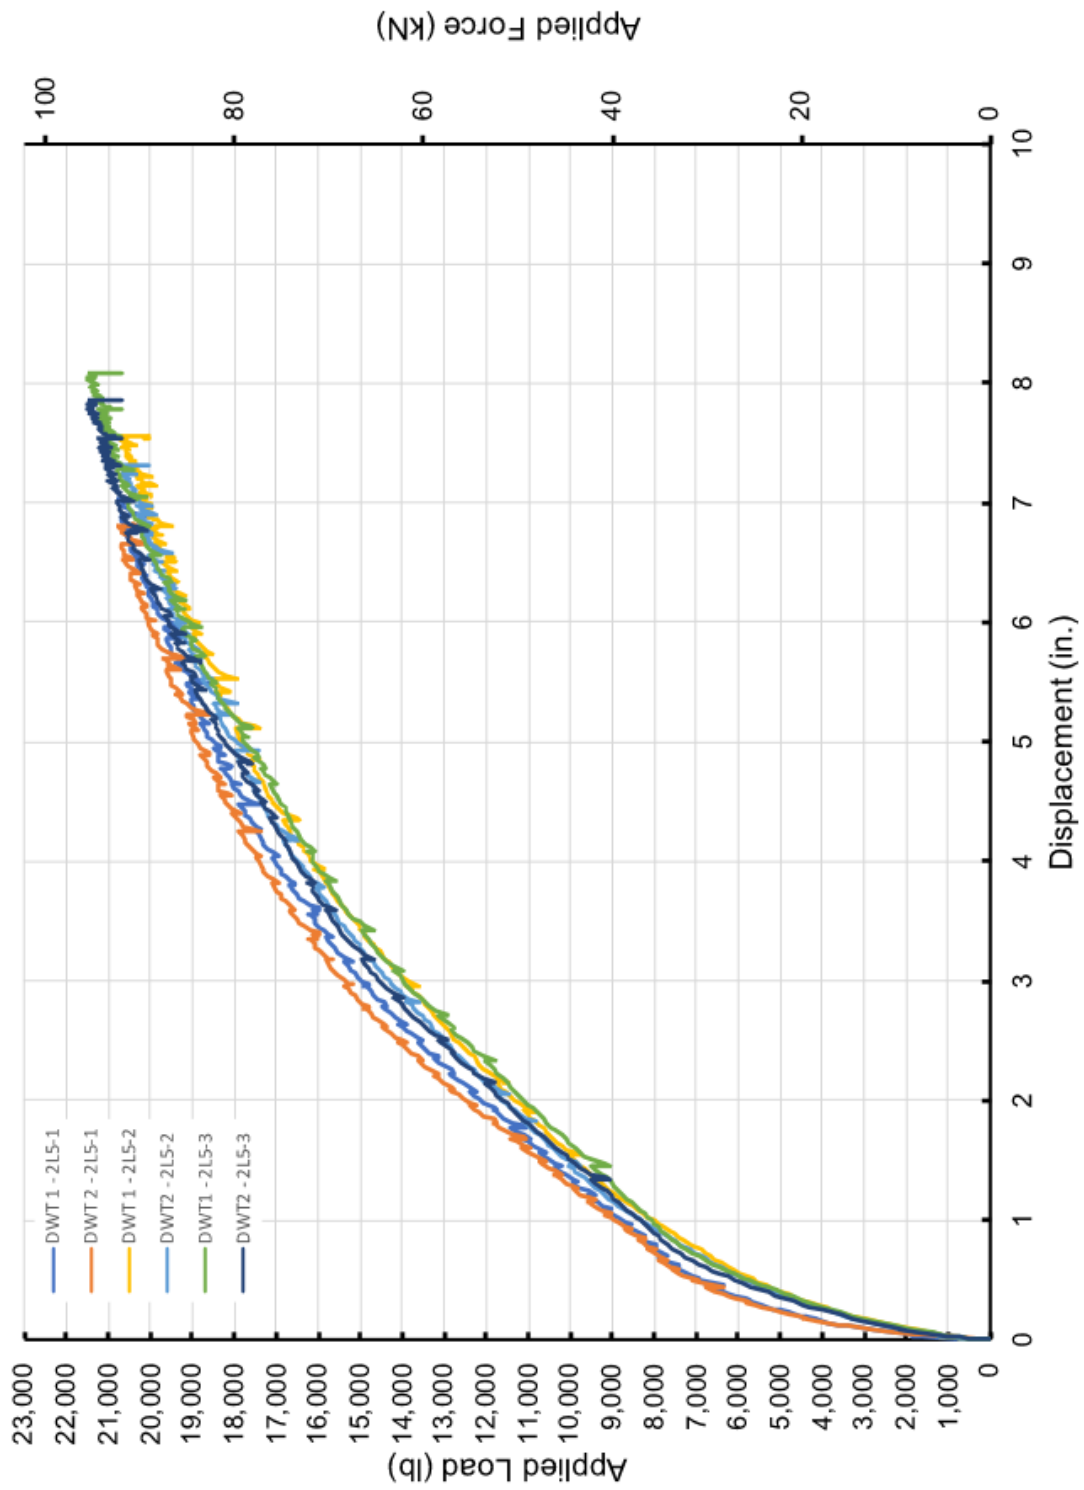
Figure 4.4-33: Force versus displacement for 2L5 series of tests.

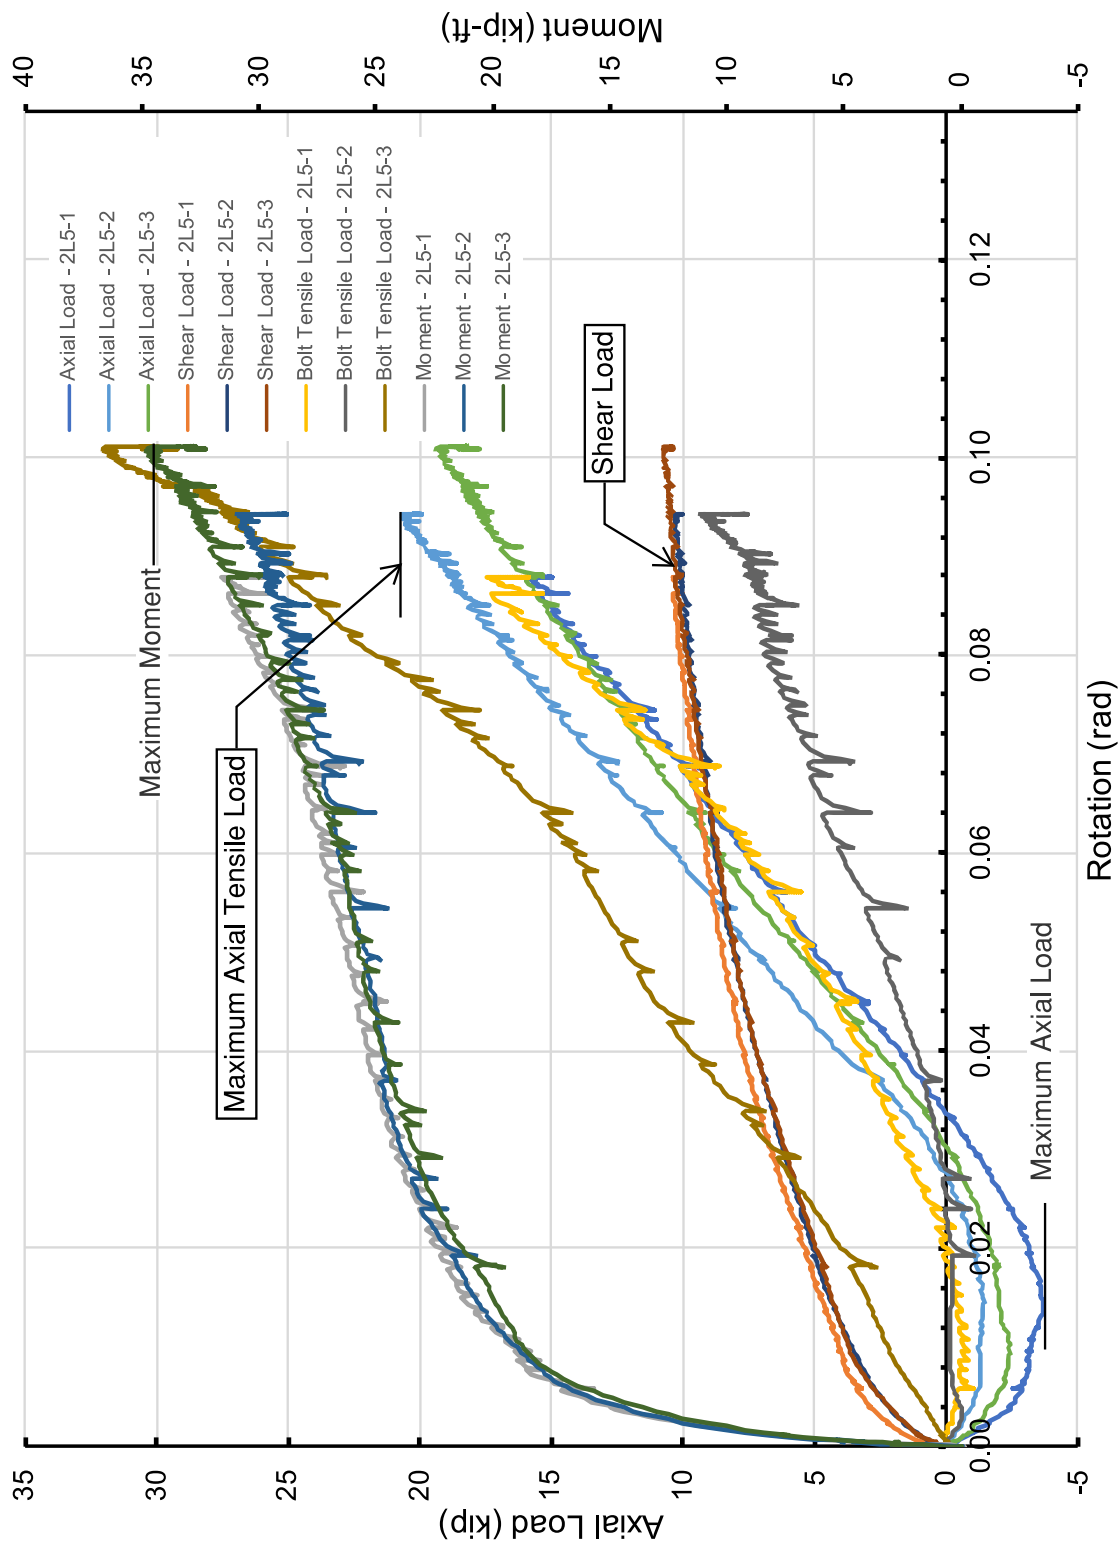
Figure 4.4-34: Load versus rotation for 2L5 series of tests with respect to DWT1 (US units).

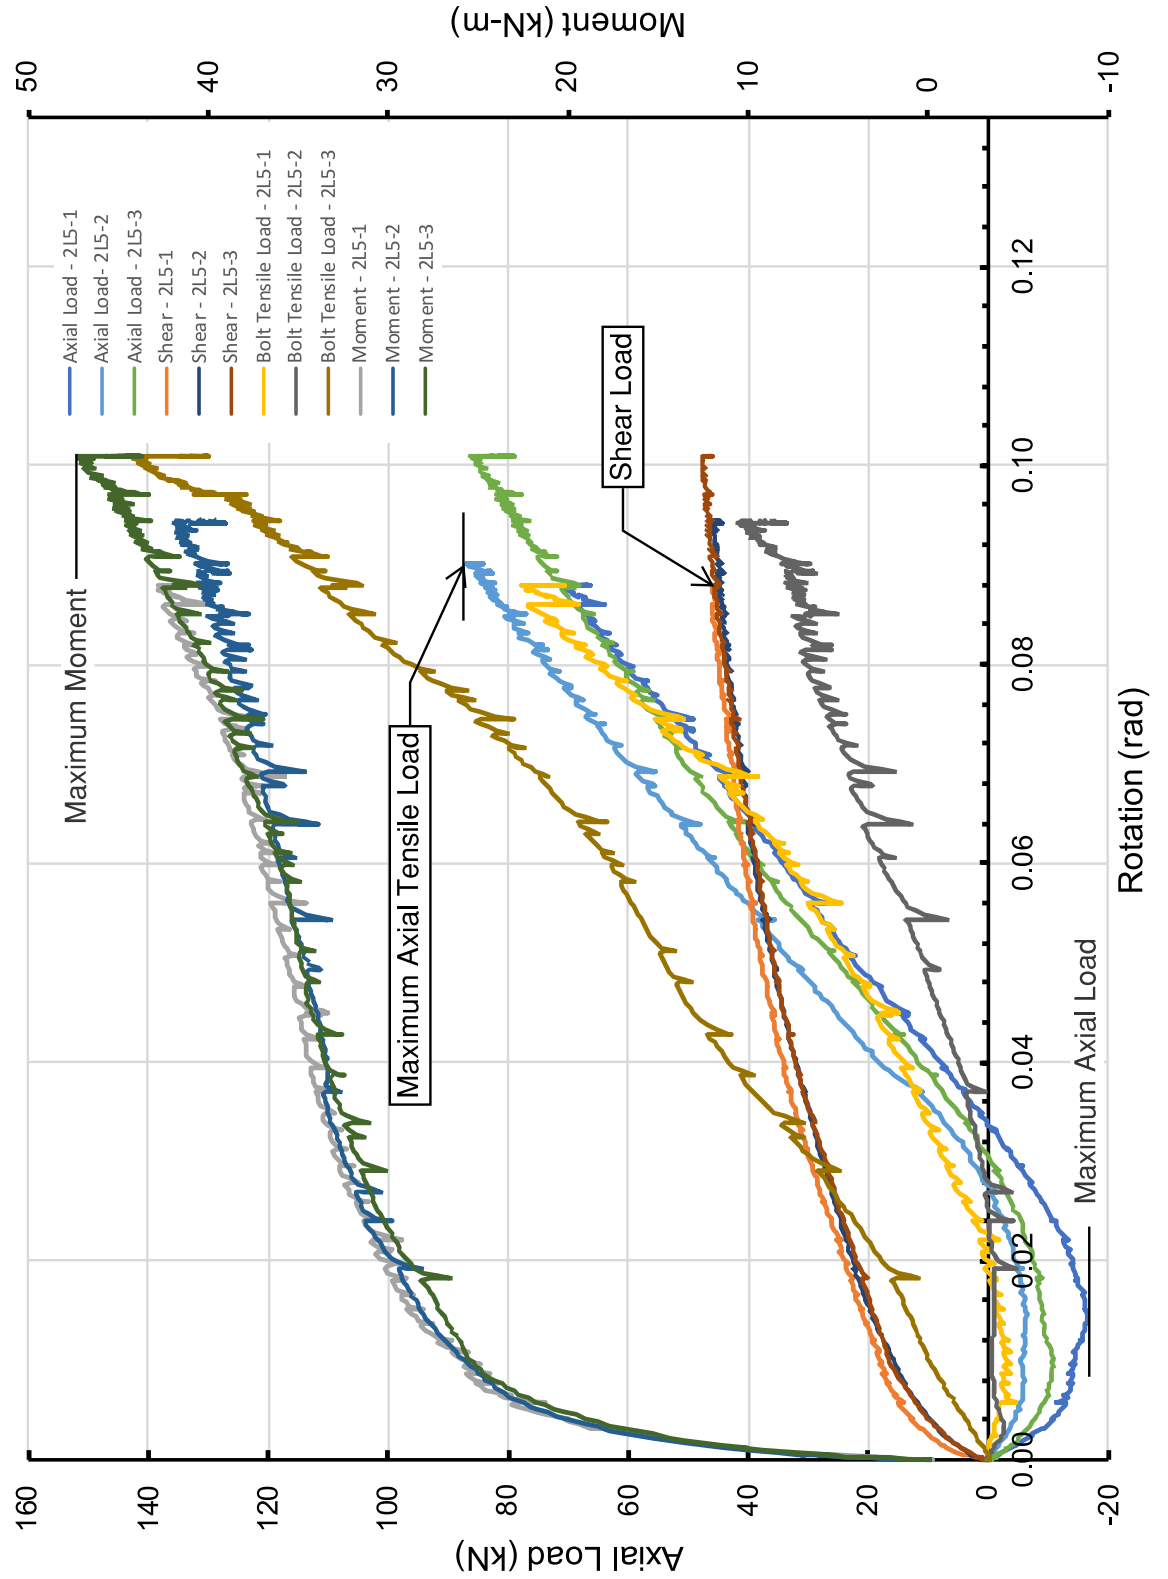
Figure 4.4-35: Load versus rotation for 2L5 series of tests with respect to DWT1 (Metric units).

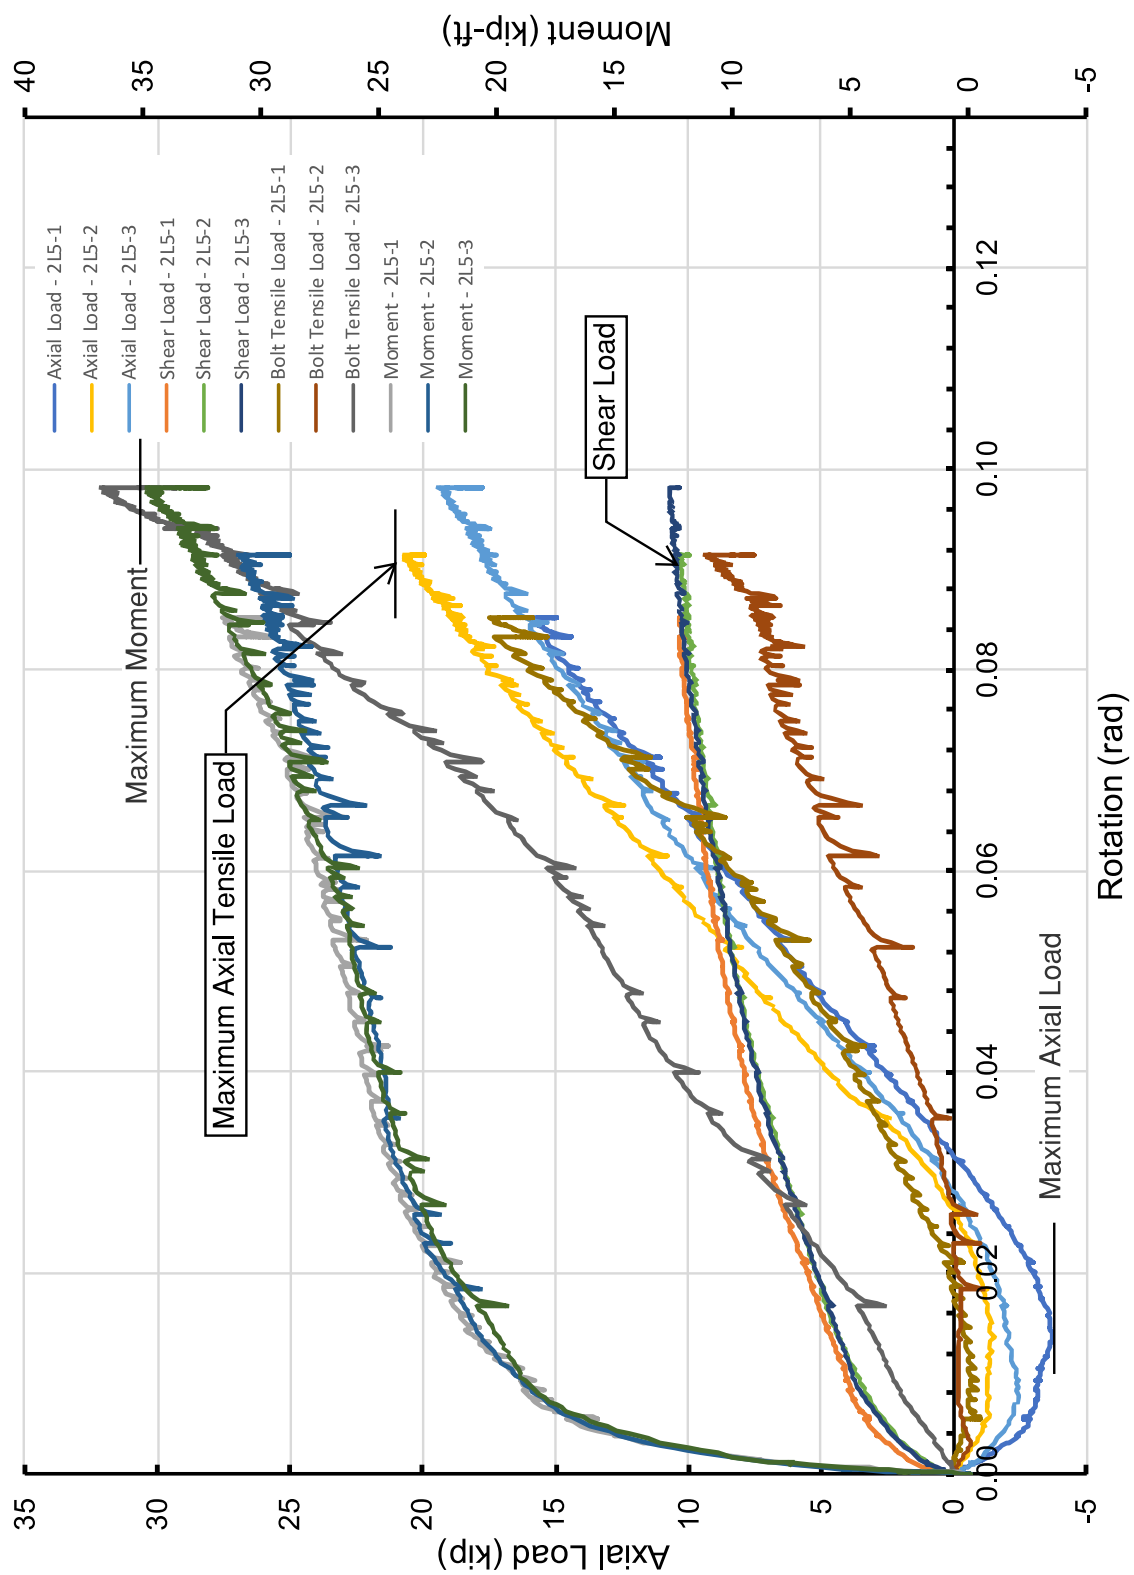
Figure 4.4-36: Load versus rotation for 2L5 series of tests with respect to DWT2 (US units).

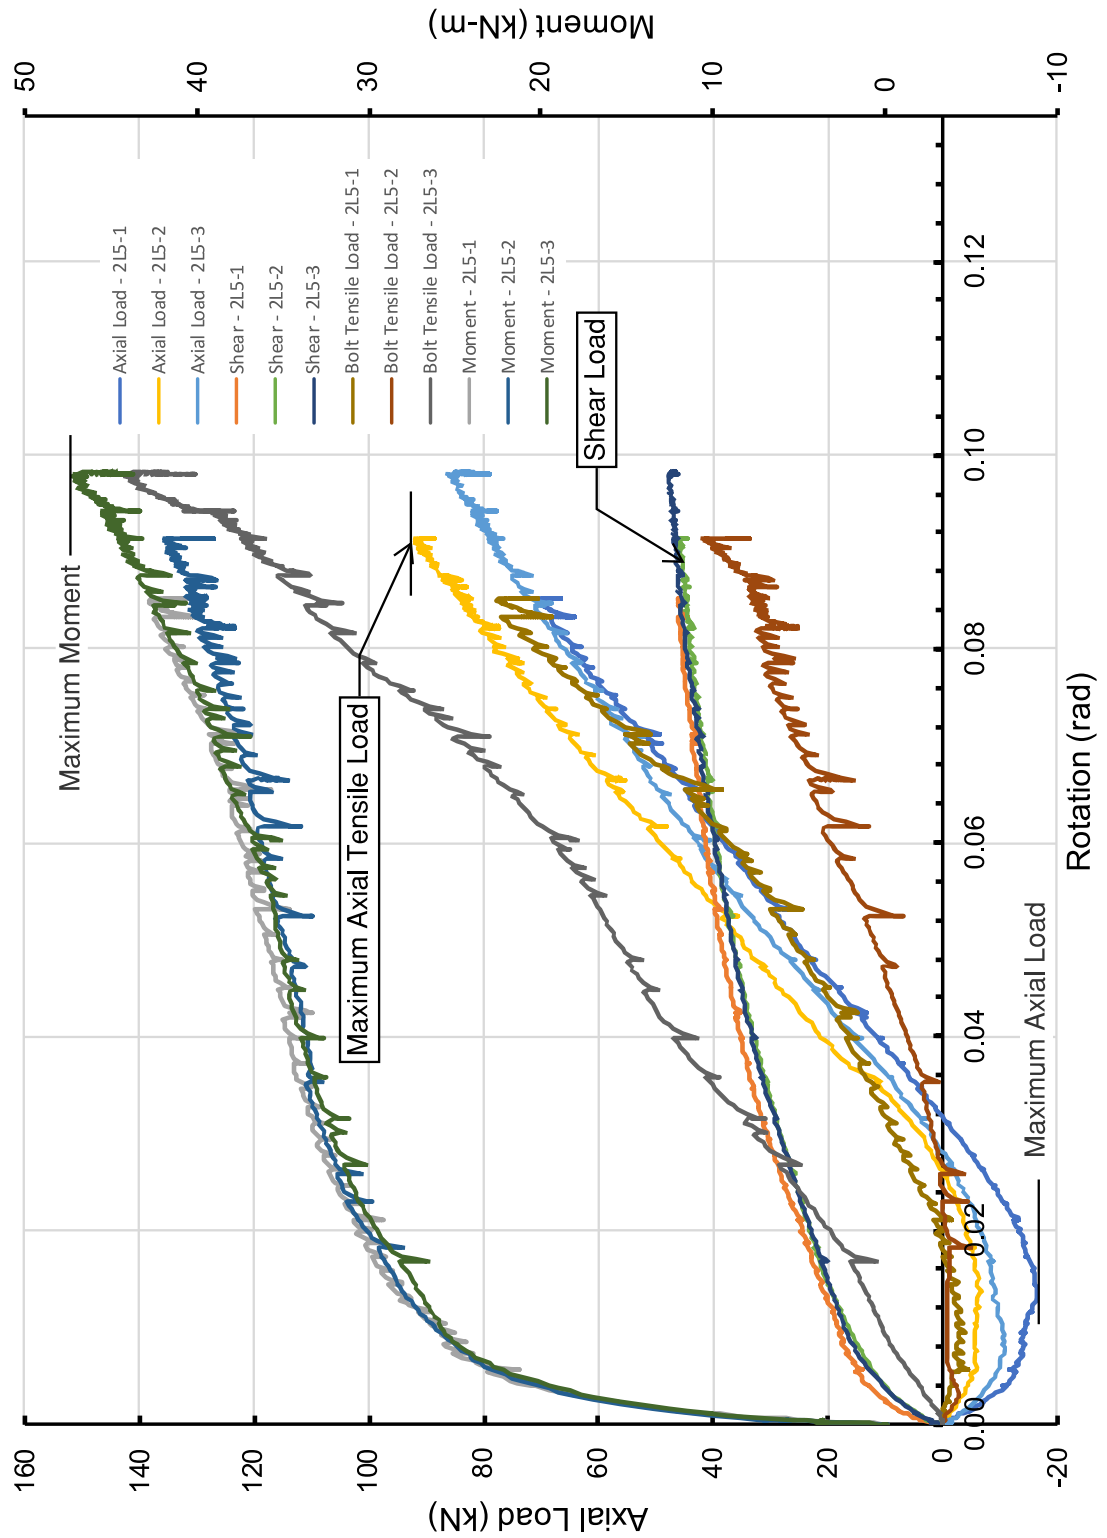
Figure 4.4-37: Load versus rotation for 2L5 series of tests with respect to DWT2 (Metric units).

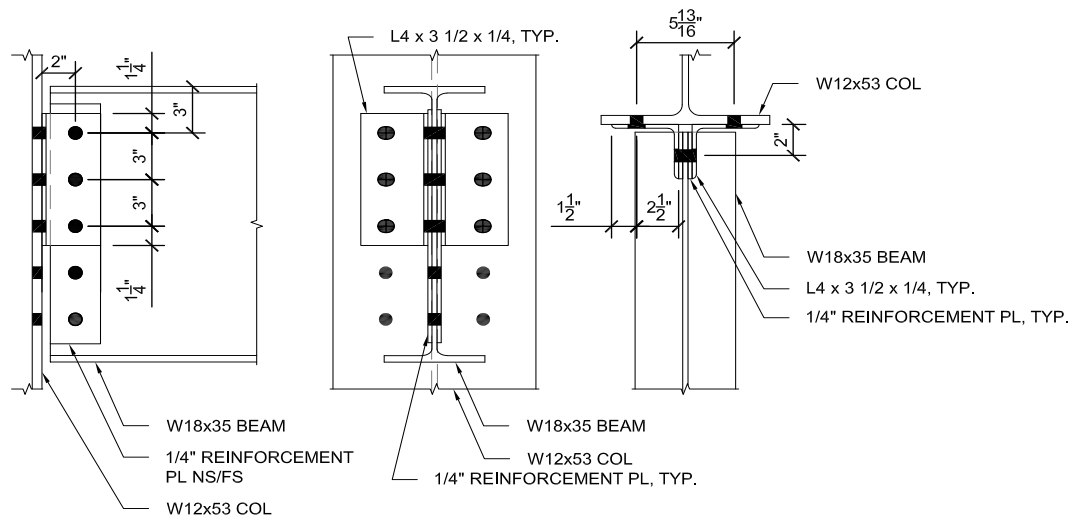
Figure A.1: Given Geometry.

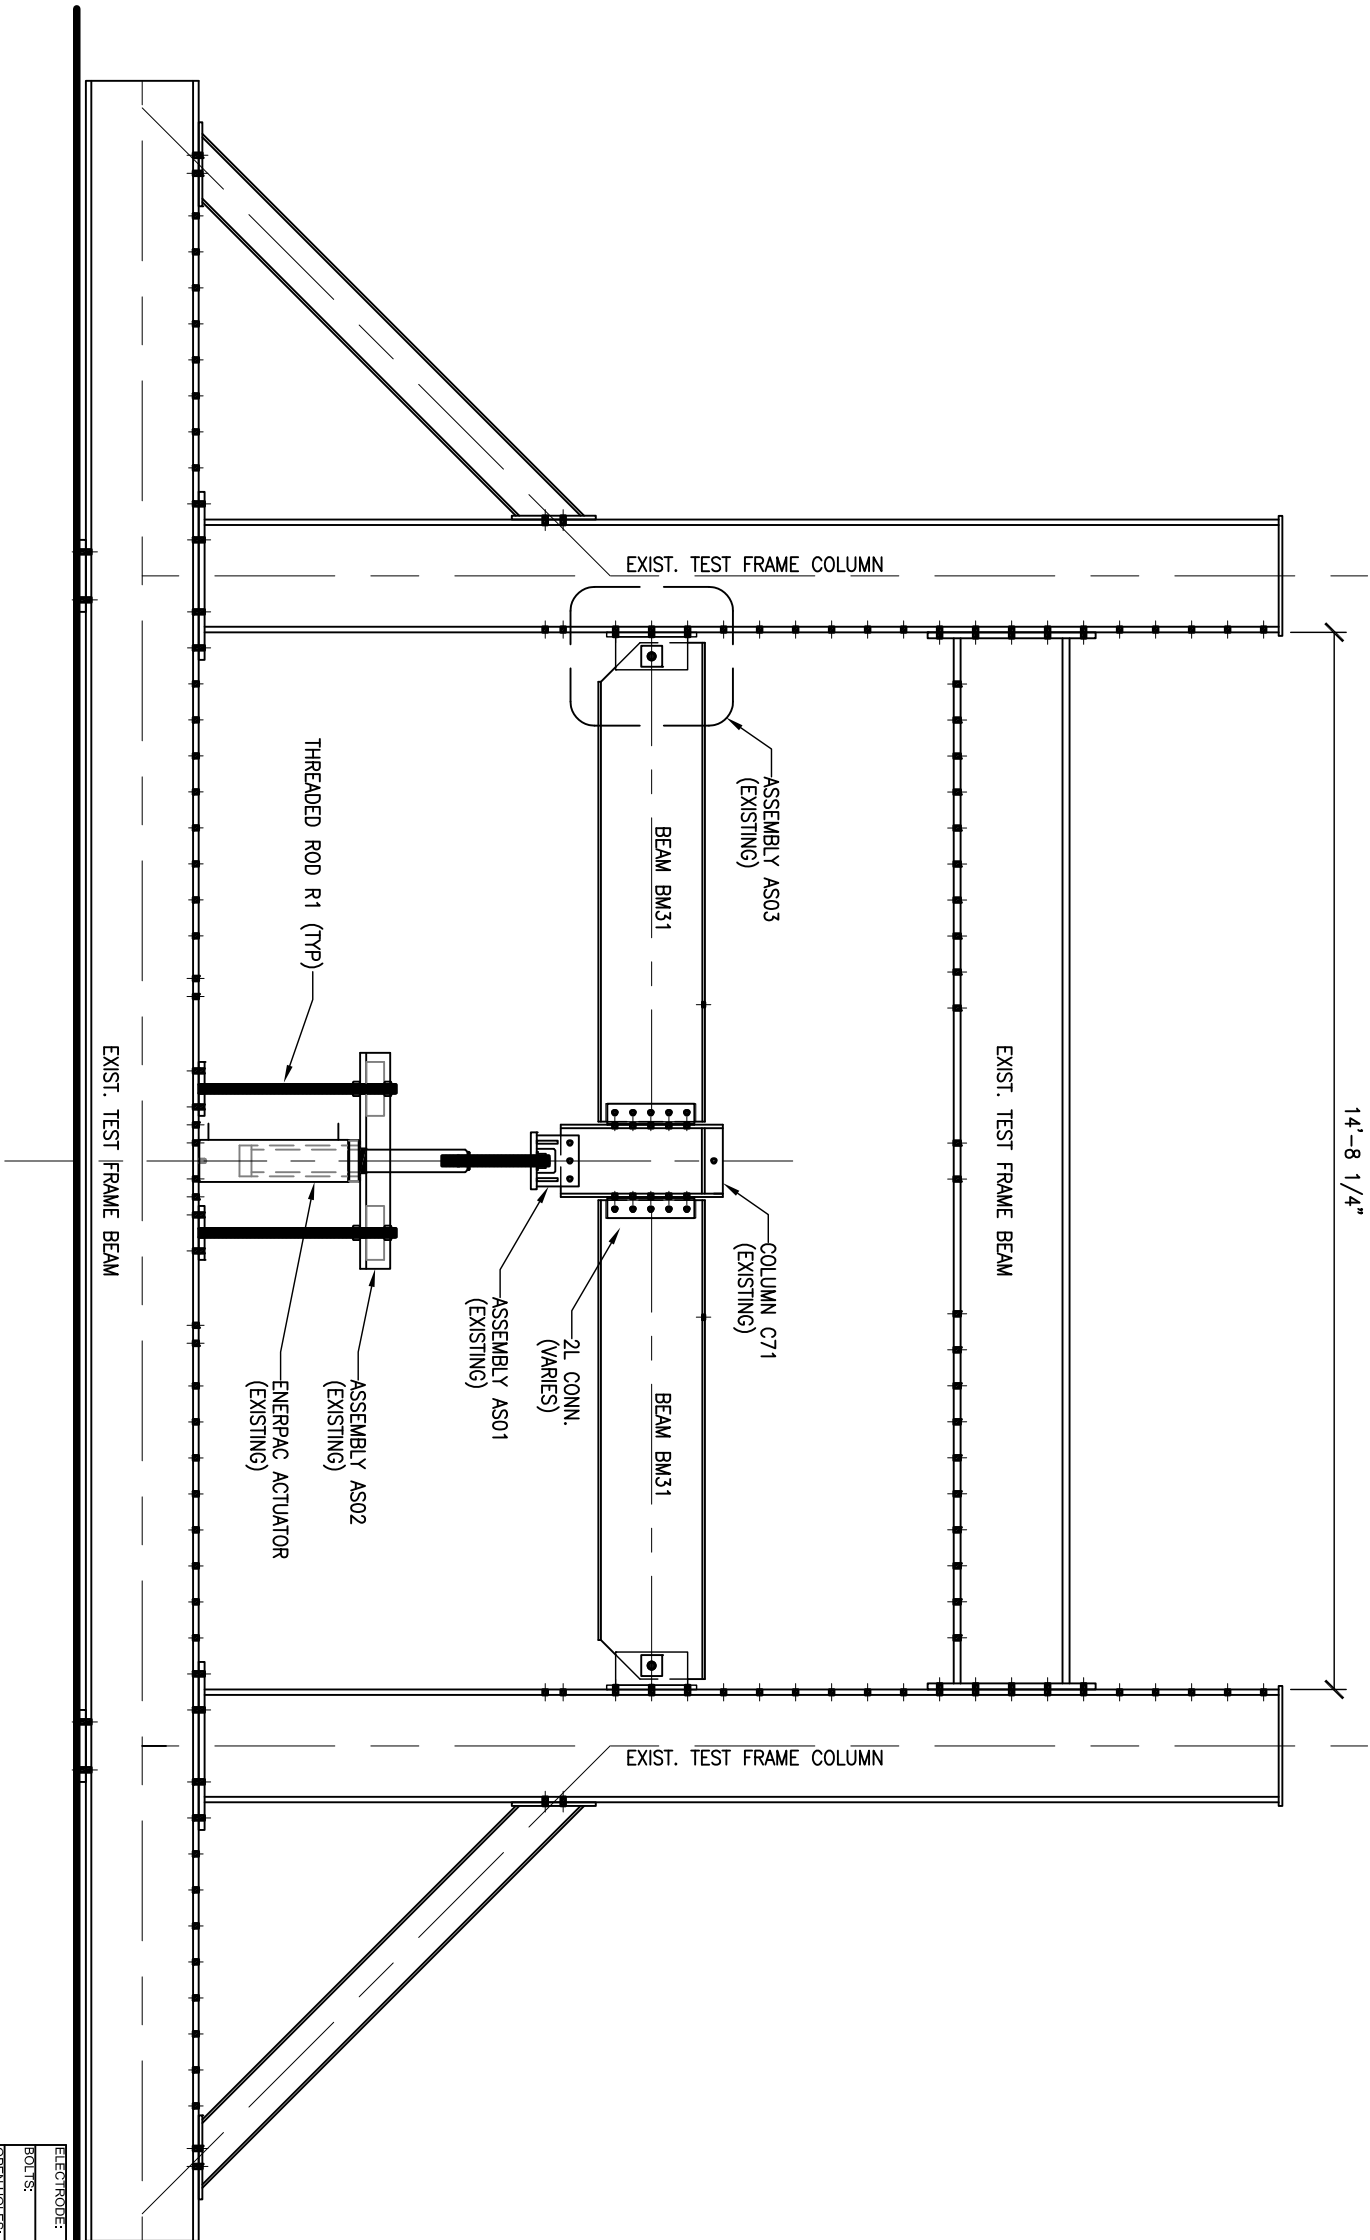
EXPERIMENTAL SETUP – 2L TEST
