Comparison of New to Established Rain Gardens

A report submitted to the faculty of the Milwaukee School of Engineering in partial fulfillment of the requirements for the degree of Master of Science in Civil Engineering, July 27, 2017.

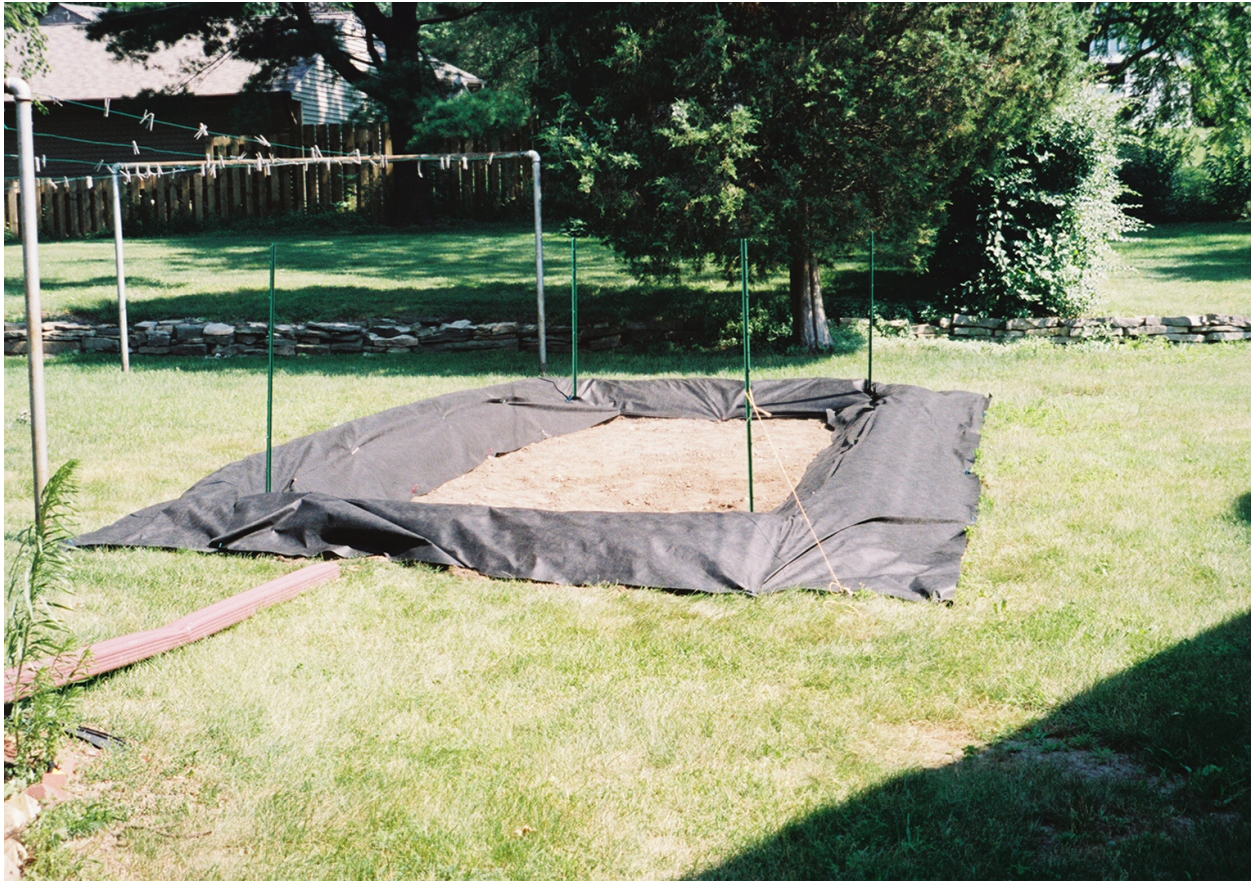
Both rain gardens were constructed by excavating the area of construction roughly six inches, and constructing a berm six inches tall around the garden area. The bottom and berm of the established rain garden were leveled during construction. This can be seen in Figure 1, which shows the currently established rain garden after its construction. Native plants were then planted and allowed to grow in each garden, and the results of these plantings are shown in Figure 2. Flow from the roof of the house on the property was routed to the established garden. Over its life, the established rain garden has maintained its initially level bottom and berm. The berm as a whole, however, has been compacted over time, bringing the garden to approximately nine inches in average depth, as opposed to the rain garden's initial 12-inch depth. The berm also has a few low spots which lowers the effective depth to approximately five inches. Overall, the established rain garden is approximately 136 square feet and can hold approximately 23 cubic feet of stormwater, which is equivalent to 0.015 inches of rainfall that can be held in the garden.

Figure 1. Construction of established rain garden.

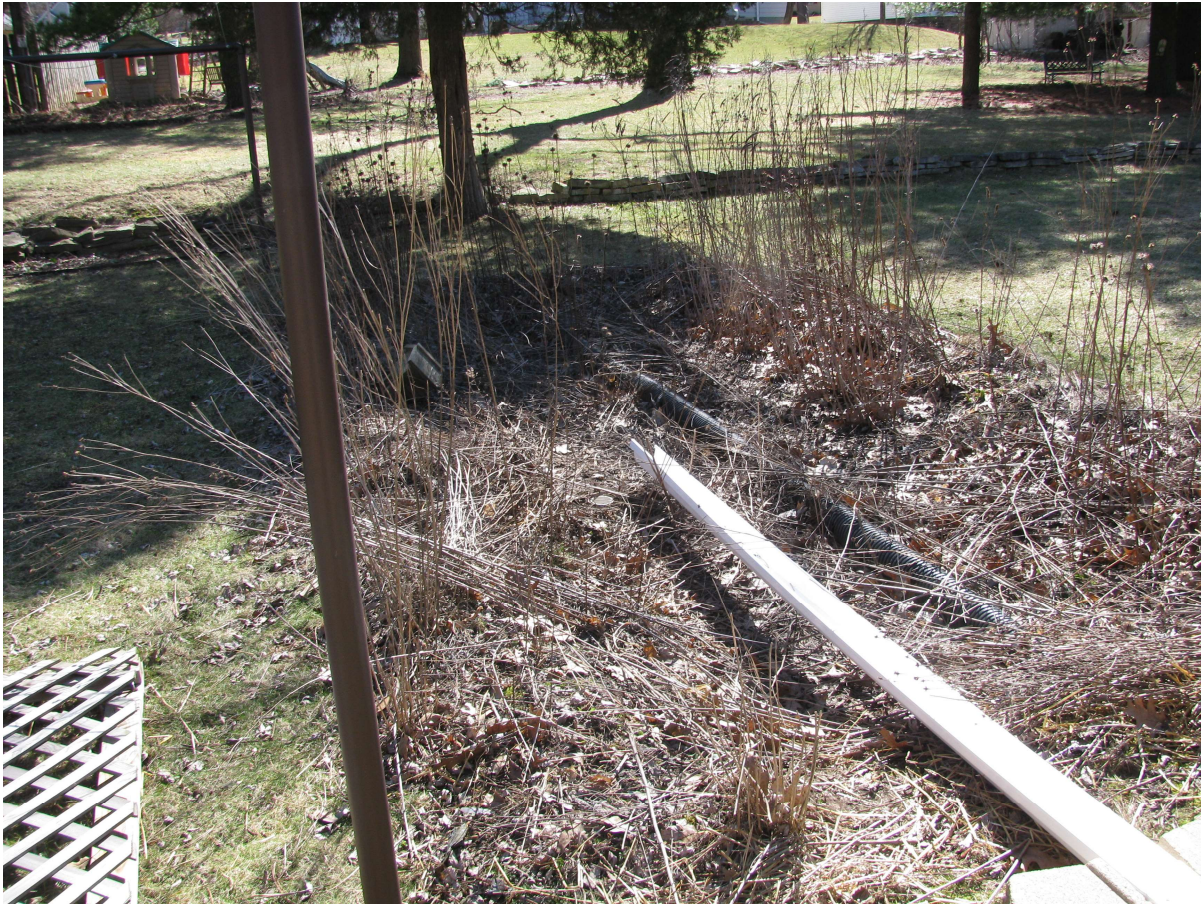
Figure 2. Established rain garden.

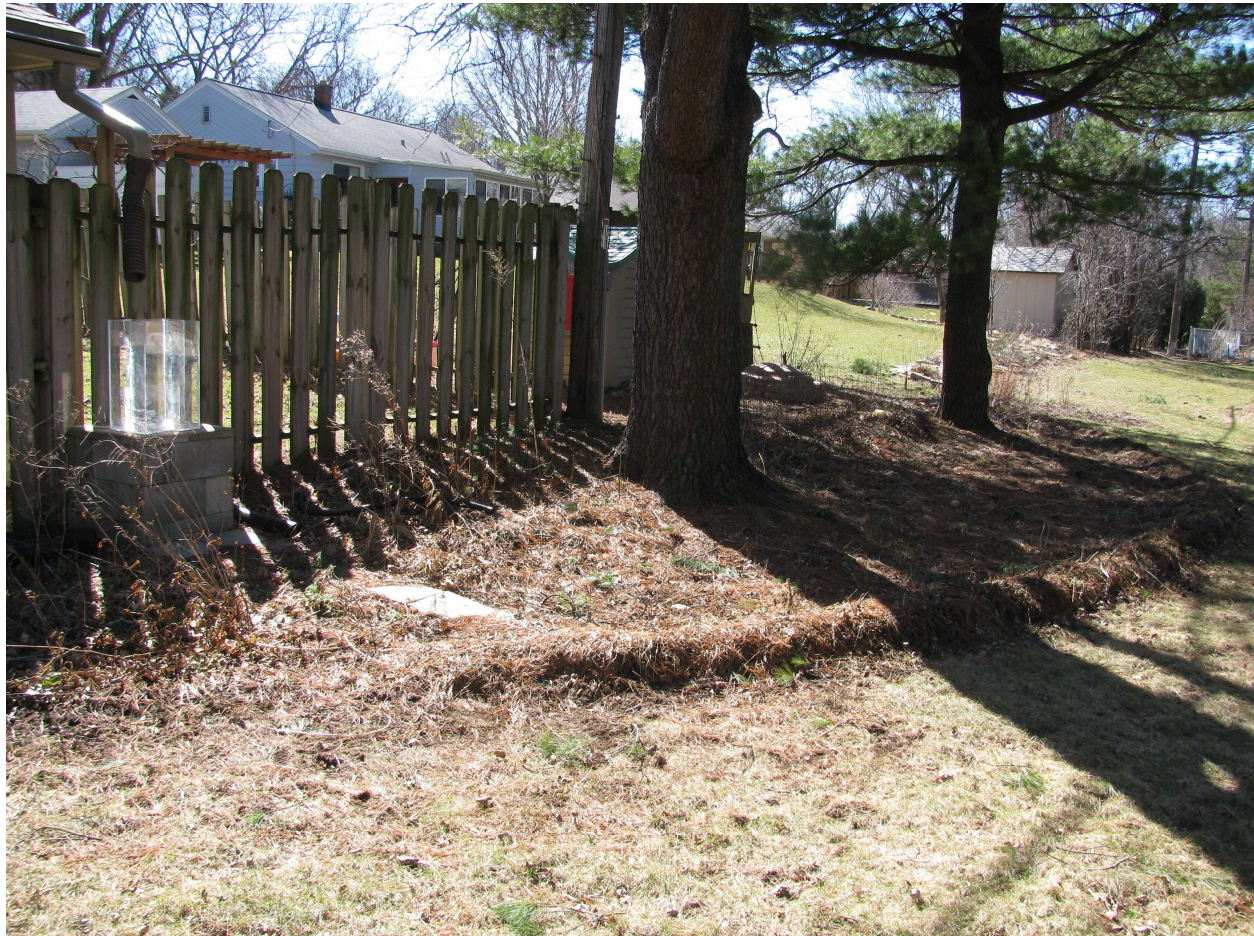
Figure 3 shows the newer rain garden which the established rain garden is being compared to. Unlike the bottom of the established rain garden, the newer garden is on a slope, from both the fence line to the berm and along the entire length of the garden. The berm on the downhill end of the garden is also shorter in comparison to the rest of the berm. Flow to the newer rain garden is from a garage roof of another property. Because of the slope of the garden and the shorter berm on one end, this rain garden is approximately 58 square feet and can only

hold approximately four cubic feet of stormwater, which is equivalent to 0.02 inches of rainfall that can be held in the garden.

Figure 3. Newer rain garden.

In Figure 13, the newer rain garden is oriented the same way as it is in Figure 3, meaning that the left side of Figure 13 is also the left side of Figure 3. As can be seen in Figure 13, the berm starts out on the left side of the figure at a height of approximately 0.6 to 0.8 feet, and steadily decreases along the length of the garden. The lowest point on the berm has a height of 0.24 feet, which can be seen on the right end of Figure 13 at the seven foot width marker.

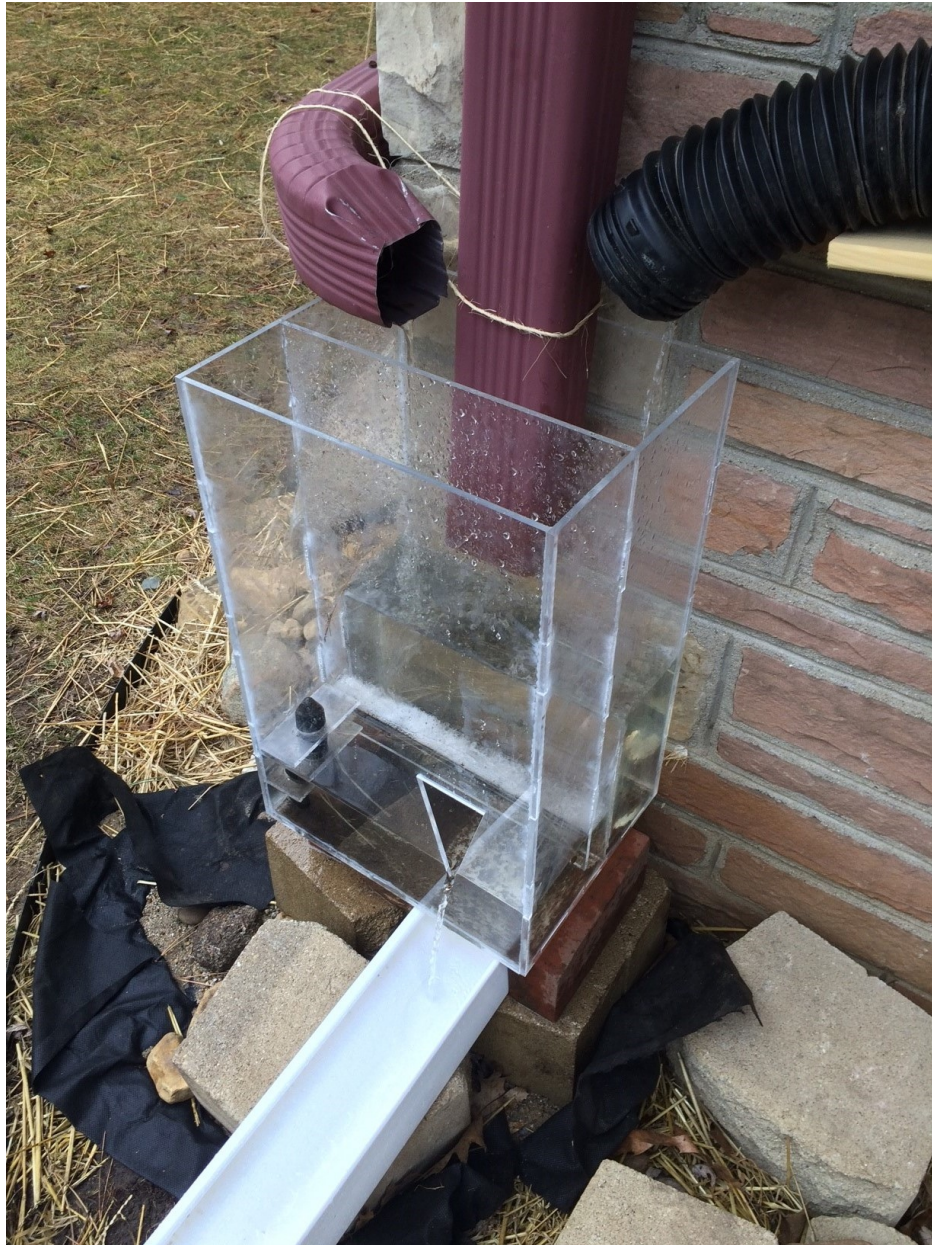
To measure the inflow into each rain garden, two flow measurement boxes were constructed. Pictured in Figure 4, these boxes were laser cut from quarter inch acrylic sheets, glued together, and sealed to ensure that flow could accurately be recorded. Flow from the roof gutters flowed directly into the rear chamber of each box. The stormwater then passed through an over-under weir to reduce the turbulence in the box; this system is pictured in Figure 5. After passing through the weir system, the water then entered the measurement chamber of the box. This chamber housed a pressure sensor which recorded the water pressure (in psi) of the water in the box every 30 seconds. From this chamber, the water left the box through a V-notch weir and entered the rain garden.

Figure 4. Flow measurement box.

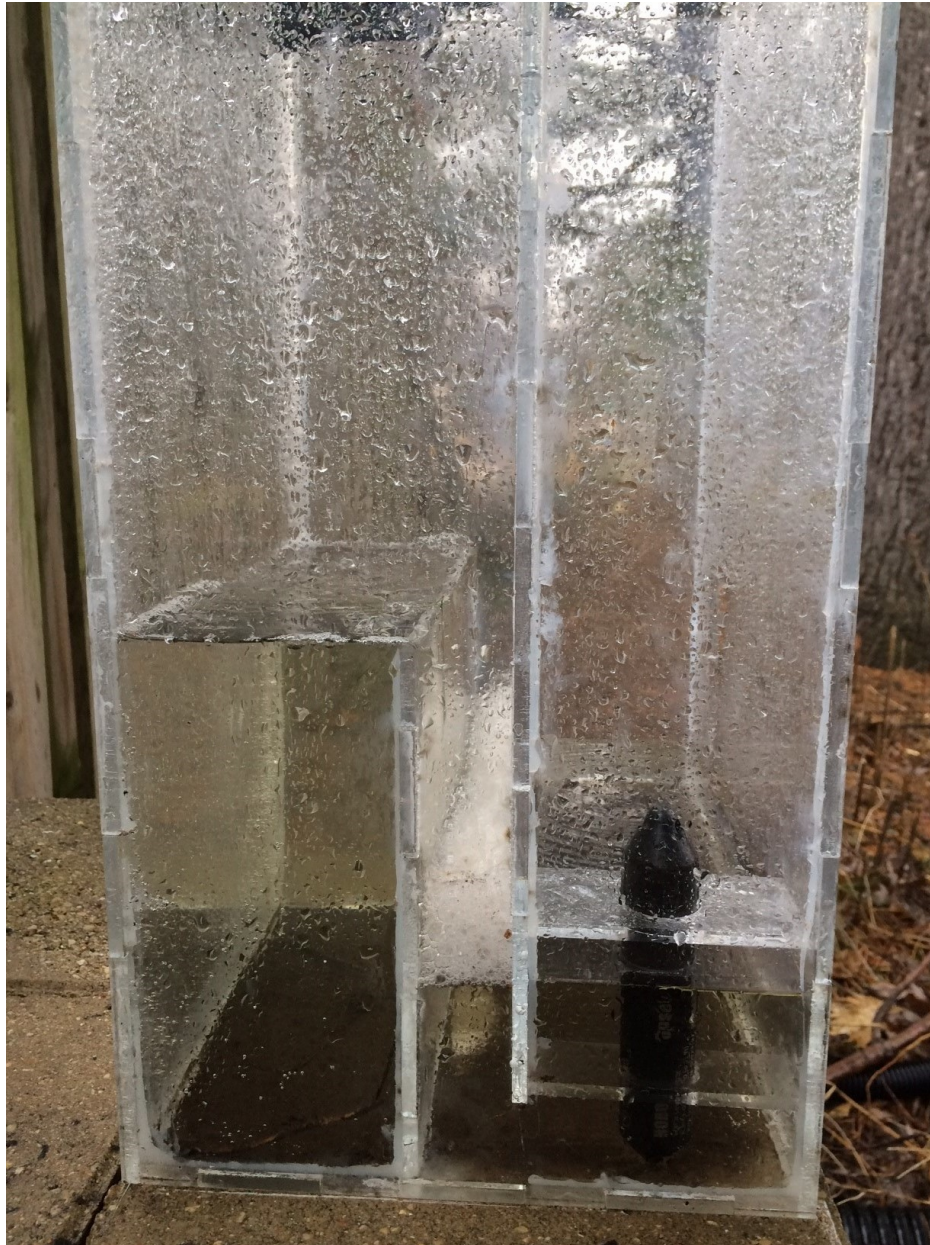
Figure 5. Flow measurement box over-under weir.

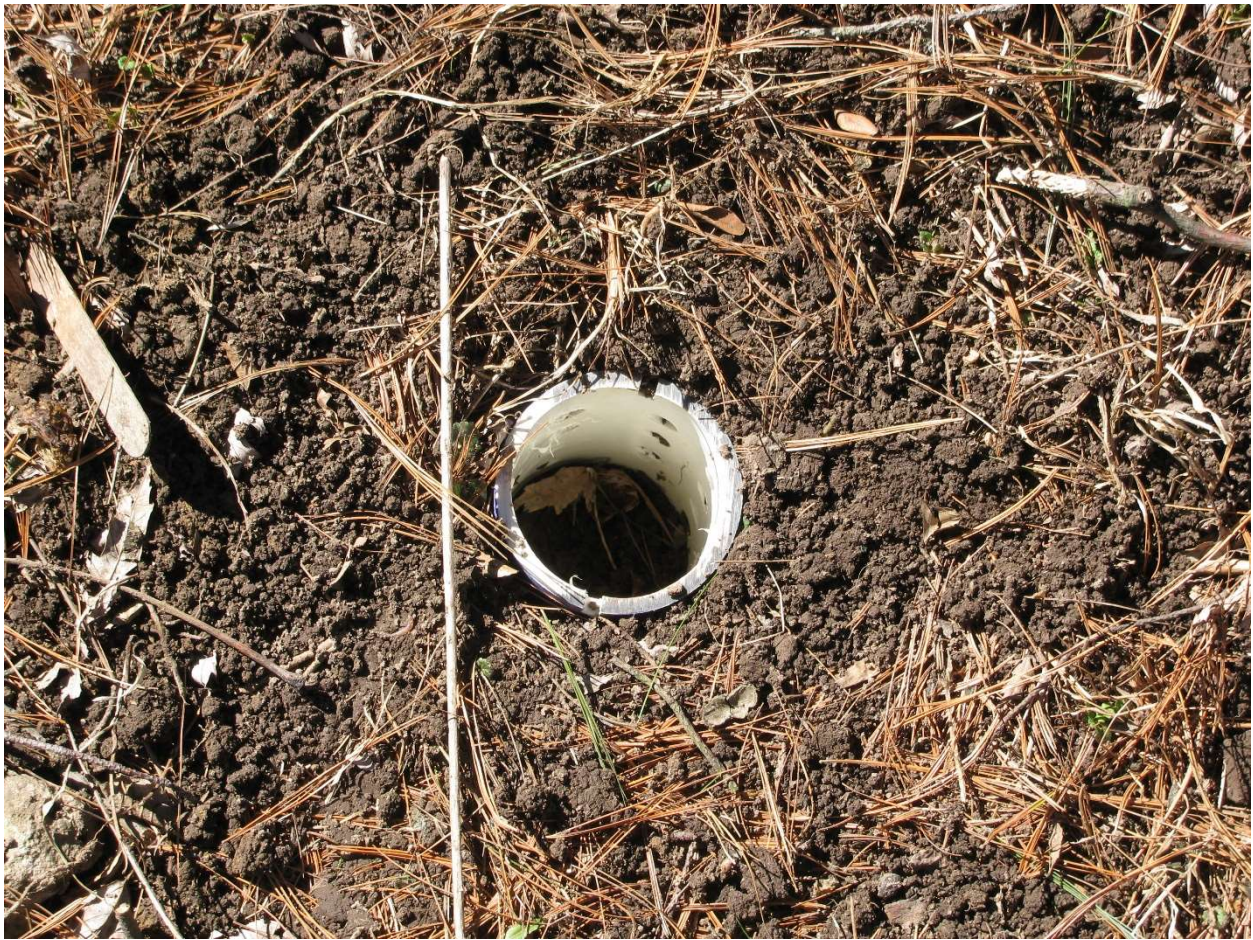
rate of the soil for each rain garden. Each sensor was placed in a perforated PVC mounting tube, as seen in Figure 6, to ensure the sensor would be kept at a consistent depth and to prevent the hole from filling in, but not restrict groundwater flow.

Figure 6. Garden water level sensor mounting tube.

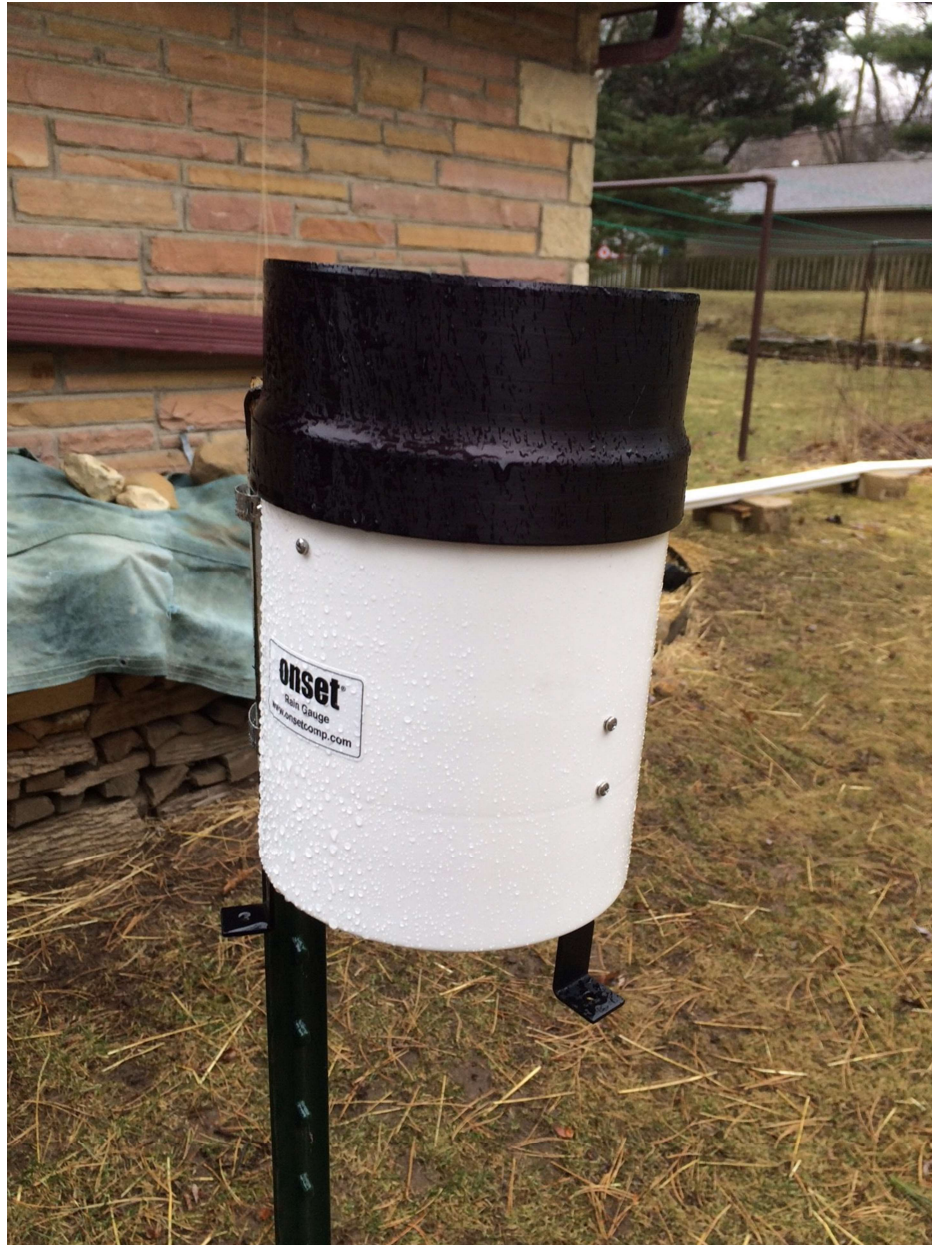
To measure the magnitude of rainfall events a tipping bucket rain gauge, pictured in Figure 7, was set up in an open area in the yard where the canopy was clear. The gauge logged the cumulative rainfall for each data collection period.

Figure 7. Tipping bucket rain gauge.

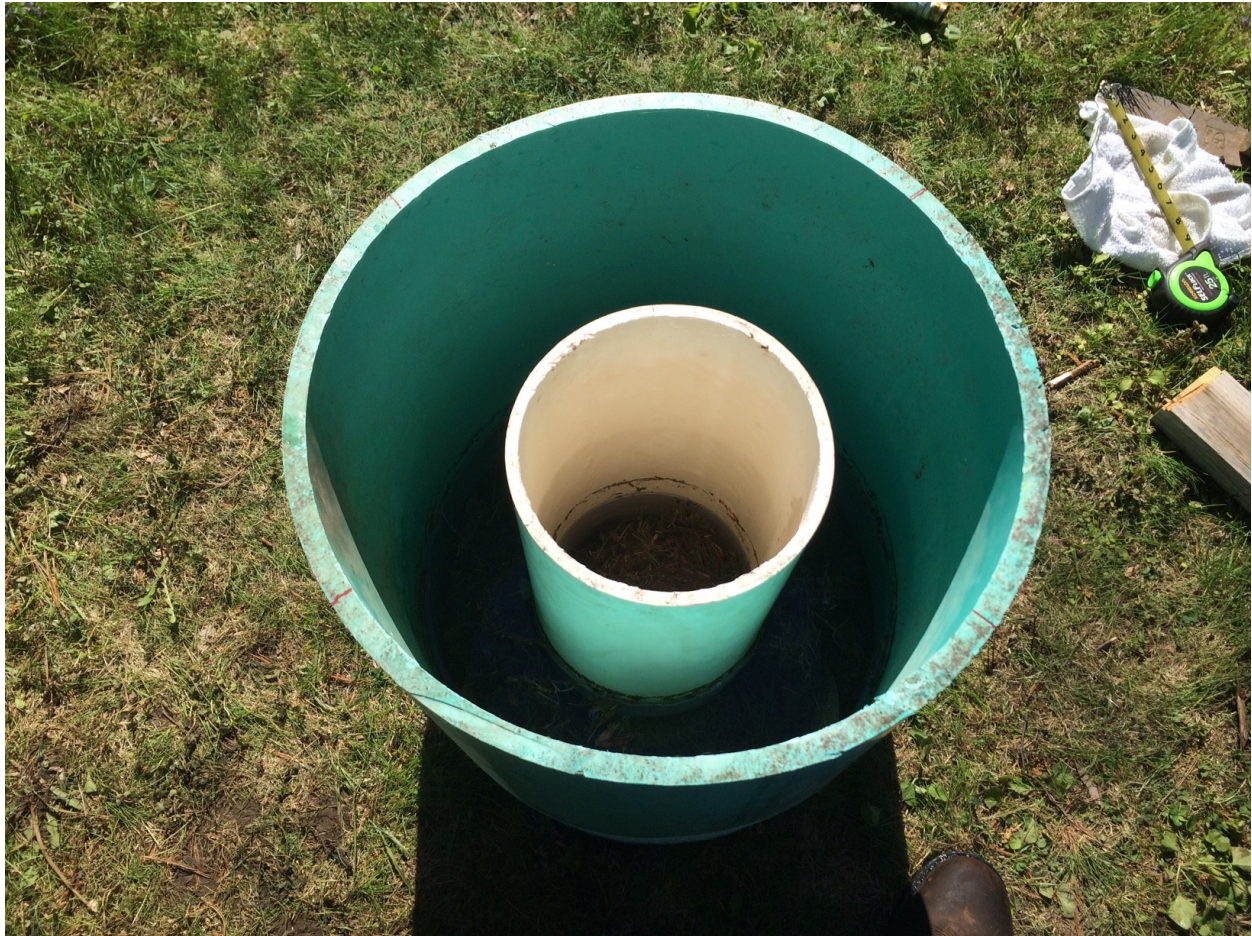
International, 2009). For the infiltrometer test, two 20-inch-long pipes were used. These pipes had nominal diameters of 18 inches and 8 inches, with outer diameters of 18.25 and 8.125, and inner diameters of 17.75 and 7.875, respectively. These sizes were chosen based on the two-to-one ratio between the pipes called for by the standard. The larger of the two pipes was driven approximately six inches into the ground and the smaller pipe was driven approximately four inches into the ground, with the smaller of the pipes centered inside the larger pipe; this setup can be seen in Figure 8. Flow was delivered to each ring by a garden hose. A flow meter, pictured in Figure 9, was attached to the hose so that the flow into the rings during the test could be monitored.

Figure 8. Double-ring infiltrometer.

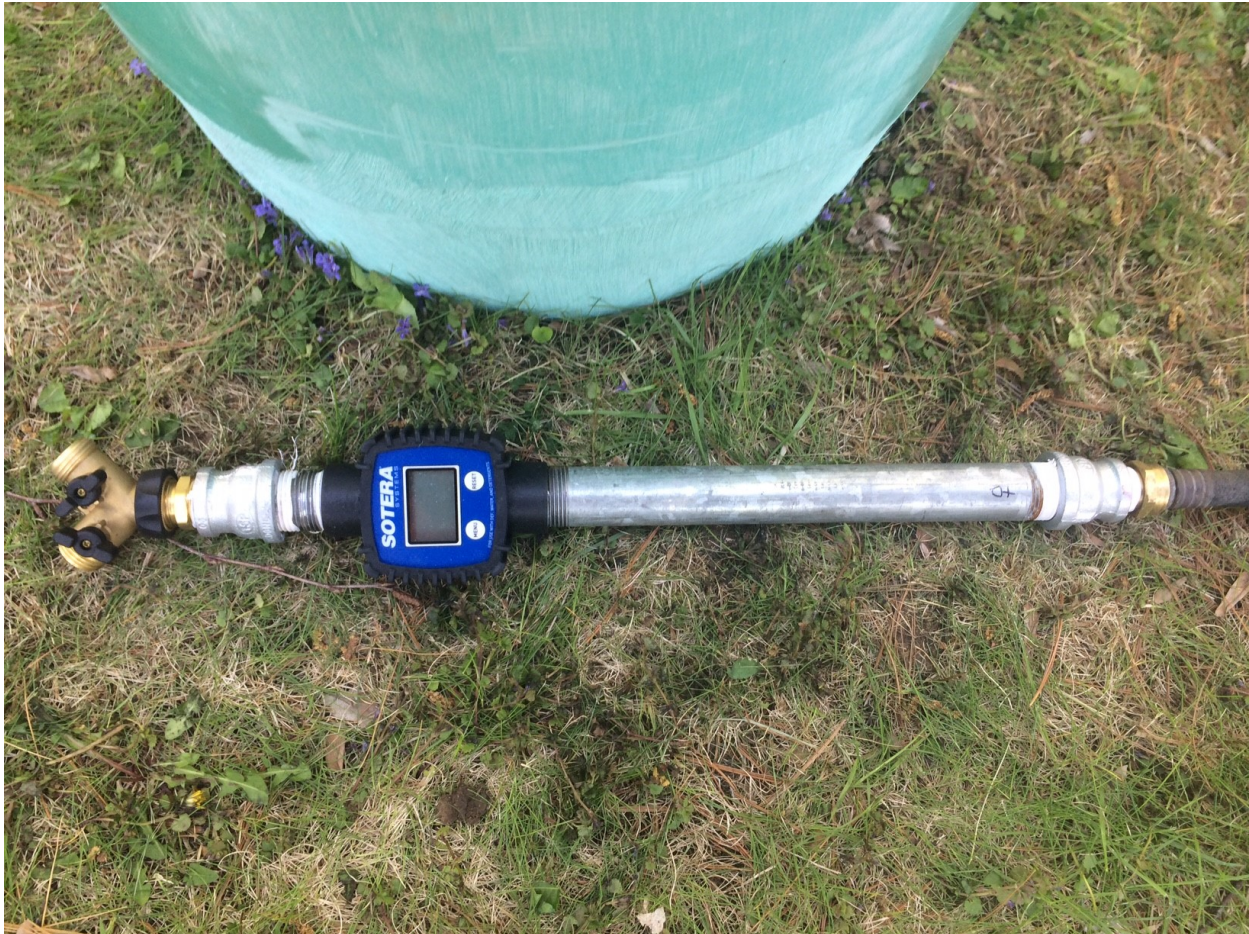
Figure 9. Hose mounted flow meter.

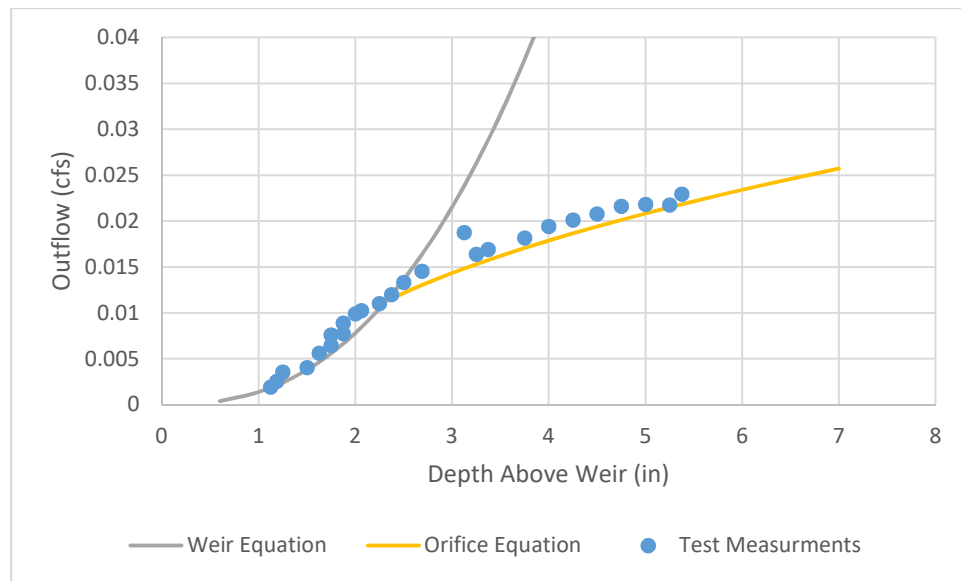
The validity of the equations used above was confirmed using a scale model of the full sized flow box by measuring the flow rate out of the box at multiple depths, and then plotting

those values against the flow rate values calculated by the equations. This can be seen in Figure 11.

Figure 11. Weir and orifice equation applicability.

Since the calculated flow rate values from the equations matched the measured values taken during the model box test, the equations presented above accurately predict the flow leaving the box during the test.

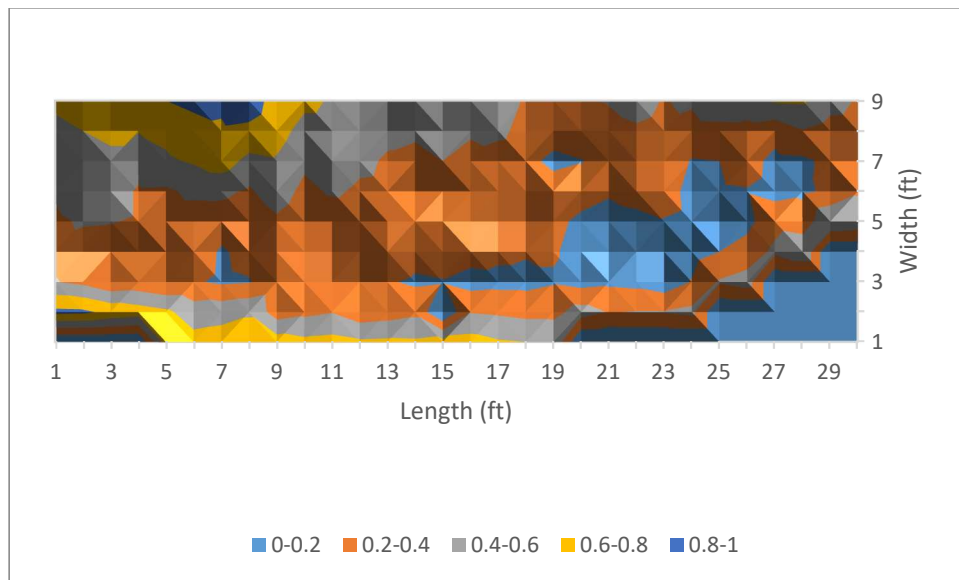
Figure 13. Topographic map of newer rain garden.

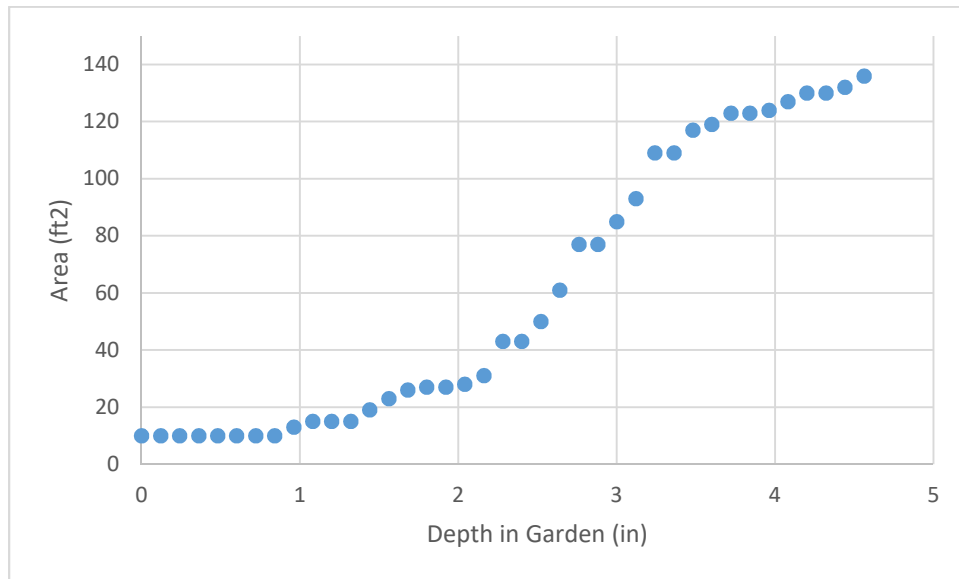
The survey data were then used to relate the ponded surface area in the garden to the depth of water present. These relationships can be seen in Figure 14 and Figure 15.

Figure 14. Established rain garden depth to ponded surface area curve.

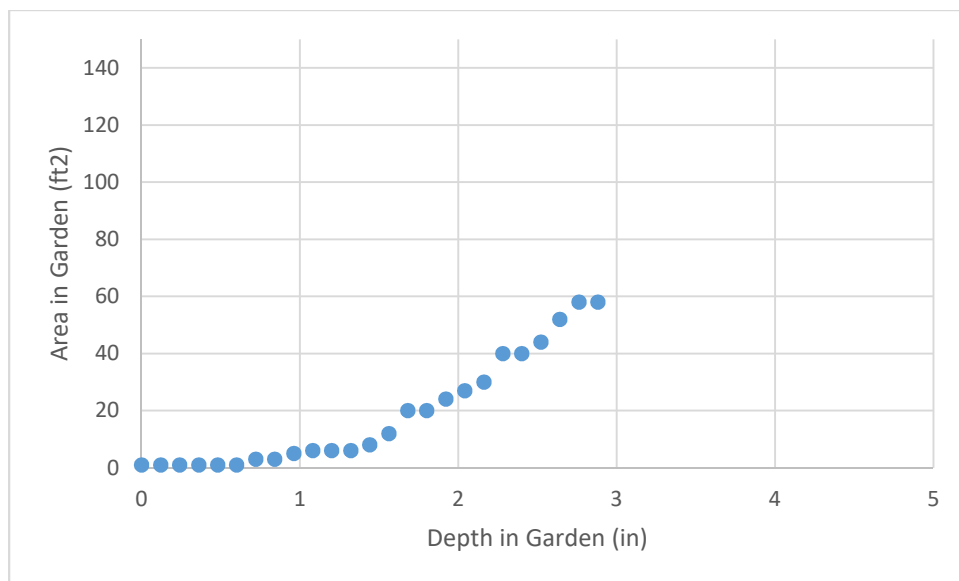
Figure 15. Newer rain garden depth to ponded surface area curve.

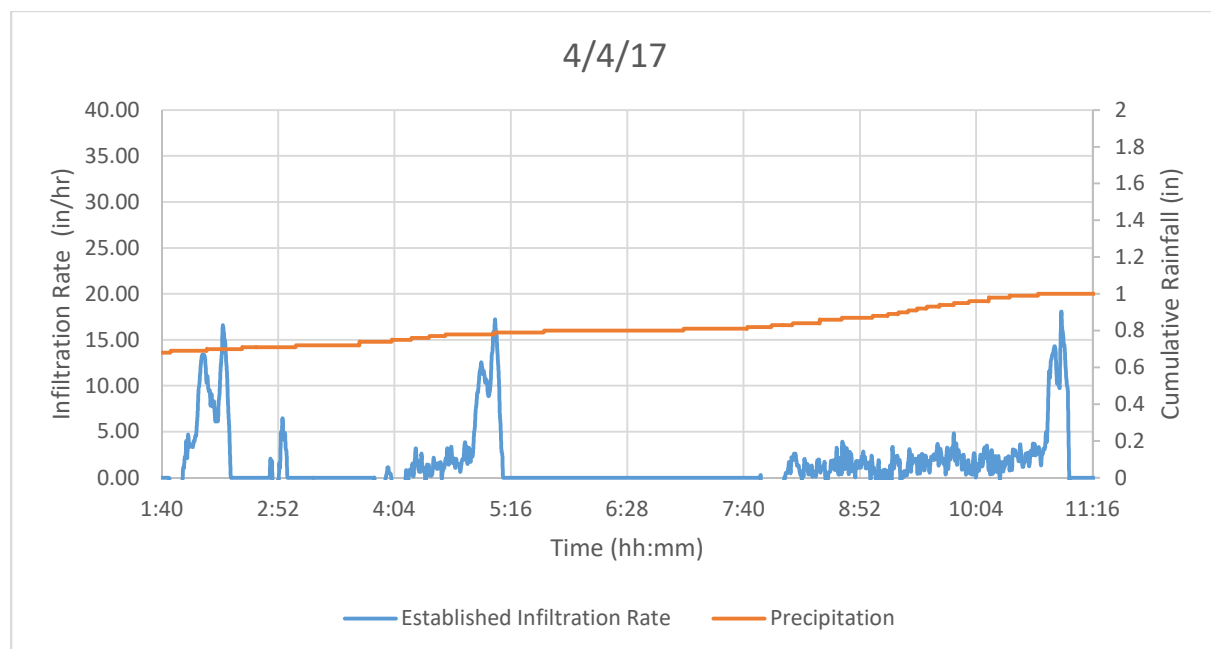
Figure 18 through Figure 24 show the calculated infiltration rates of the established rain garden during various recorded events. These events were chosen because they had a long enough duration to produce a significant ponded area in the rain garden, leading to more accurate infiltration values. For all graphs, infiltration values (blue) are read from the left vertical axis, and cumulative precipitation values (orange) are read from the right vertical axis. The

precipitation values shown are cumulated over a seven-day period, the actual rainfall during a single event is the difference between the cumulative rainfall at the start of the event, and the cumulative rainfall at the end of the event. For example, in Figure 18, the rainfall during the event was approximately 0.4 inches, because there was 0.6 inches of cumulative rainfall before the event, and one inch of cumulative rainfall after the event.

In Figure 18 through Figure 24, there are drastic changes in the infiltration rate values shown, followed by periods of relatively even infiltration rate values. The reason for the large variances in the infiltration rate values is because the infiltration rate calculation is based on the ponded surface area of the garden. Because the measurements for this experiment were taken at 30-second intervals, there are intervals at the beginning and end of a rainfall event when the garden has a very small pond, but a relatively large inflow, which causes the infiltration rate for that interval to be significantly higher than what it actually is. As a result, the infiltration rate for an event from Figure 18 through Figure 24 is read from the portion of each figure when the data level off and remain relatively steady for a period of time. The data from these sections of the events were then averaged to determine the overall infiltration rate for the established rain garden, which can be seen in Table 4.

The data collected during the various rainfall events suggest that the established rain garden has an average infiltration rate of approximately six inches per hour. Compared to the infiltrrometer test performed in the yard, it would appear that the established garden has a lower infiltration rate than that of the rest of the yard, which was approximately 12.64 inches per hour. Although there was no calculated infiltration data for the newer rain garden, comparing the calculated infiltration data for the established garden to the infiltrrometer test results of the newer garden would suggest that the established rain garden has an infiltration rate about equal to that of the newer rain garden, which was approximately 6.76 inches per hour.

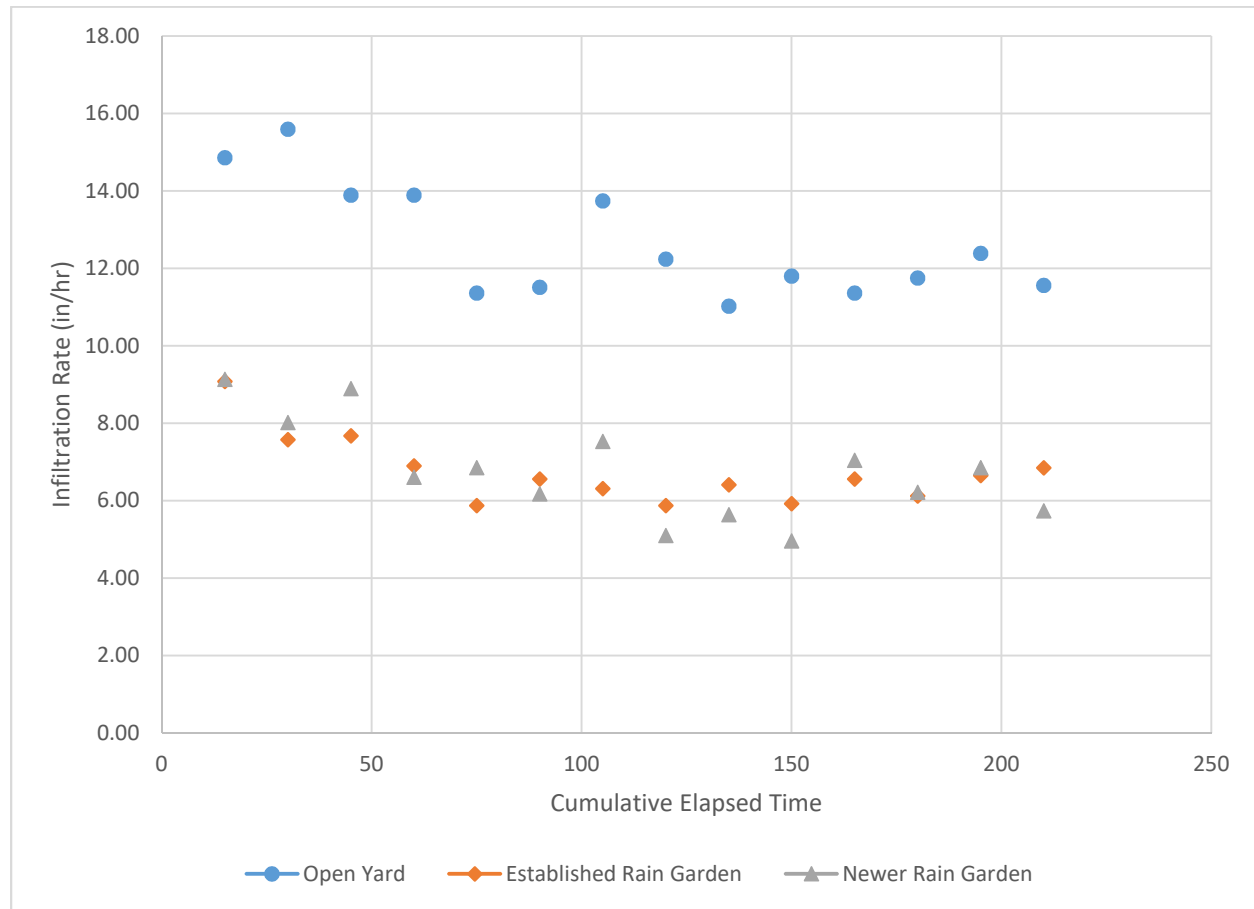
The infiltration rate column shows the calculated infiltration rate based on the volume required to fill the rings and the elapsed time during the trial run. In both the volume and infiltration rate columns, inner ring refers to the area inside the center eight-inch pipe, and annular area refers to the area between the inside of the 18-inch pipe and the outside of the eight-inch pipe; these infiltrometer results were also plotted in Figure 25.

Figure 25. Plotted infiltrometer test results.

The results from the established rain garden infiltrrometer test also agree with the results of rainfall event analysis. The infiltrrometer test showed an average of approximately 6.74 inches per hour, which is about equal to that of the newer rain garden and still less than that of the yard. These results would suggest that the infiltration rate of rain gardens does not change over their lives.
