Robustness of Shear Plate Connections under Quasi-Dynamic Loading

A Report Submitted to the Faculty of the
Milwaukee School of Engineering
in Partial Fulfillment of the
Requirements for the Degree of
Master of Science in Structural Engineering

May 2016

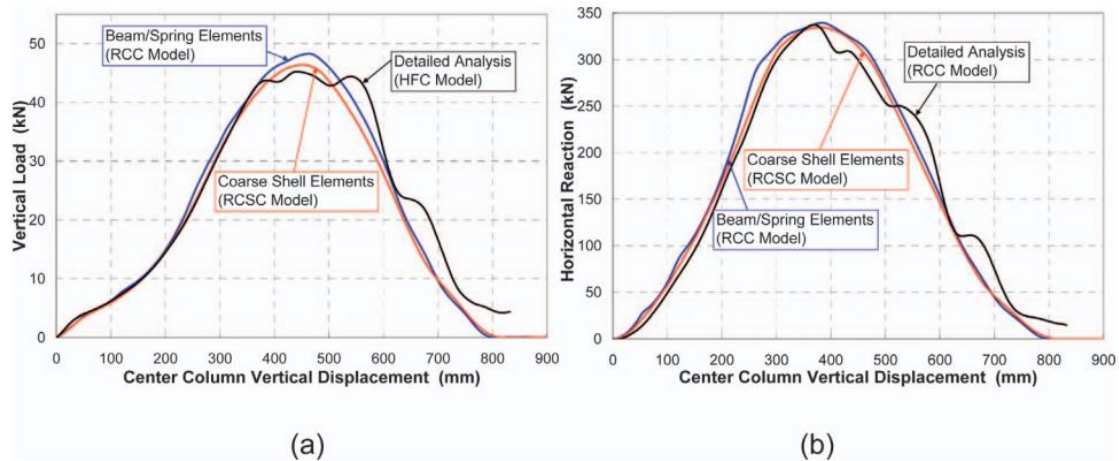
Figure 2.8: (a) Applied Vertical Load versus Center Column Vertical Displacement; (b) Horizontal Reaction versus Center Column Vertical Displacement [8].

A reduced coarse shell connection (RCSC) model was utilized to compare the data found by the RCC. In this model, a coarse shell element mesh was used to emulate the beam, column, and connection. An elastic-perfectly plastic spring was supplemented into the system to ensure shear rigidity and strength. The failure in the model is due to sequential failure/erosion of the shell elements representing the connection. A comparison of these three models can be seen in Figure 2.8.

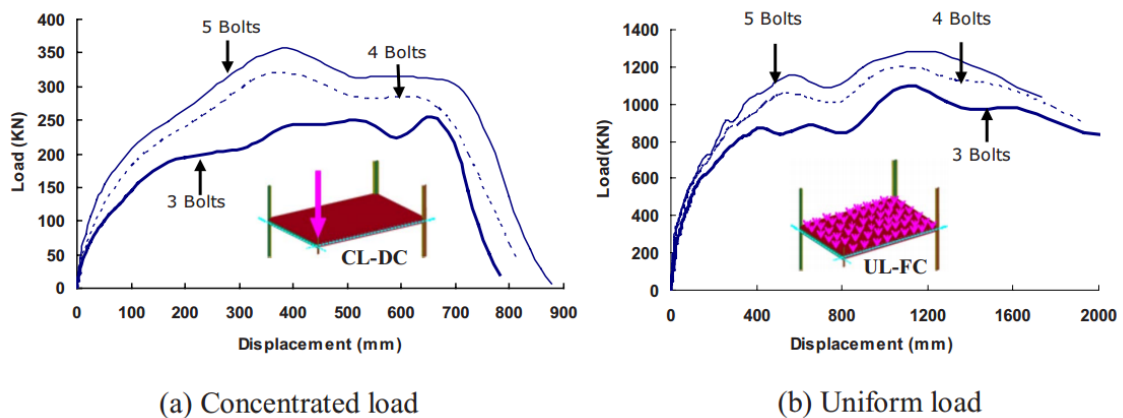
Figure 2.10: Effect of Number of Bolts in Shear Tab Connection on Floor Load-Deflection Response [10].

It was found that when an interior column was removed, the concentrated load simulations produced failures of the floor system that progressed through failures of shear tab connections. Extra bolts were added to the simulation to investigate the effect of bolt number. Three-, four-, and five-bolt configurations were used utilizing A325 bolts. The results showed that as the number of bolts increased, greater strength occurred. It was found that when utilizing five bolts instead of three, the capacity increased by 40%. The uniform load model did not agree with these results due to the fact that the connection fails much sooner than the full capacity of the floor is reached, increasing the capacity of three to five bolts by 17%. Figure 2.10 shows the load versus displacement plots between the concentrated load and uniform load models with respect to the number of bolts used.

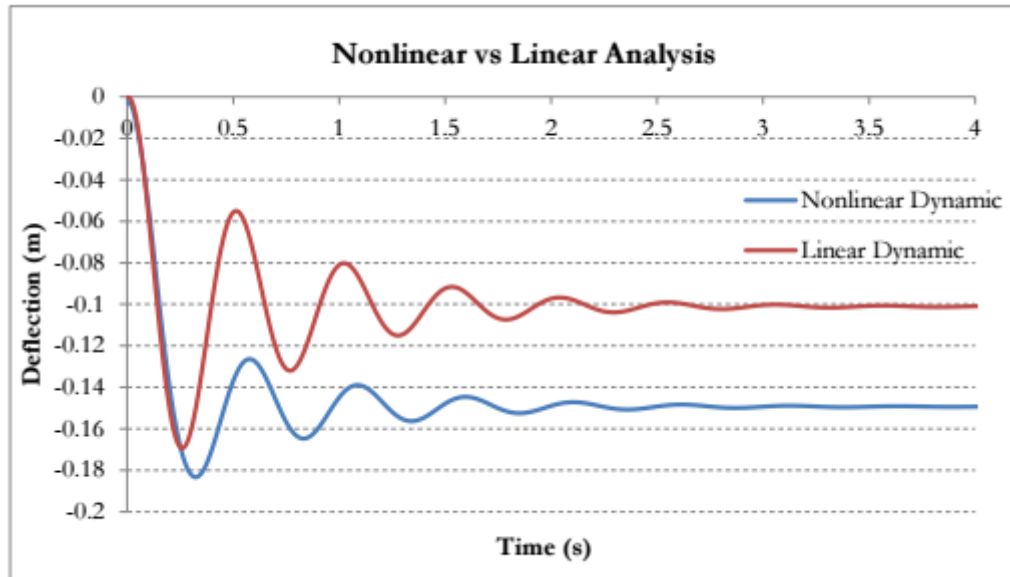
Figure 2.11: Comparison of Linear and Nonlinear Vertical Deflection of Joint at Column Removal [16].

A comparison of the linear dynamic and nonlinear dynamic response shows that the nonlinear dynamic achieves higher deflection and stabilizes at about 0.05 m more of deflection than the linear dynamic. Figure 2.11 shows the plots of the responses as deflection versus time.

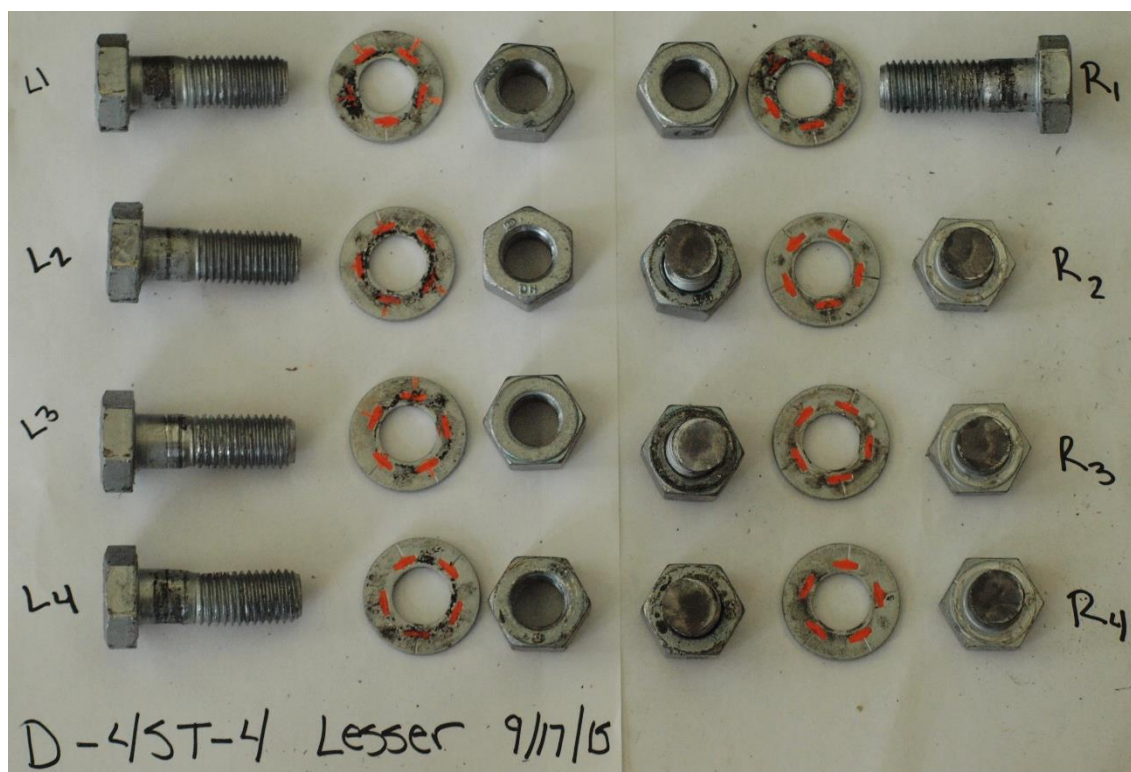
Figure 4.35: Test D4ST4 Test Bolts.
